**Bulletin:** GDC25-005

**Description:** Exhaust Gas Temperature Sensor Circuit Short to Battery or Open

**Applies To:** US24 and Newer Emissions, Product Class (B2)

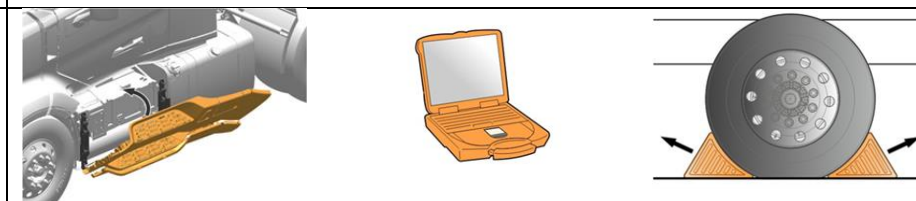
Install the LH fairing. Install the tether. Latch the fairing.  
Connect the diagnostic tool (Premium Tech Tool).  
Delete the diagnostic trouble codes according to the diagnostic tool (Premium Tech Tool) instructions.  
Disconnect the diagnostic tool (Premium Tech Tool).  
Start the engine. Check for leakage.  
Stop the engine. Remove the wheel chocks.
