# VEHICLE - WARRANTY BULLETIN

BULLETIN 2025-6 | VERSION A

Can-Am On-Road

## Pulse Rear Central Reflector Replacement

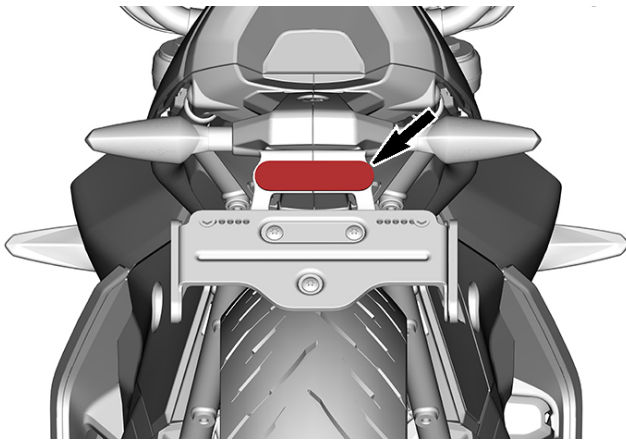
1. Remove and discard the rear reflector from the vehicle.

2. Clean the surface to eliminate all glue residues, dust and grease.
3. Cut a 60 mm (2 3/8 in) strip of 3M RP45 VHB™ tape.
4. Peel off the protective liner from the new reflector.
5. Peel off the protective liner only on one side of the 3M RP45 VHB™ tape.
6. Apply the 3M RP45 VHB™ tape centered on the adhesive of the new reflector.

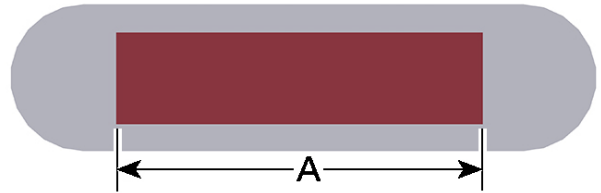
• A = 60 mm (2 3/8 in)

3M recommends the usage of a roller to ensure good contact and to remove air bubbles.

7. Peel off the protective liner on the other side of the 3M RP45 VHB™ tape.
8. Align and firmly install the new reflector. Follow the tape product application instructions to ensure a good bond. 3M recommends to apply a pressure of at least 1 kg/cm<sup>2</sup> (15 PSI) and wait minimum 24 hours before stressing the bond.
