## Technical Service Bulletin

<b>GROUP</b> <b>CAMPAIGN</b>	<b>NUMBER</b> <b>25-01-069G</b>
<b>DATE</b> <b>SEPTEMBER 2025</b>	<b>MODEL(S)</b> <b>GV70 (JK1A)</b> <b>GV70 ELECTRIFIED</b> <b>(JK1A EV)</b>

**SUBJECT:** WIRELESS PHONE CHARGER REPLACEMENT  
(SERVICE CAMPAIGN T81G)

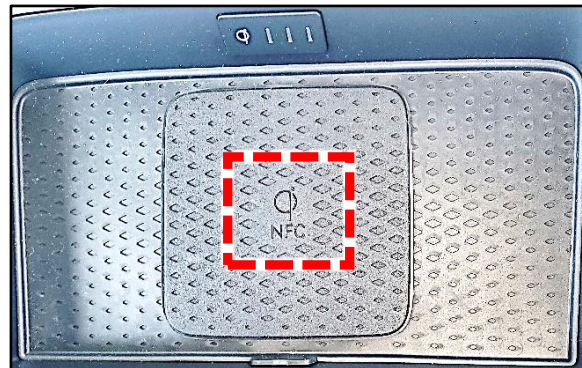
**Description:** Certain GV70 (JK1A) and GV70 Electrified (JK1A EV) vehicles may have an inoperative Wireless Phone Charger (WPC) due to an improper (non-NFC) part installation. This bulletin provides instructions to replace the Wireless Phone Charger with the Near Field Communication (NFC) feature.

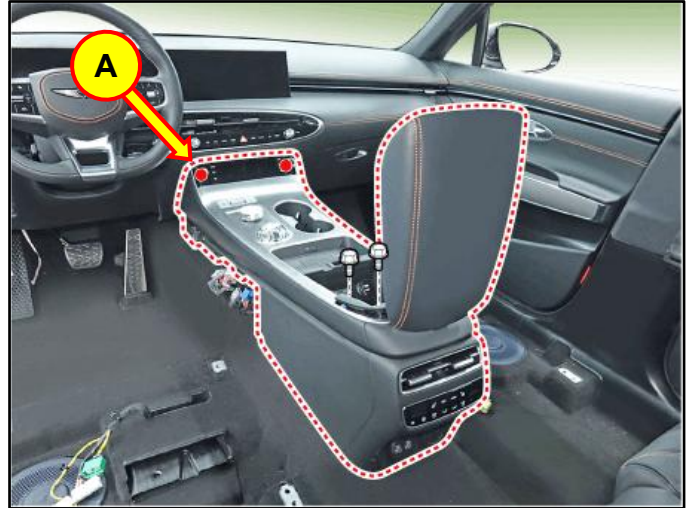
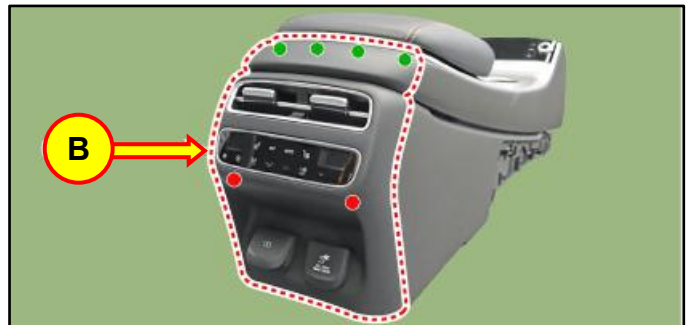
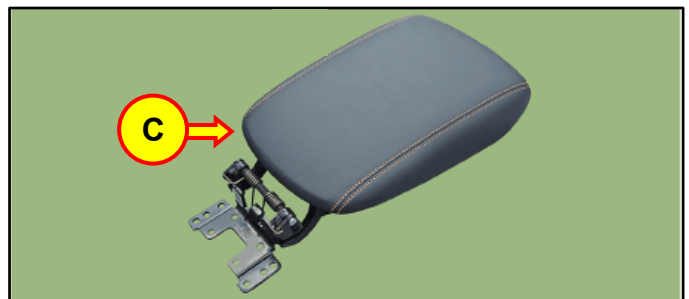
1. Remove the floor console assembly (A) by referring to the shop manual:
  - **Body (Interior / Exterior / Electrical) > Floor Console > Floor Console Assembly > Removal and Installation**
2. Remove the floor console rear cover (B) by referring to the shop manual:
  - **Body (Interior / Exterior / Electrical) > Floor Console > Floor Console Rear Cover > Removal and Installation**
3. Remove the floor console armrest (C) by referring to the shop manual:
  - **Body (Interior / Exterior / Electrical) > Floor Console > Floor Console Armrest > Removal and Installation**

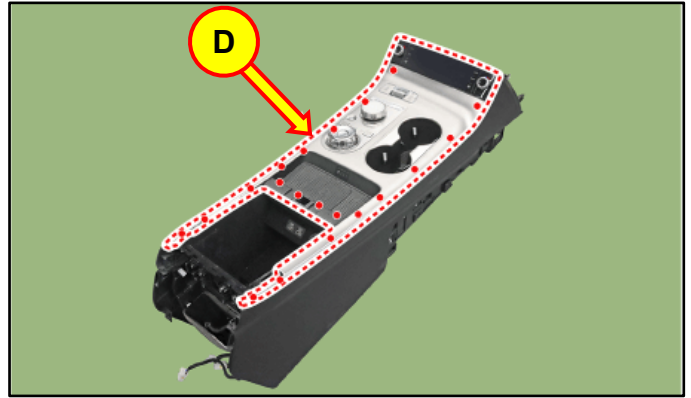
4. Remove the floor console upper cover (D) by referring to the shop manual:
- **Body (Interior / Exterior / Electrical) > Floor Console > Floor Console Upper Cover > Removal and Installation**

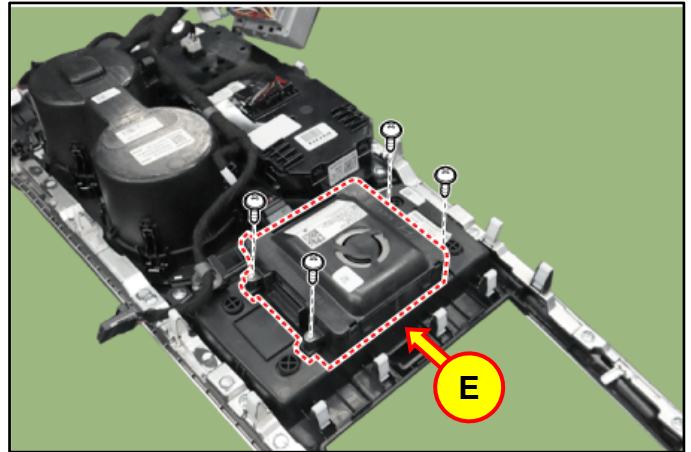
5. Remove the WPC (E) by referring to the shop manual:
- **Body (Interior / Exterior / Electrical) > Driver & Driving Assistance System > Charger System > Removal**

Do **NOT** remove the USB chargers or wireless charging lamp.

6. Install the new WPC.

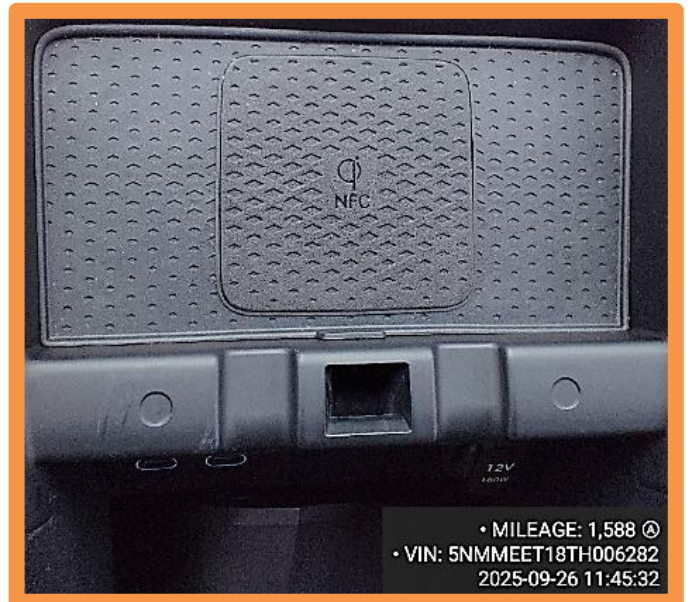
Using STUI, take a photo of the new Wireless Phone Charger installed in the vehicle with the letters 'NFC' showing.

Upload the photo to STUI.
