Service Alert

Mazda North American Operations
Irvine, CA 92618-2922

Subject: WHITE STAINS ON INTERIOR RESIN PARTS	Service Alert No.: SA-042/25
	Last Issued : 09/29/2025

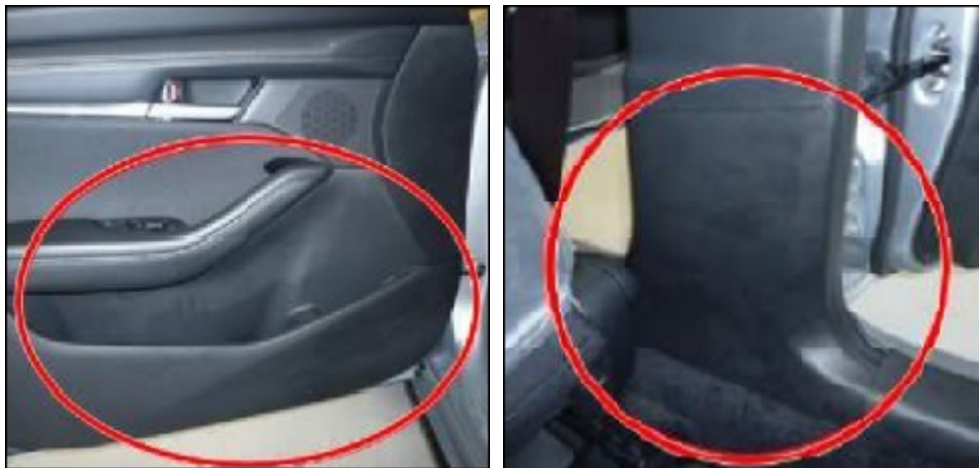
Interior parts made of resin have antistatic coating to prevent dust from sticking on the surfaces, and depending on the conditions of use, the antistatic components may crystallize slightly, giving an appearance of white stains on the surface.

To remove the stains, wipe the stained surface with a towel soaked with water mixed with a small portion of a neutral detergent. If the white stains reappear again, simply wipe them again in the same way.

NOTE: The antistatic effect does not deteriorate with this procedure.
