# Technical Service Bulletin

### Audi Q4 e-tron

94 Service info: moisture deposits in taillights

Transaction No.: **2079298/1**

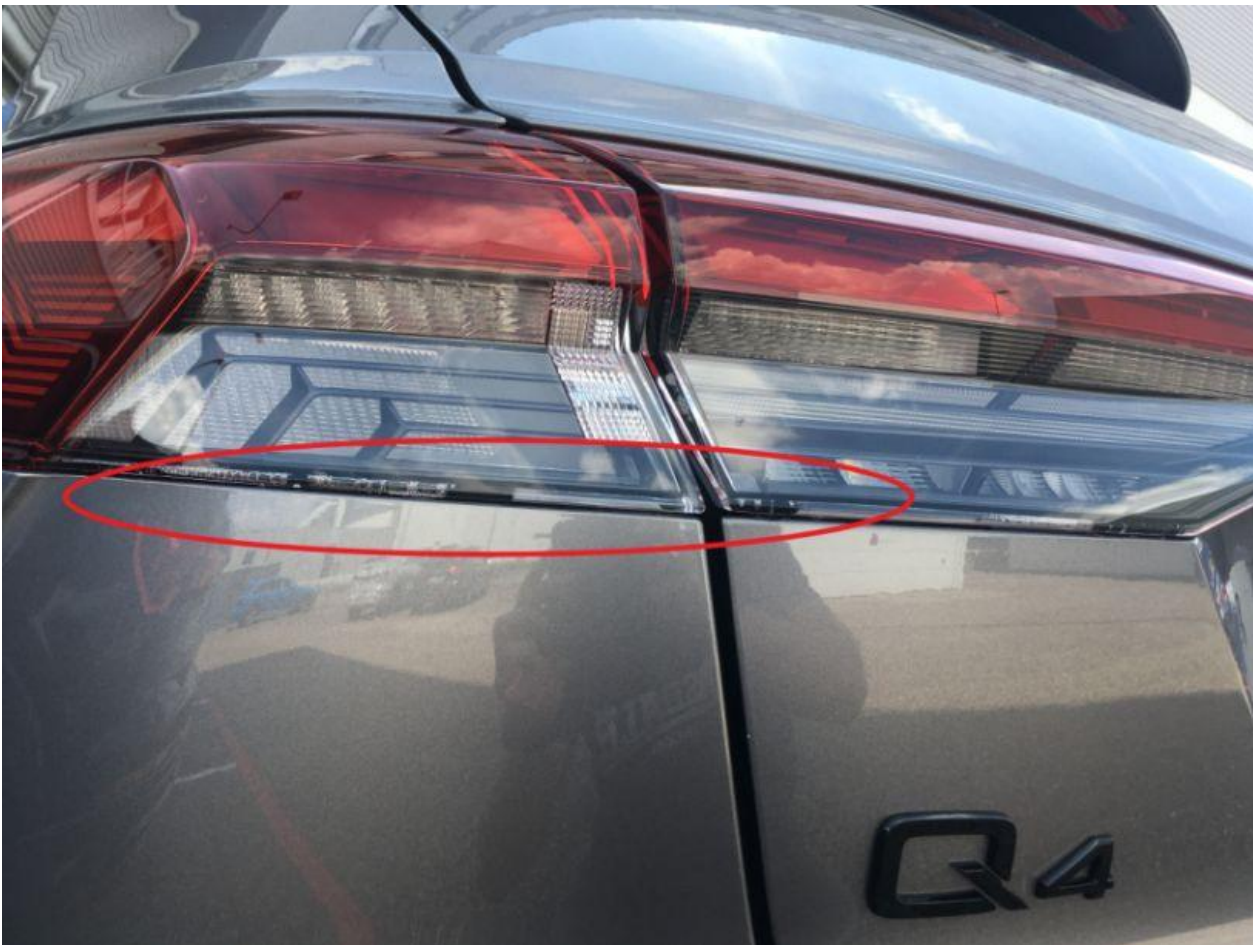
There is moisture/water, and/or dirt deposits at the lower edges of the taillights.

For design reasons, the bottom section of the taillights is transparent. In very wet conditions (heavy rain, spray), water and (possibly) dirt may be deposited. The component is not damaged.

There is no reason to replace parts or attempt repairs. Unjustified work/replacement parts will be charged back. Invoicing under warranty is not permitted.

The function of the component is not affected.
