# Technical Service Bulletin

<b>Topic</b>	48 Electric steering column adjustment does not work properly or at all
<b>Market area</b>	United States 444 Volkswagen of America, Inc. (6444)
<b>Brand</b>	Audi
<b>Transaction No.</b>	2079458/1
<b>Level</b>	EH
<b>Status</b>	Released for publishing
<b>Release date</b>	Sep 29, 2025

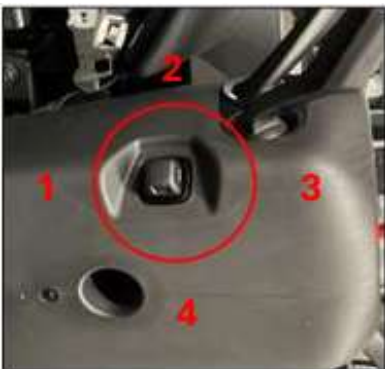
Diagram of positions:

**Start the routine as follows:**

1. Press the button back 3 times in succession (towards driver, **position 3**)

2. Press the button forwards once (towards front of vehicle, **position 1**)
3. Press the button back once (towards driver, **position 3**)
4. Press the button upwards once (towards headliner, **position 2**)
5. Press the button downwards once (towards floor mat, **position 4**)

**Do not replace any components. Instead, re-adapt the electric steering column adjustment.**

- **Without tester:**
