LP Regulator Orientation and Cover

Bulletin Type:	TSB	Publication Date:	October 2025
Bulletin #(s):	25-015	Make(s):	Jayco & Entegra Coach
Job Code(s):	9803637	Model(s):	Seneca XT (29T), Accolade XT (29T)
Flat Rate(s):	9803637A .10 HR – LP Regulator Cover and Orientation Inspection 9803637B 1.0 HR – LP Regulator Cover and Orientation Inspection and Repair	Model Year(s):	2024 - 2025

Incident:	Orientation for LP regulator needs to be changed and cover installed
Affected Units:	2024-2025 Jayco Seneca XT (29T) units; 2024-2025 Entegra Accolade XT (29T) units
Parts Kit: 25-015JM	Parts Kit #: 25-015JM
	Part Kit Contents: 1 - COVER,RGLTR LP STY: UFP ASME TK 1 - BRACKET,LP RGLTR 7.13X6.00 16GA STL BPC 2 - RIVET,PLSTC .63 BLK PLGR 4 - SCREW,HEX WSHR .25X1.00 TEK3 ZC 2 - SCREW,MACH TR QUAD 10-24X .63 ZC 2 - NUT,HEX KEPS 10-24 ZC
Misc. Tools & Supplies:	Screw Gun with 3/8" Drive head & Square Head Bit, 1/2" wrench, 1" hole saw
Parts Return Information:	N/A

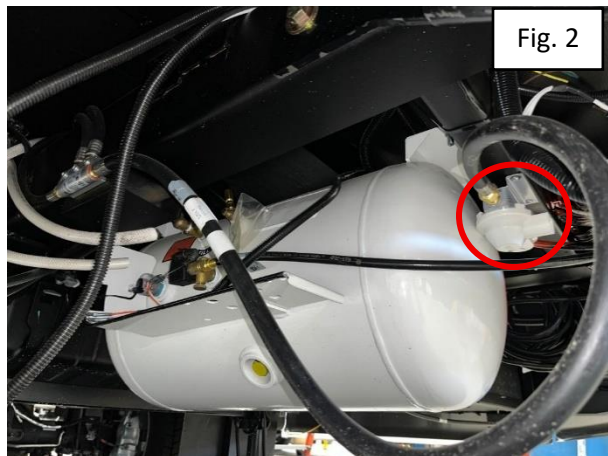
2. Remove the regulator and bracket from the coach using a screw gun with a square head bit. (Figure 2)

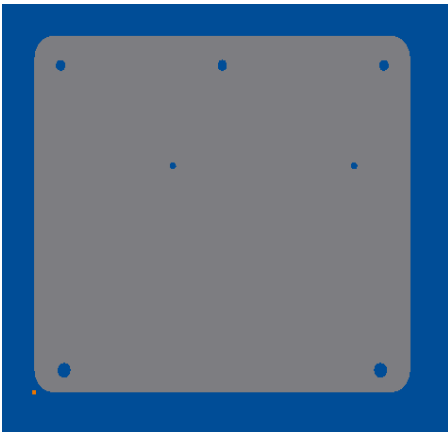
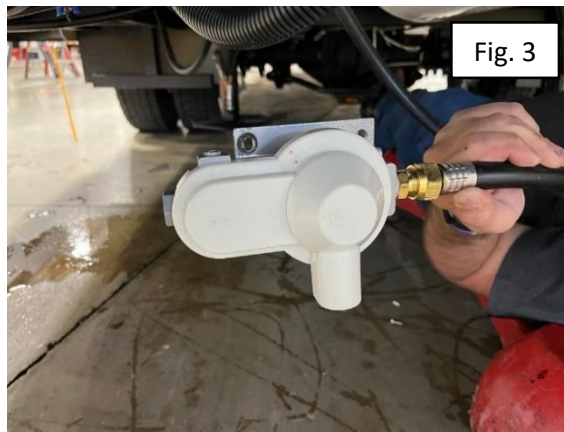
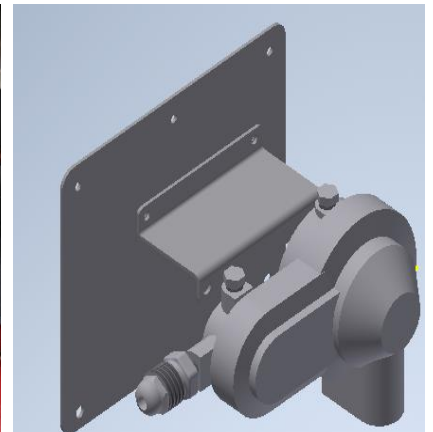
3. Disconnect the supply hose from the regulator using a 1/2" wrench.
4. Attach the regulator and bracket to the new mounting bracket using the supplied machine screws and washers. (Figure 3)
 - a. **Note: It is CRITICAL that the regulator vent be facing downwards.**

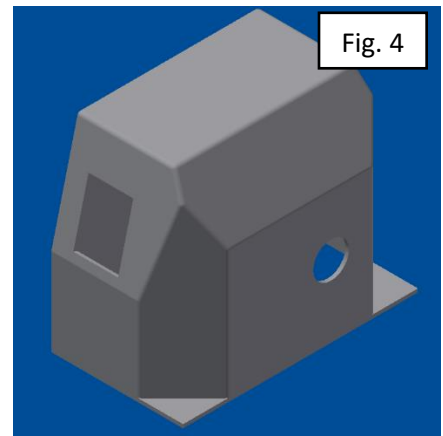
5. Place the new cover over the regulator and mark the location of the regulator vent. Use a 1" hole saw to cut a 1" hole in the cover for the regulator vent. (Figure 4)

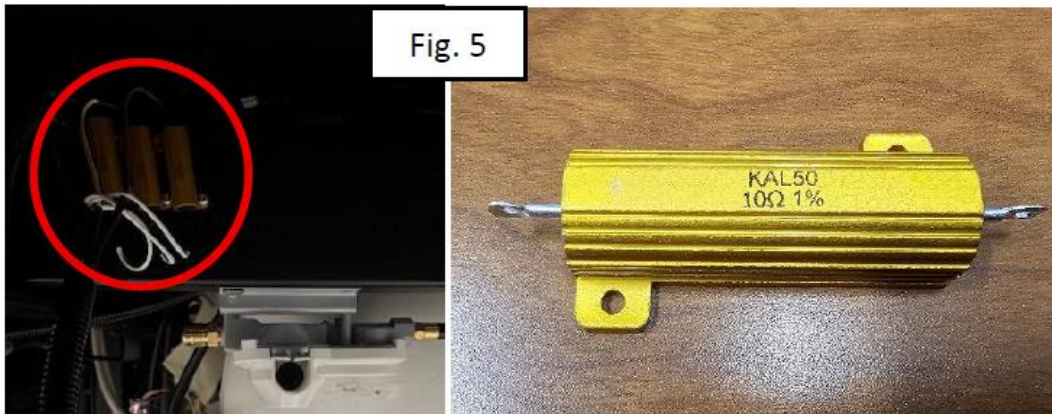
6. Re-install the bracket and assembly onto the coach, without the cover.
 - a. Note: There may be resistors on the frame rail where the LP Regulator will be mounted. (Figure 5) In the event the coach has the resistors in this location, route the LP lines away from the resistors. Contact Jayco Motorized Service for additional assistance.

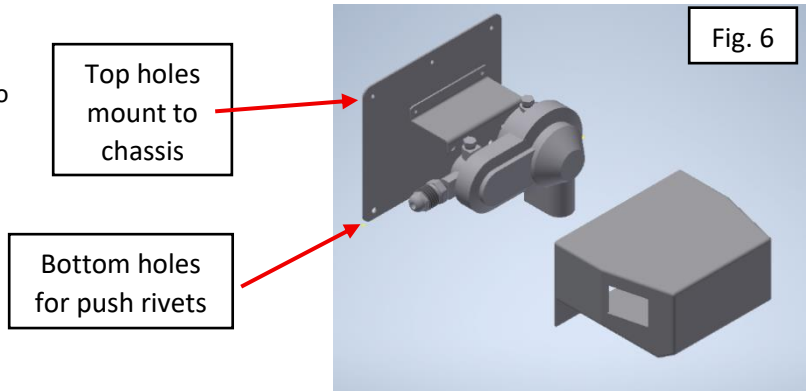
7. Attach the cover to the new mounting plate over the regulator. Secure it to the bracket using the supplied push rivets (X2). (Figure 6)

8. Re-install the bracket and assembly onto the coach.
9. Reconnect the LP lines. Do a LP drop pressure test.
