The "Easy entry and exit feature" function deactivates itself

| Topic number | LI91.10-P-078305 |
| Function group | 91.10 - Front seats |

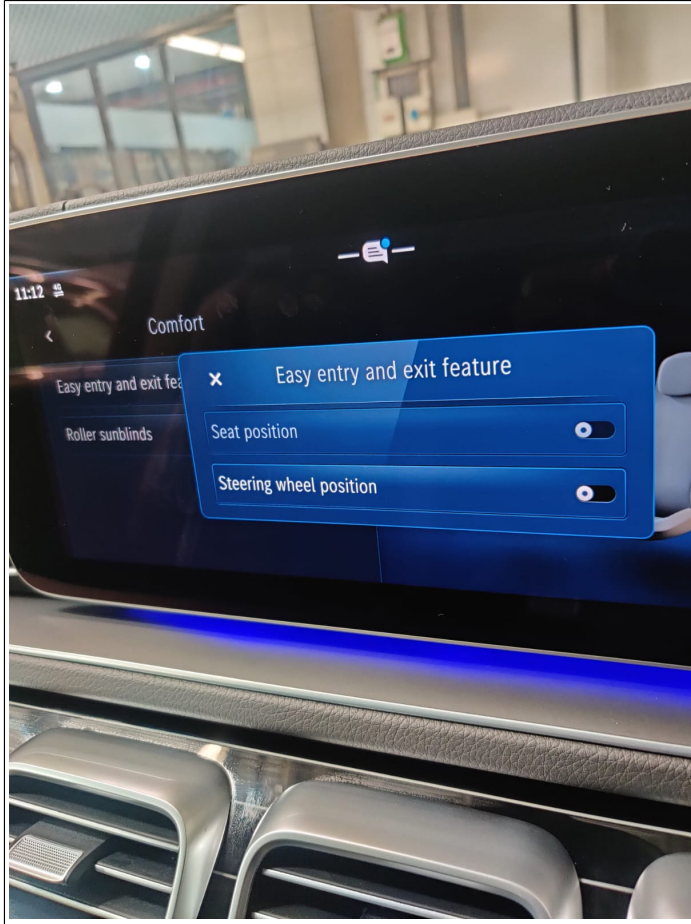
The "Easy entry and exit feature" function deactivates itself after a brief period. (see attachment)

| Attachments | |
|---|---|
| Function+decativated+condition_infotainment+dispa-ly.jpeg | Example of deactivated function |

Update the HU7 to the latest software version, then perform a factory reset of the HU7.

Steps to perform factory reset: Navigate to Settings > System > Reset > Reset to factory settings and confirm

If the problem persists, please record HU7 log and also a trace of the Body CAN (For Star 2 Body Can 1 and for Star 3 Body Can 2) during the symptom and send via a TIPS case to the Telematics team.
