Service Bulletin

Bulletin No.: PIT6444

Subject: FCC and RCC Screen Delamination Protective Film Removal

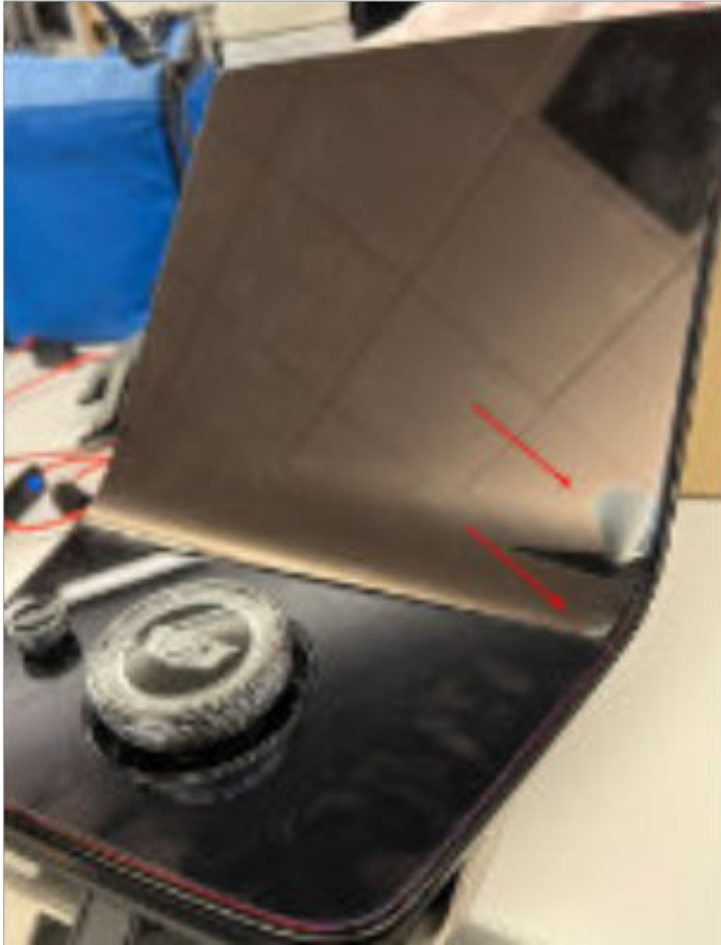
<p>Condition</p>	<p>Some Customers may comment that delamination or bubbles on FCC(Front Command Center) and/or RCC(Rear Command Console) screen.</p>

<p style="text-align: right;">7008820</p>
<p>Cause</p>	<p>The screen protective film has not been removed.</p>

The screen protective film is needed to be removed.
