## Panoramic Glass Roof has a Pop Noise

Supersedes 23-004, dated January 17, 2025, to revise the information highlighted in **yellow**.

Year	Model	Trim Level	VIN Range
2019–23	RDX	ALL	ALL
2022–23	MDX	ALL	ALL

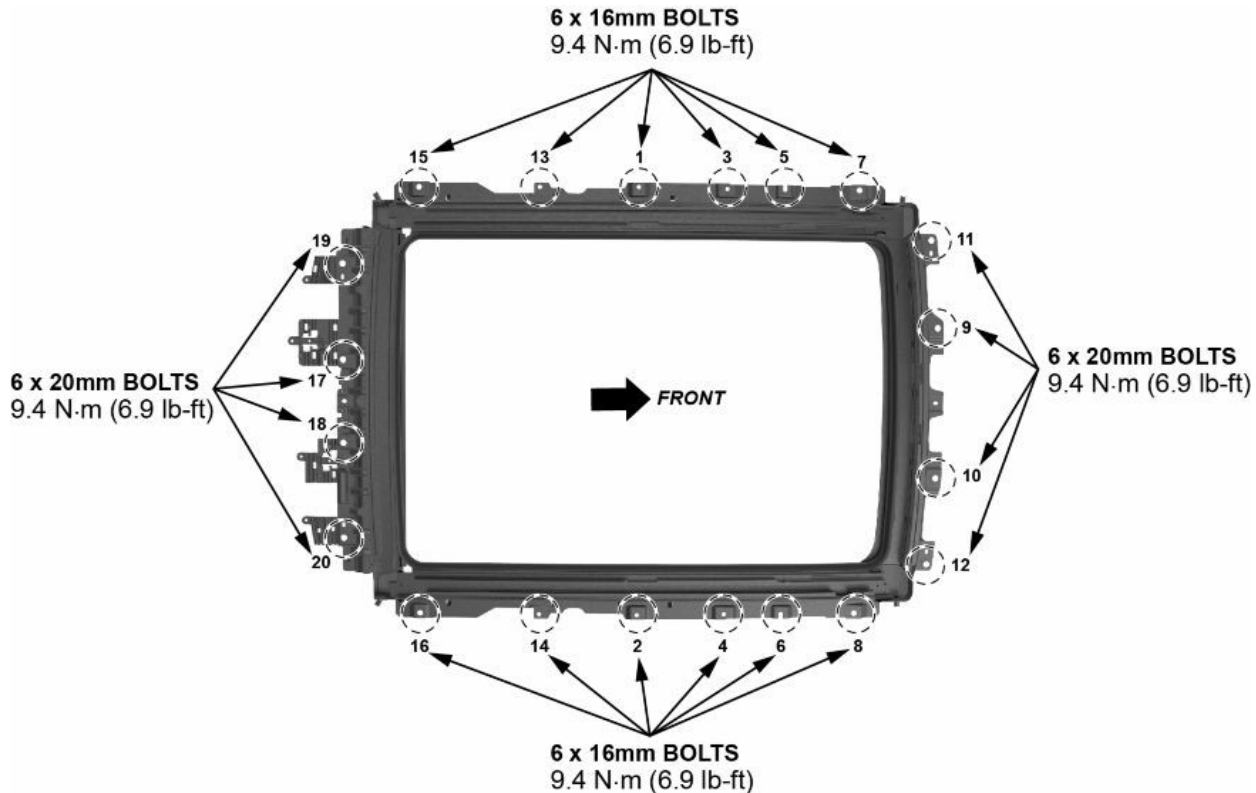
1. Replace the panoramic glass roof frame assembly, then torque to specification in the order shown.

**IMPORTANT:** There are two distinct bolt sizes included in the kit that are **not interchangeable**. Using the incorrect size bolt in either location will not properly secure the panoramic roof frame assembly.

- Make sure to **ONLY** use the included bolts from this service kit when installing the Sunroof Frame Assembly Kit.
- There are two distinct bolt sizes included in the kit that are **not interchangeable**. Using the incorrect size bolt in either location will not properly secure the panoramic roof frame assembly.
