Misfire No. 4 Cylinder (DTC P0304)

Year	Model	Trim Level	VIN Range
2017-21	Civic	TYPE R	ALL

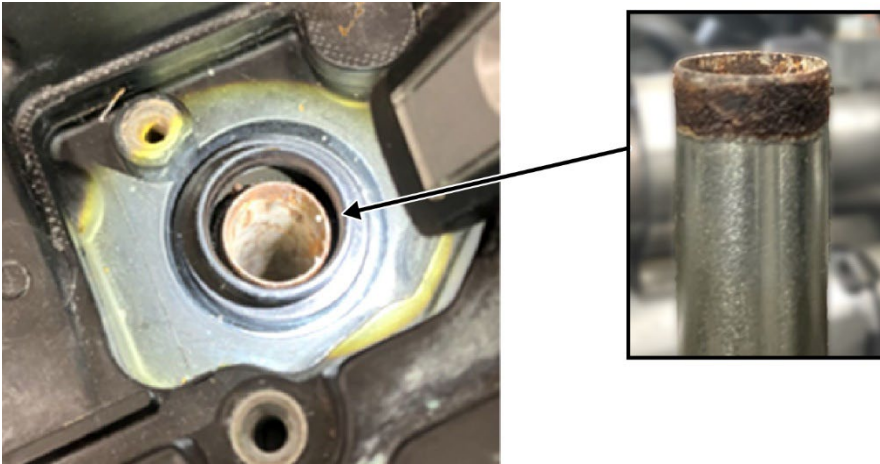
1. Connect HDS to the DLC. ([Click HERE](#))
2. Verify DTC P0304 is stored.
3. Remove the engine cover and remove the no. 4 ignition coil. ([Click HERE](#))
4. Inspect cylinder no. 4 spark plug tube, remove any residual water from the plug tube area.
5. Remove cylinder no. 4 spark plug and inspect for any corrosion on the plug.
6. Remove the remaining ignition coils.
7. Remove the cylinder head cover. ([Click HERE](#))
8. Inspect cylinder no. 4 ignition coil, plug tube, and spark plug of residual water and corrosion.

Are there any signs of water and/or corrosion on the ignition coil, plug tube, or spark plug?

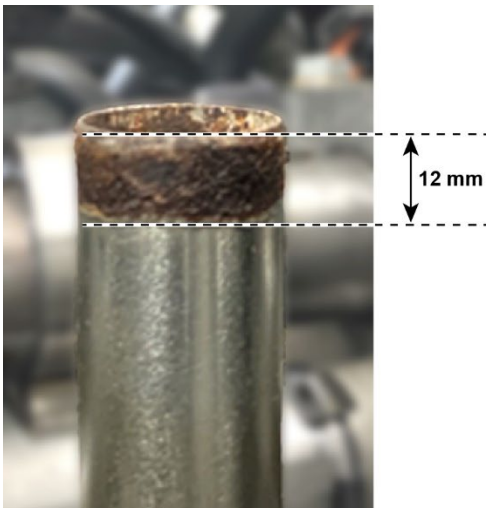
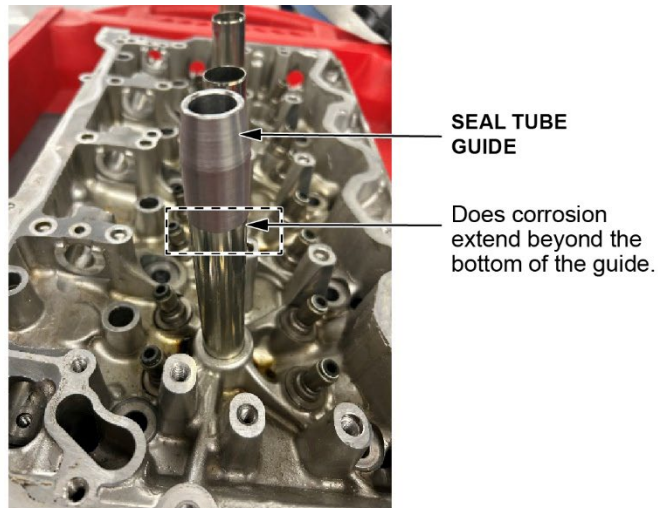
9. Place a clean shop towel around the bottom of the no. 4 spark plug tube and another clean shop towel down inside the spark plug tube. Remove the rust and corrosion from the spark plug tube using a burgundy-colored abrasive pad.
10. After cleaning the rust and corrosion:
 - Check the spark plug tube for small holes and/or cracks
 - Place the seal guide on to the no. 4 spark plug tube

Does the corrosion on the no. 4 spark plug tube exceed 12 mm or extend beyond the bottom of the seal tube guide?
Are there small holes and/or cracking in the tube?

Yes – Take a photo of the spark plug tube corrosion/hole(s)/crack(s), then proceed to **Repair Procedure B**.

No – Go to **Repair Procedure A**.

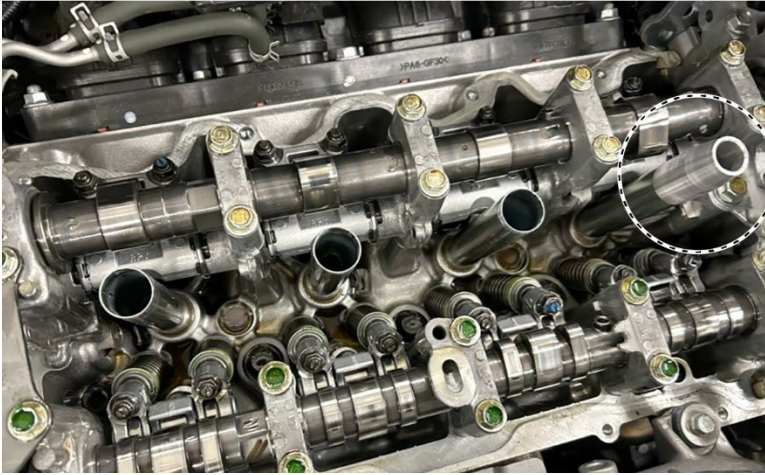
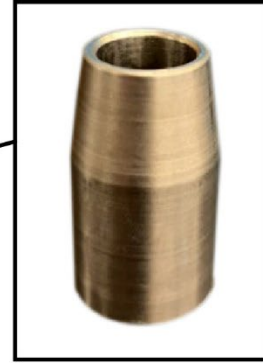
1. Install the seal tube guide tool on top of the clean no. 4 cylinder plug tube.

NOTE: Make sure the tapered end of the seal tube guide tool is pointing up.

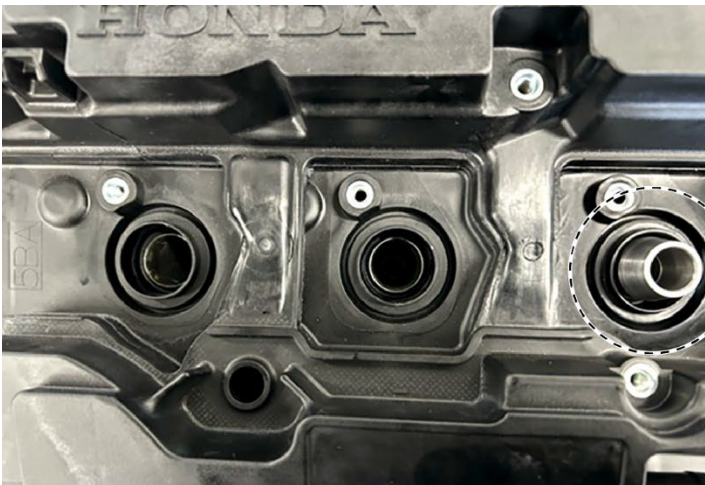
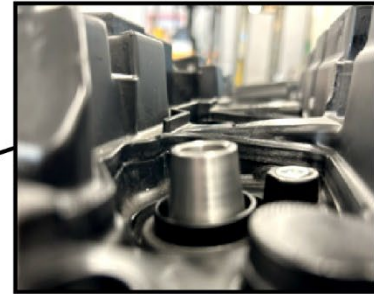
2. Apply a light coat of fresh engine oil to the **new** head cover plug seal, then carefully slide the head cover over the seal tube guide and onto the cylinder head.

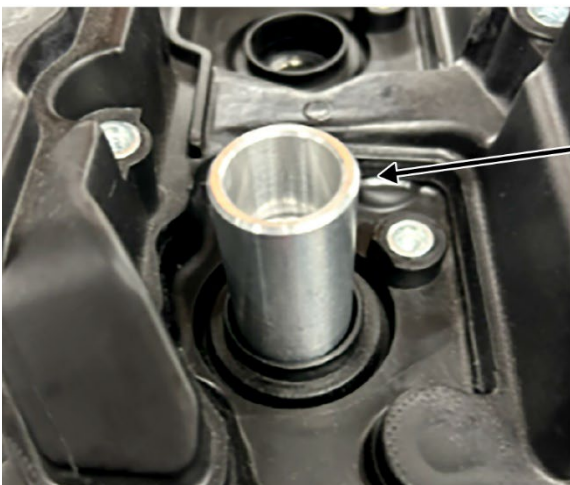
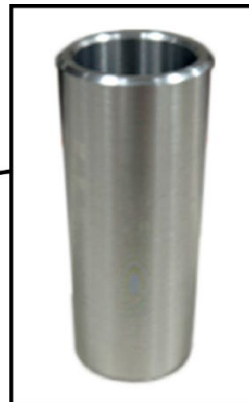
3. Set the seal tube setter tool in the head cover and on top of the seal tube guide. Make sure the plug tube is properly set in the cylinder head cover.
