# ConMet Oil Pan Insert Additional Issues

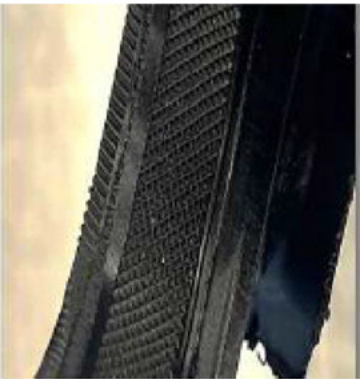
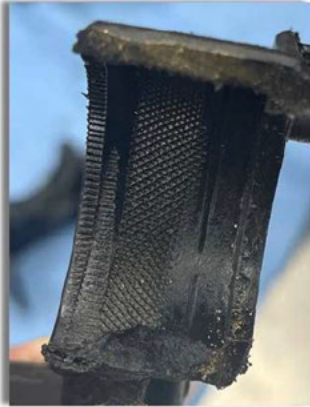
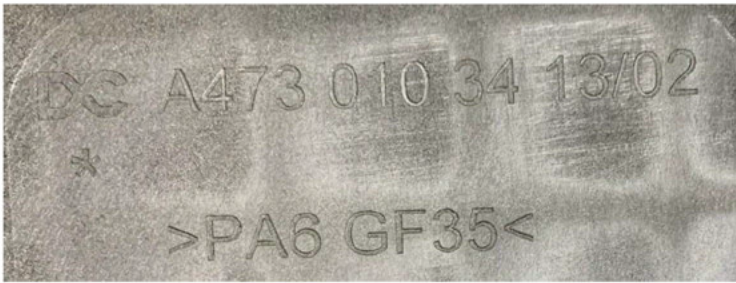
- Oil leak from oil pan drain plug area due to spinning inserts. Original issue was resolved by supplier updates to the oil pan manufacturing process. Original clean point date of 7/28/2021 based off of DMC serial numbers provided by ConMet.

- DDC has been meeting regularly with ConMet to review the issue and potential ICA's and PCA's.
- Discrepancies found on ConMet's drawing when compared to Bolhoff (knurling supplier) recommendations. Not achieving proper adhesion between the insert and oil pan.
- EVAC line (equipped at truck plant) contributing to issues.
- **New clean point date of 6/4/2024 for oil pans in production at DDC, starting ESN 472912S1170614.**
- Oil pans built on and after the clean point date will have an "\*" under the Detroit part number (see image to the left).

- Replace oil pan.
