Technical Service Bulletin

Topic	Running gear - Noise identification
Market area	Bentley: worldwide (2WBE),China 796 VW Import Comp. Ltd (Vico), Beijing (6796)
Brand	Bentley
Transaction No.	2074954/3
Level	EH
Status	Released for publishing
Release date	Sep 24, 2025

New Continental GT / C and New Flying Spur

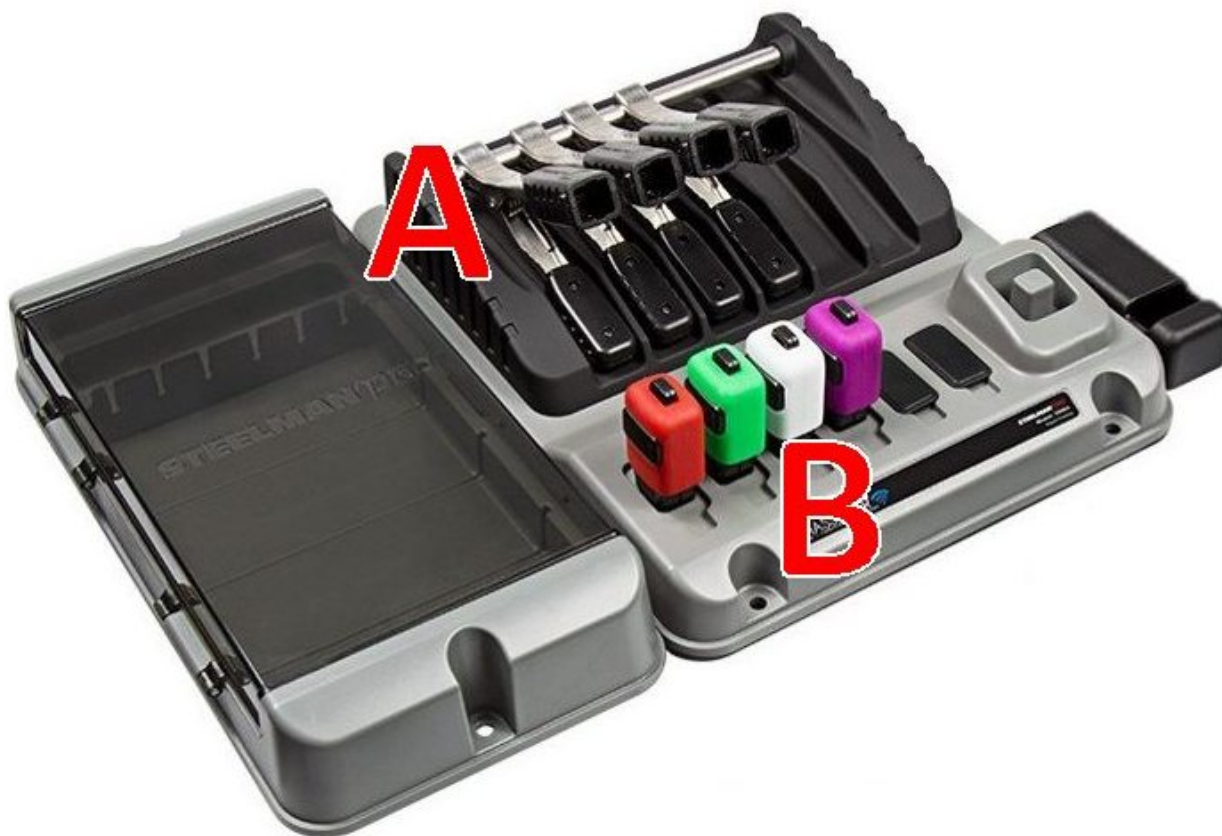
3) Referring to Figure 1 - Using the sensor clamp/s (Point A) and Bluetooth module/s (Point B) provided in the kit - Record the noise

TIP: In order to locate the noise it could be necessary to use multiple clamp and module assemblies, the operative must refer to the appropriate user instructions

NOTE: If the noise is only evident during a road test, the clamp and module assembly must be positioned outside of the cabin for the best results, please be aware that recordings from outside of the vehicle may not help identify the issue at higher speeds or noisy geographical locations, therefore a recording from inside the cabin will also be required
