## 2022+ Indian Chief Models Whistling Noise from Engine or Intake

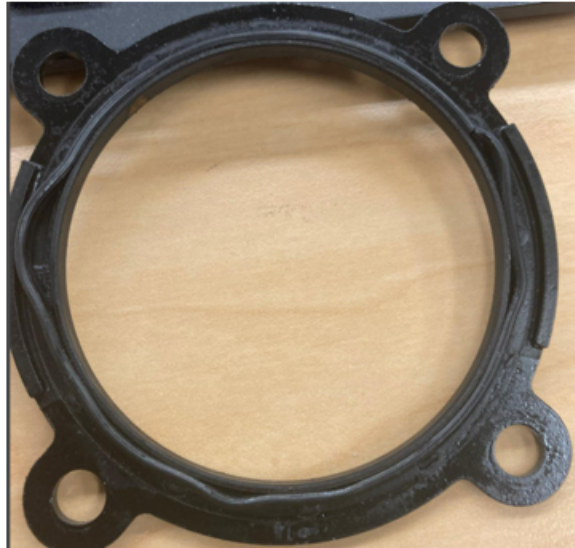
**Potential Cause:** This noise may be traced back to the air box O-rings. During installation, these O-rings can become pinched, misaligned, or smashed, which disrupts the seal and creates an abnormal whistling sound as air passes through the intake system.

**1. Remove the air box cover and inspect the O-rings** around the intake tract. Look for signs of:

- Flattening or distortion
- Improper seating
- Damage from over-tightening

**2. If any issues are found, replace the O-rings** and ensure proper installation.

Correctly seated and undamaged O-rings will restore the proper seal and eliminate the whistling noise. Always verify the noise is resolved after reassembly and test ride.
