GROUP	MODEL
GEN	2023-2024MY Forte (BDm)
NUMBER	DATE
103	November 2025

## TECHNICAL SERVICE BULLETIN

### TIRE MOBILITY REPLACEMENT

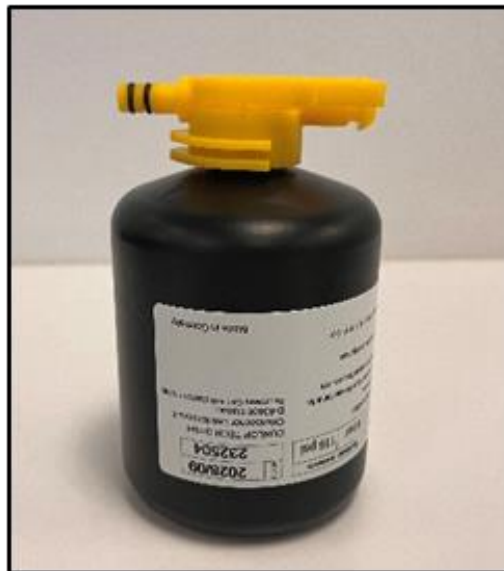
This bulletin provides information to replace the Tire Mobility Kit (TMK) sealant can or TMK bag assembly on certain 2023-2024MY Forte (BDm) models produced from March 01, 2023 through November 30, 2023. Lower ambient temperatures can create a vacuum effect inside the TMK sealant can, causing the sealant can cap to open, resulting in the tire sealant leaking. Follow the procedure outlined in this publication to replace the sealant can or TMK bag assembly on the applicable vehicle.

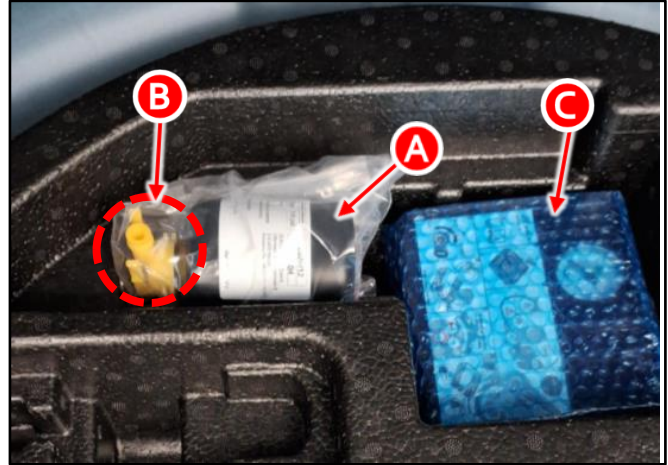
1. Insert the NEW sealant can (A) ensuring the yellow cap (B) is facing upright.

If leaked sealant has penetrated the inflator bag, test the inflator (C) for proper operation. If inflator and/or other damaged parts require replacement due to leaked sealant, follow normal warranty procedures and attach a KVID photo of the damaged component to the warranty claim.

2. Reinstall all removed parts in reverse order of removal.
