Technical Journal

PS3 Step in Lights Flashing

REF NO: TJ 37362.1.0	ISSUING DEPARTMENT: Technical Service	CAR MARKET: United States and Canada	
PARTNER: 3 US 7515 Polestar		ISSUE DATE: 2025-10-09	STATUS DATE: 2025-10-27
FUNC GROUP: 3540	FUNC DESC: Llighting, interior	Page 1 of 3

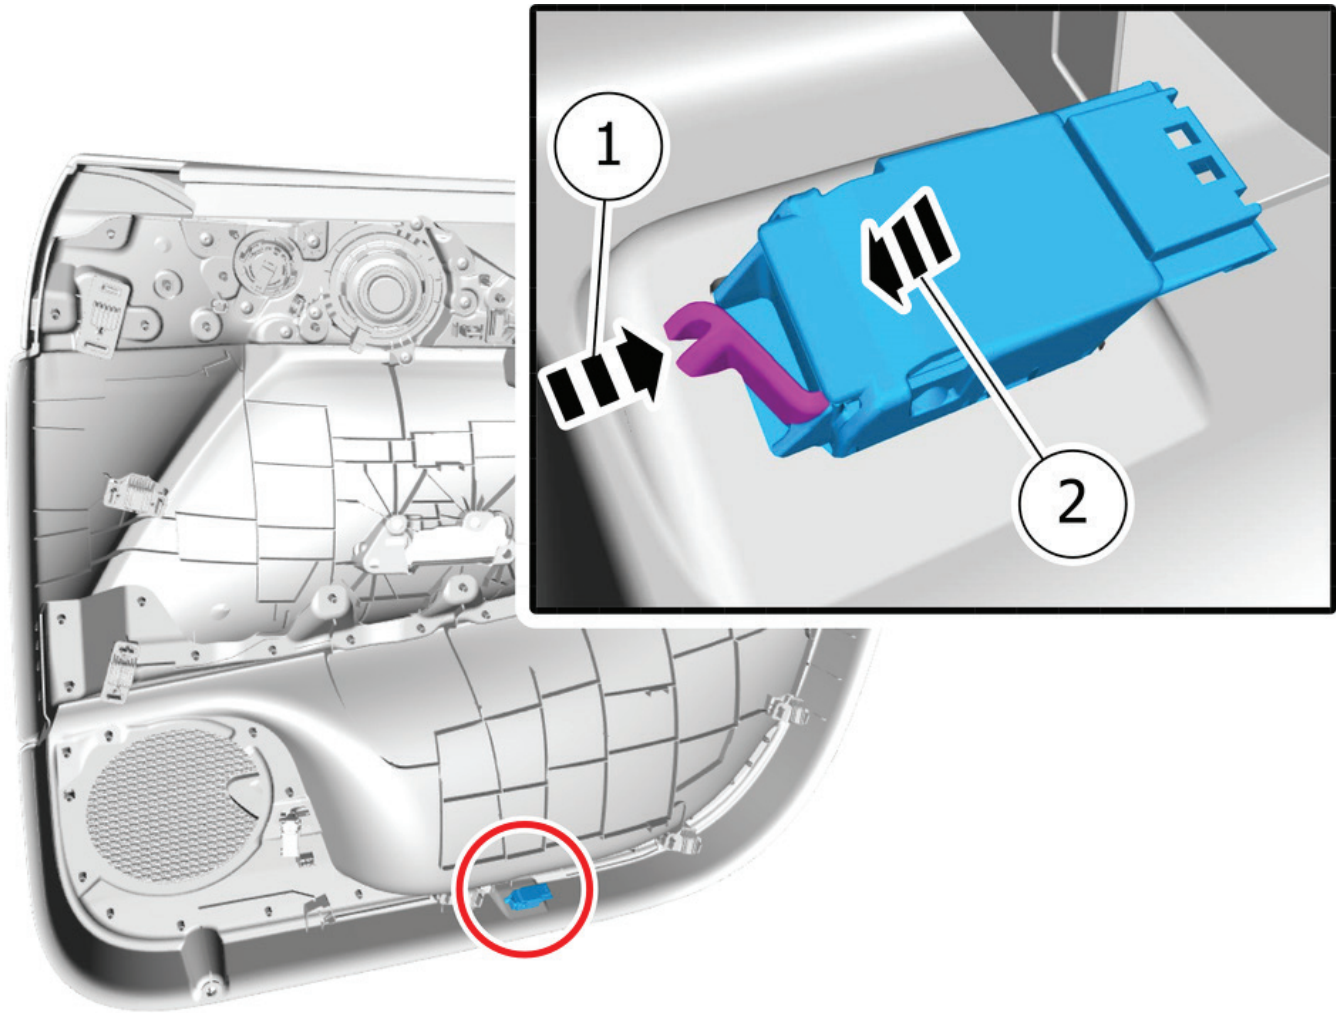
If step-in lights are flashing, sometimes in alternating colours on one or more doors as attached movie TJ_37362_1.MOV, please follow advice under service.

1. Disconnect the affected step-in lamps from its connector and wait for one minute
2. Reconnect the lamp and then run the service function "Auto-addressing Interior Illumination" using VIDA.

If the issue persists, replace the affected step-in lights.

3. Remove the door panel as per Vida instructions.
4. Replace the affected step-in lights. Refer TJ_37362_1.jpeg
5. Run the service function "Auto-addressing Interior Illumination" using VIDA.
