L636-
A.18.25

Differential cable fixing

Urus SE

During ongoing product monitoring, Automobili Lamborghini S.p.A. introduced a reinforced differential cable clip

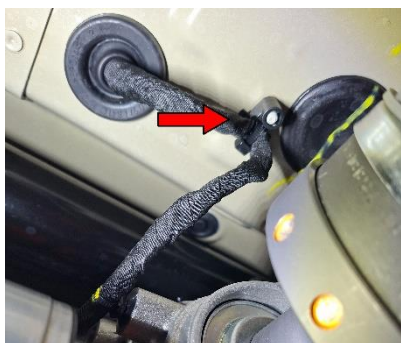
Figure 2 - Clip position and cable in correct position

2. Check that the upper clip of the wiring is properly fixed and that the wiring is not damaged (see images).

3. If the wiring is not damaged (figure 2), you only need to replace the clip (**operation B**).
4. If the wiring is damaged (figure 3), it will need to be replaced (**operation C**).

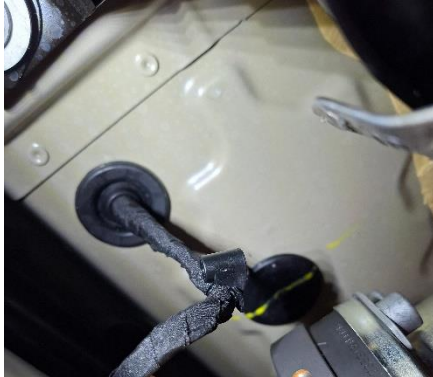
Figure 4- Clip disconnected

1. Release the clip from the prisoner if still in position.
