## Condition

| Model(s) | Year(s) | VIN Range | Vehicle Specific Equipment |
|---|---|---|---|
| A3 Sportback e-tron | 2016 – 2018 | All | Not applicable |

## Workshop findings:

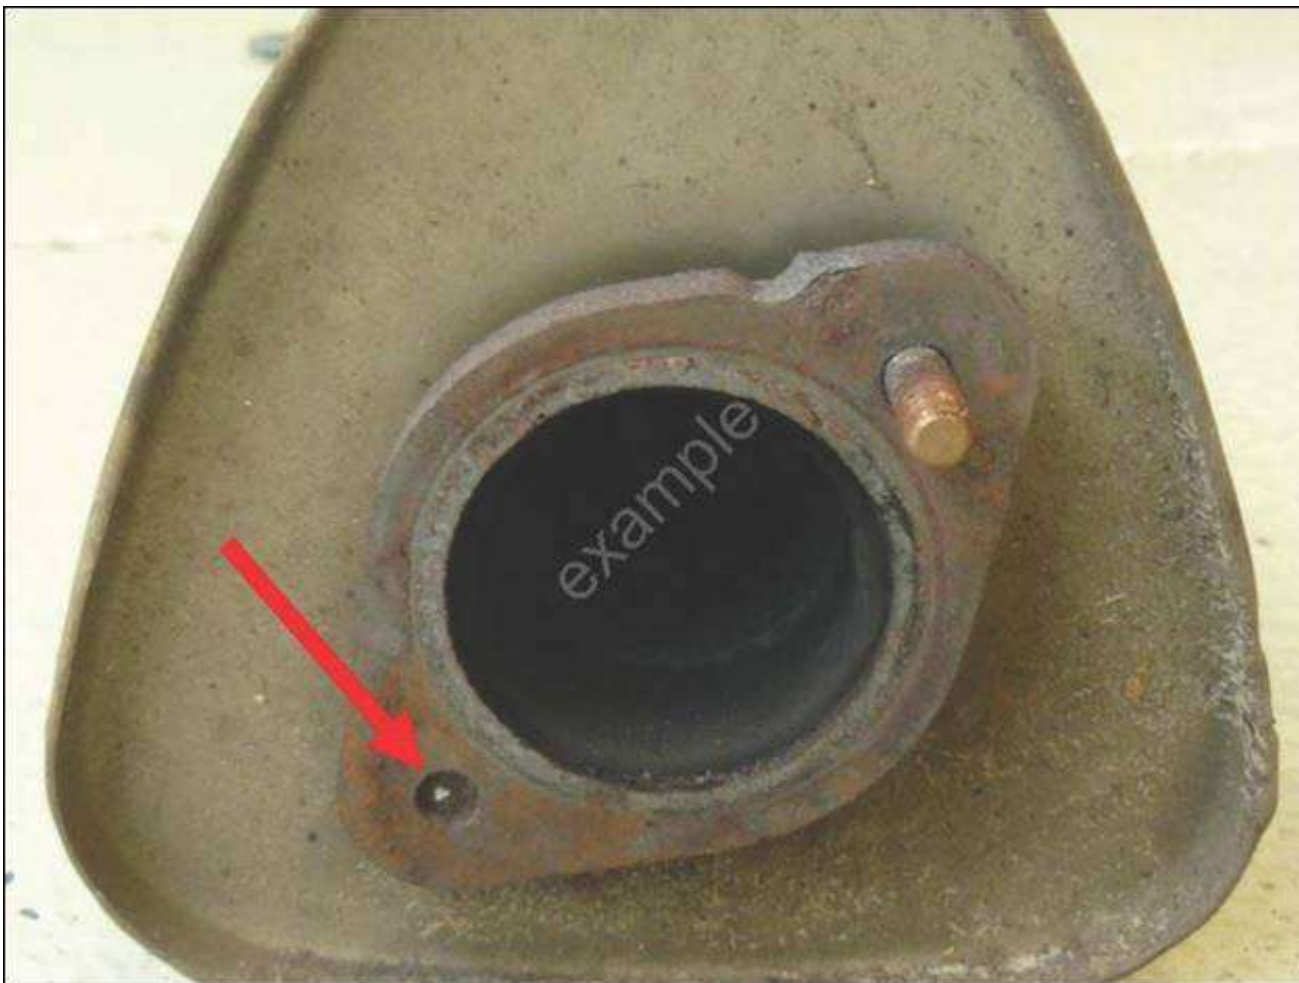
- During assembly/maintenance work on the exhaust system, one (see Figure 1, red arrow) or both studs on the flange of the front silencer are torn off.

**Figure 1.** Example of torn-off stud on front silencer (red arrow).

Drill out torn-off studs on the flange of the front muffler and replace them with alternative studs.

It is not necessary to replace the front silencer in this case. If one or both studs on the flange of the front silencer have been torn off (see image 1, red arrow), both studs must be replaced with alternative studs (see *Required Parts and Tools* in ELSA). If the front muffler is replaced under warranty without good reason, the costs will be charged back.

- **If necessary:** Remove front silencer according to
- Center-punch torn-off studs slightly using a suitable tool. Then drill out torn-off studs one after the other using a commercially available metal drill (diameters: 3.5 mm, 5.0 mm and 6.8 mm).
- Then cut threads (M8) in holes using a suitable tool.
- Screw stud (for part number, refer to *Required Parts and Tools*) into thread.
- **If necessary:** Install front silencer according to the *Workshop Manual*.
- Replace nuts and gasket according to the *Workshop Manual/Parts Information*.
