WSP3 - Check Roof Spoiler Joint Dimension and Rework If Necessary (Workshop Campaign)

Model Line: **Cayenne Coupé (9YB)**

Model Year: **As of 2024**

Concerns: **Joint dimension between roof spoiler and roof**

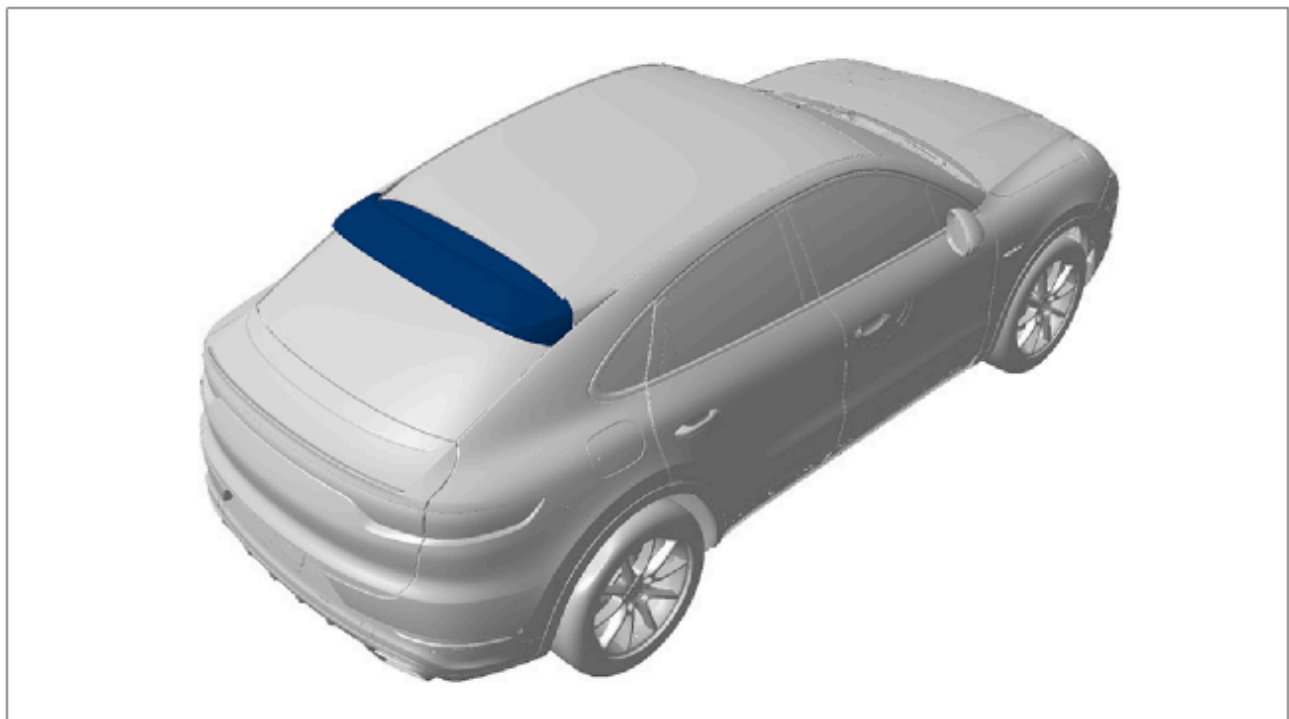
Roof spoiler installation position

Cause: **There is a possibility that due to faulty attachment of the roof spoiler the joint dimension from the roof spoiler to roof does not comply with specifications on the affected vehicles.**
 This may lead to damage to the roof or be perceived by the customer as a visual impairment.

Action: Check joint dimension between roof spoiler and roof and rework if necessary.

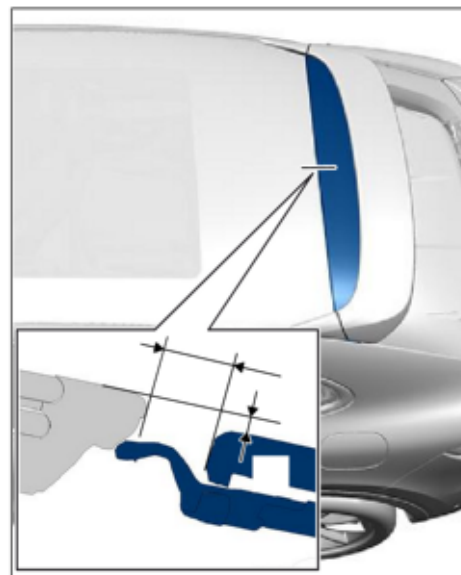
Roof spoiler center trim to roof

Work Procedure: 1 Measure joint dimension \Rightarrow *Roof spoiler center trim to roof -F-* and offset \Rightarrow *Roof spoiler center trim to roof -V-* between roof spoiler center trim and roof.

- F** – Roof spoiler center trim joint: **5.5 mm** +1.5 mm – 0.5 mm
- V** – Roof spoiler center trim offset: **-1.2 mm** + 1.0 mm – 0.8 mm

Assessment		Action
(✓)	Joint dimensions and offset are OK .	Check roof spoiler attachment. Continue with Step \Rightarrow 3.
(✗)	Joint dimensions and/or offset are not OK .	Clip in possible loose clips. Continue with Step \Rightarrow 2.

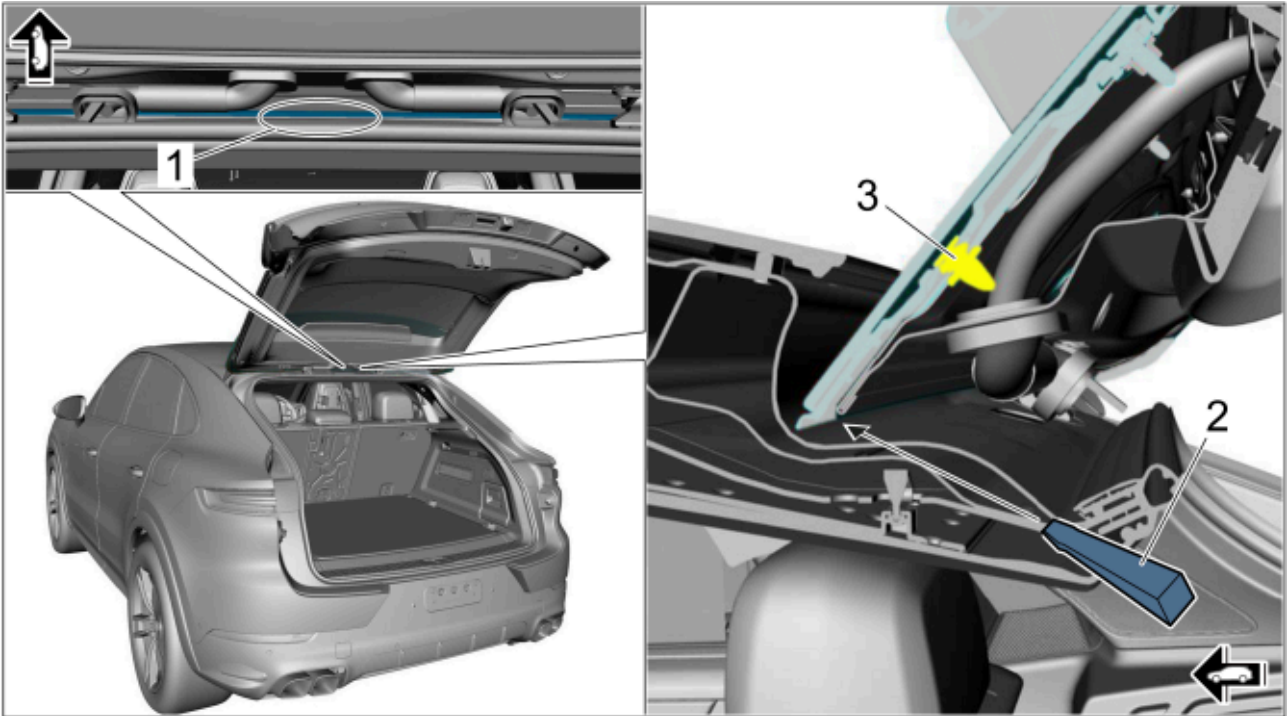
Check secure installation of the roof spoiler

3 With the rear lid open, in the middle in \Rightarrow *Check secure installation of the roof spoiler -Arrow direction-* press against the inner side of the roof spoiler center panel in the area \Rightarrow *Check secure installation of the roof spoiler -1-* using a suitable tool, e.g. plastic wedge \Rightarrow *Check secure installation of the roof spoiler -2-*.

Assessment		Action
(✓)	The roof spoiler center trim is fixed.	The roof spoiler attachment is OK . Enter the campaign in the warranty and maintenance logbook. End of action. Invoicing for Scope 1 .
(✗)	The roof spoiler center trim is loose or a clip ⇒ <i>Check secure installation of the roof spoiler -3-</i> jumps out of the latch again.	The mounting of the roof spoiler is not OK . Continue with Step ⇒ 4. Invoicing for Scope 2 .
