# Service Bulletin

Bulletin No.: PIP6064A

**Subject: Diagnostic Tip - LZ0 Multiple DTCs Due to Melted Harness**

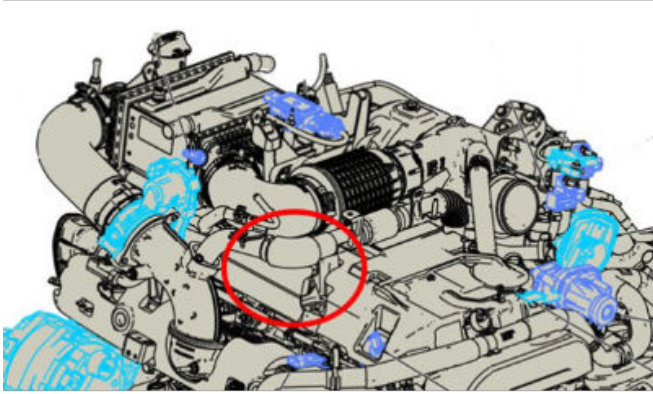
6927354

<b>Involved Region or Country</b>	North America
<b>Condition</b>	MIL on with any of the following DTCs set in the ECM: B2AEF, P00EA, P00EB, P00EC, P01BB, P01BC, P01BD, P0202, P0203, P0204, P0206, P0264, P0265, P0267, P0268, P0270, P0271, P0276, P0277, P0335, P0403, P0405, P0406, P045A, P045C, P045D, P0489, P0490, P0521, P0522, P0651, P0685, P0686, P0690, P0960, P0962, P103B, P103C, P1249, P124A, P124B, P124D, P1682, P16A7, P16B3, P16BC, P16BD, P17F5, P17F6, P17F7, P17FA, P17FB, P17FC, P2053, P2147, P2148, P2150, P2151, P2153, P2154, P2156, P2157, P216B, P216C, P217B, P217C, P217E, P217F, P2381, P2382, P2384, P2564, P2565, U1608, U1609, U160C, U1610, U1611, U1615, U1617, U1639, U163D, U1643, U1647, U1659, U165A, U1818 and/or P0641.
<b>Cause</b>	This may be caused by a damaged wire harness that has come into contact with the EGR cooler outlet pipe or the duct bracket.

If you have any of the above DTCs, check the harness for damaged in the area indicated in the picture below. Repair as necessary and secure the harness to prevent repeat damage.
