Volvo Car Customer Service

TJ Instruction VCC-517278-1

Title	Temperature sensor, evaporator	Page	1 (5)
Action	Product fix	Operation number:	98734-2 98733-2

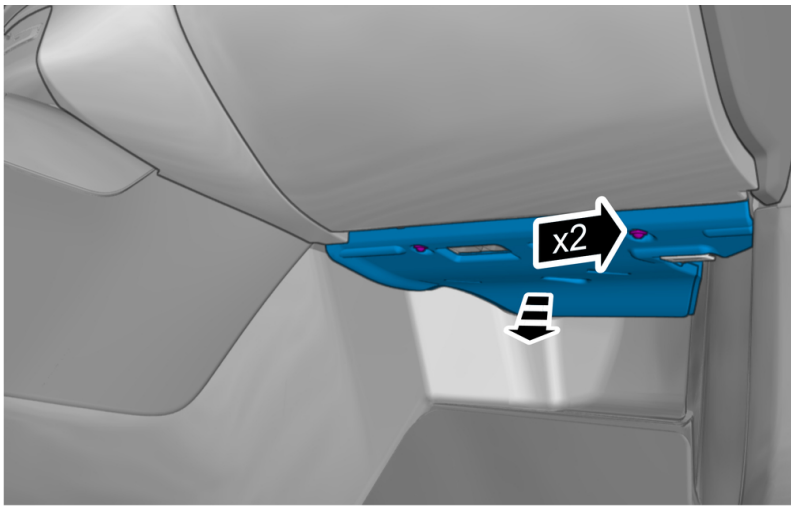
Remove the screws.
Detach the panel.

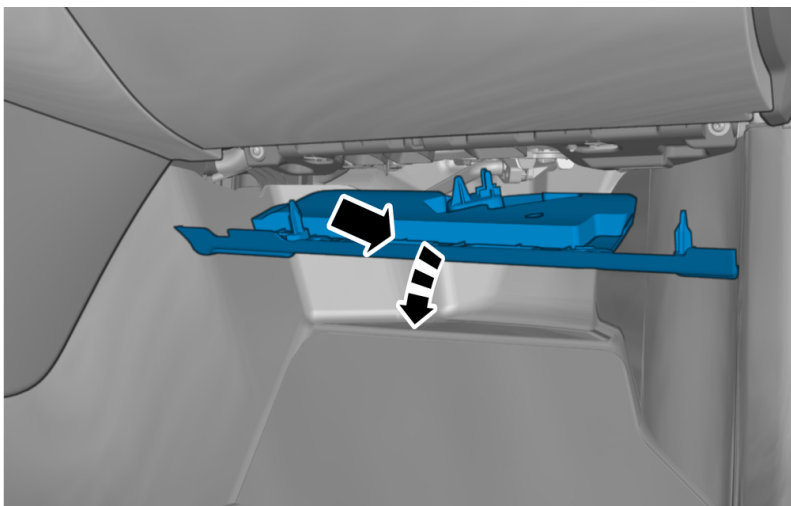
Remove the panel.

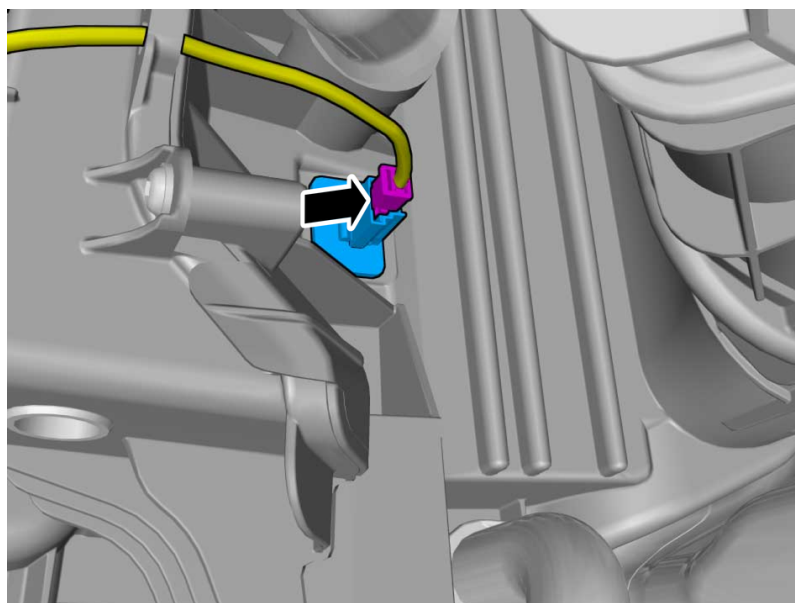
Disconnect the connector.

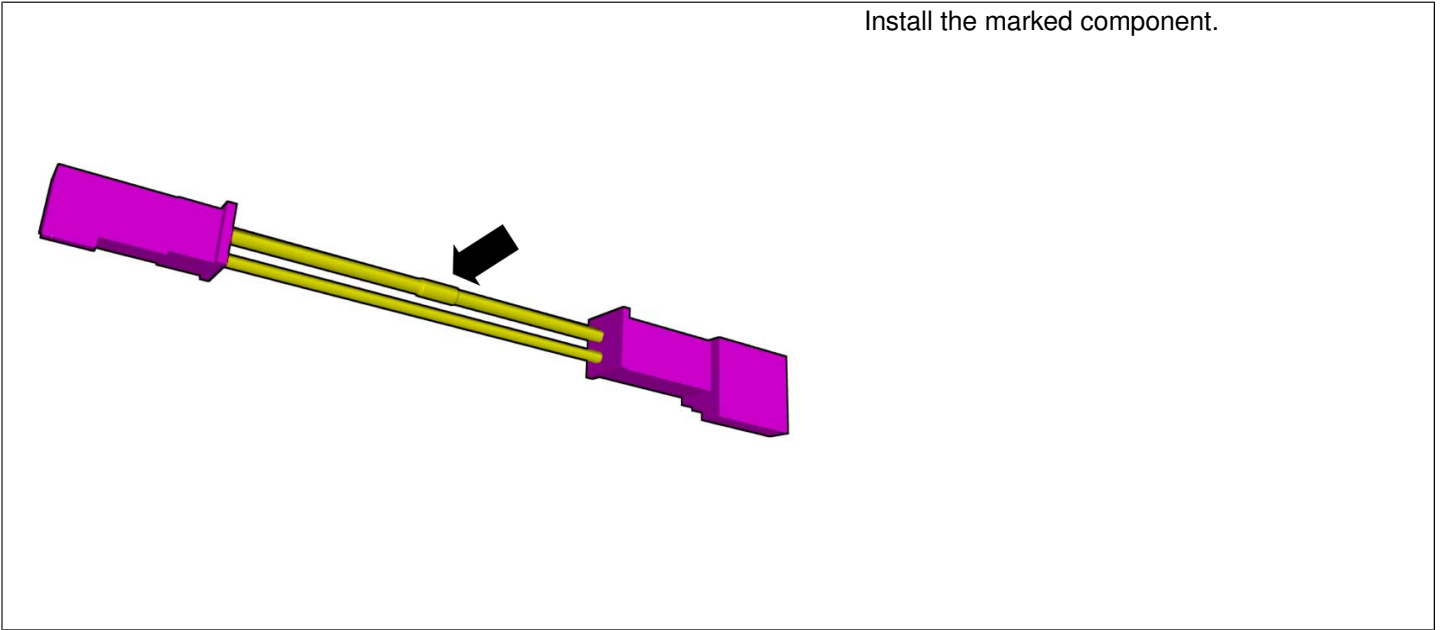
Install the marked component.

Caution! Make sure that the components are positioned correctly.

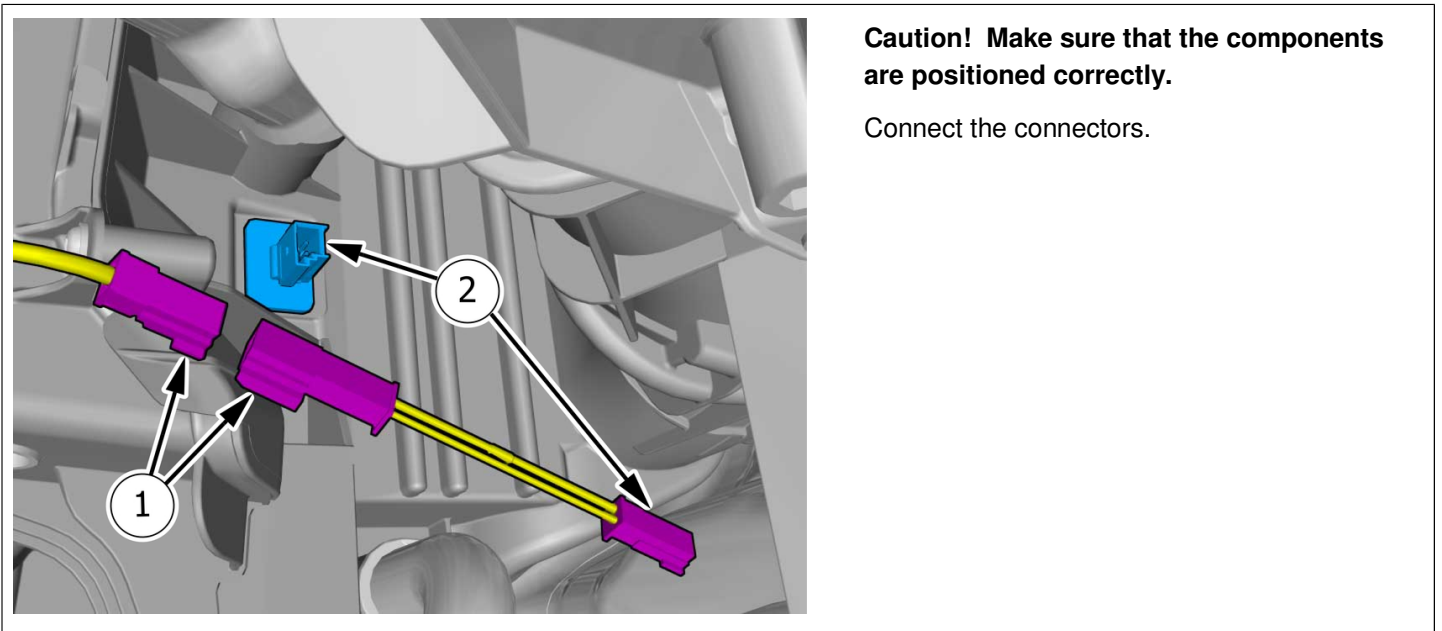
Connect the connectors.
