Technical Journal

Technical Journal Title Hood Hard to Close		Ref. No. TJ 36902.1.0	
Issuer (Dept.) Technical Service		Issue Date 10/24/25	Status Date 10/31/25
Car Market United States and Canada	Partner 3 US 7510 Volvo Car USA	Function Group 8213	
Function Description Catch		Page Page 1 of 4

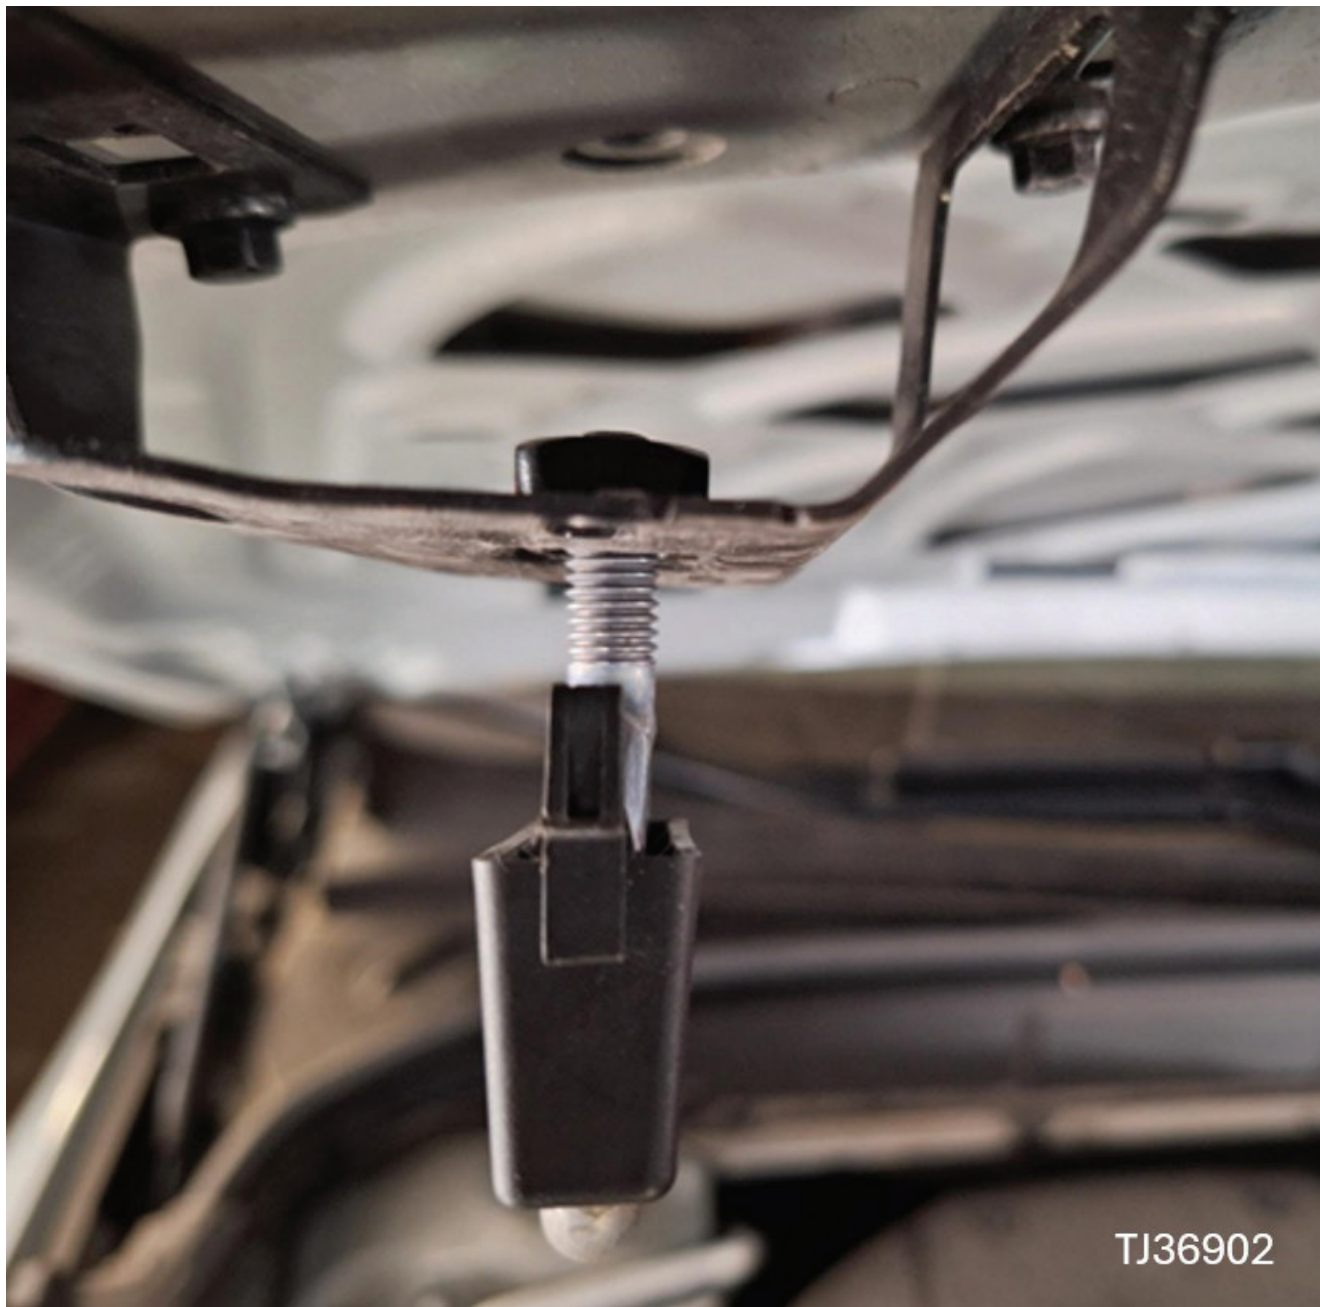
1. Adjust the hood (see attachment TJ_36902_1.mp4). Close and open a few times (2-3 attempts) to make sure the hood is properly latching. Make sure to check the bump stop after adjustment, so there is no gap between hood and bump stop (should have contact but not pressed against).
2. Check the latch of the hood after adjustment. As reference picture shows (TJ_36902_1.jpg), the screw should stick out on the other side.
3. If this doesn't solve the issue, replace the part.

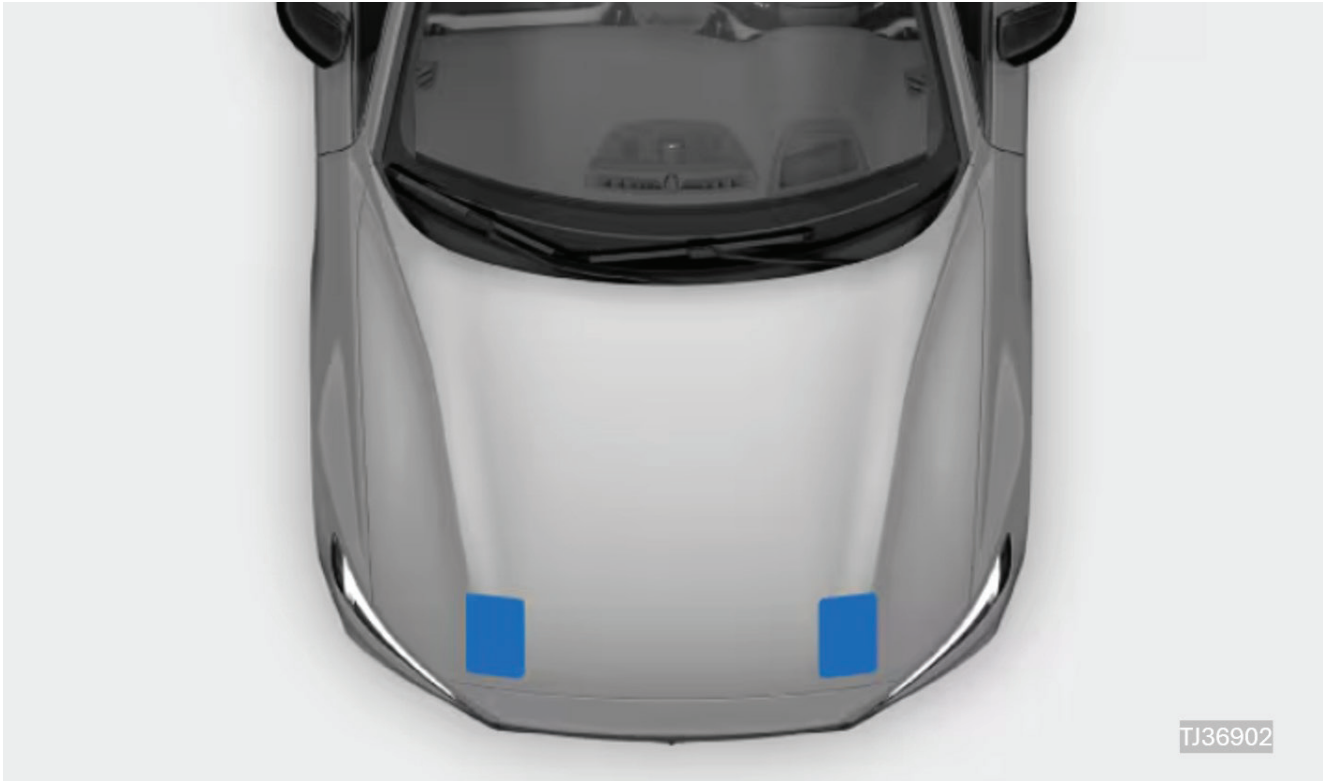
Please inform the customer of the proper way of closing the hood, see attachment as reference (TJ_36902_2.jpg).
