CERTAIN 2020-2023 MODEL YEAR ESCAPE VEHICLES — INSPECT FRONT DOOR CHECK-ARM REINFORCEMENT SPOT WELDS

SERVICE INSPECTION PROCEDURE

SUBJECT: **Customer Satisfaction Program 23B56 - Supplement #2**
Certain 2020 - 2023 Model Year Escape Vehicles
Inspect Front Door Check-Arm Reinforcement Spot Welds

On all of the affected vehicles, the front door check-arm reinforcement welds can crack and may eventually pull away from the door structure. If not repaired, the check-arm reinforcement may eventually detach from the door structure. This can cause a rattling noise and increased door opening/closing efforts. It may also interfere with door glass operation and the ability of the check arm to hold the door in the open position.

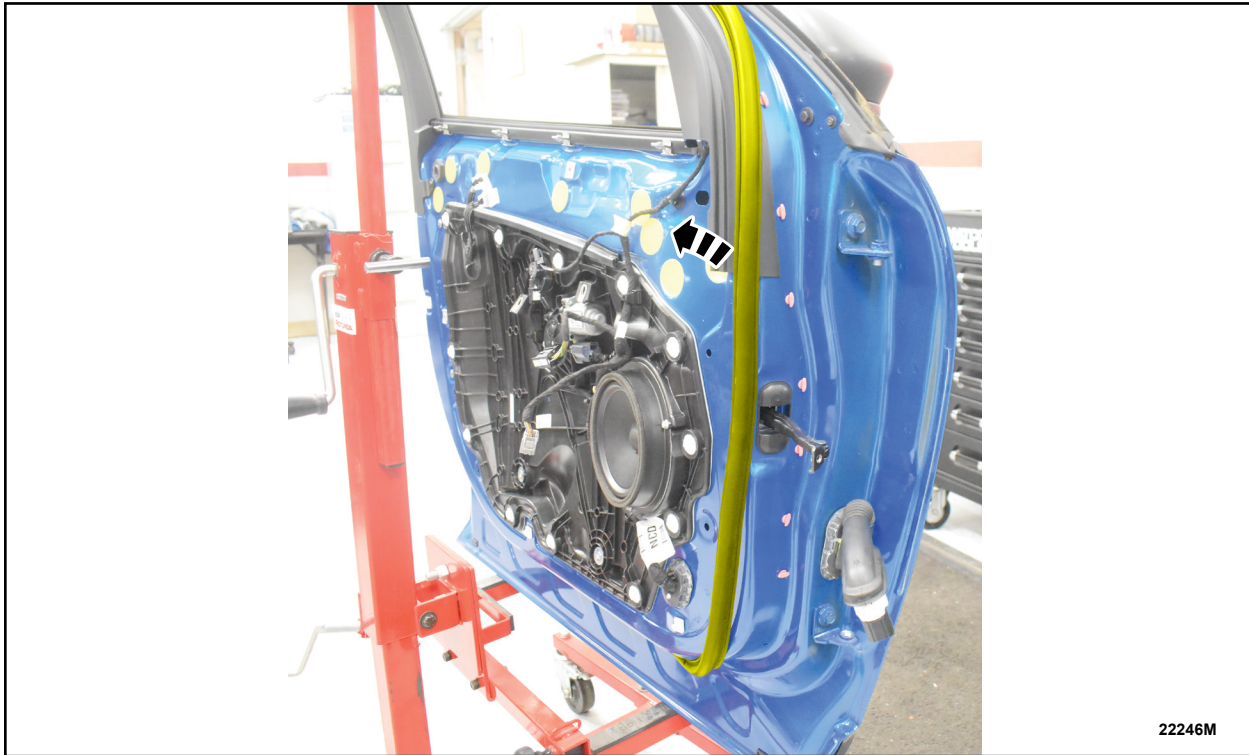
FIGURE 6

4. Carefully release the door mounted weatherstrip retainers from the seal and position the weatherstrip to the side as shown in Figure 6.

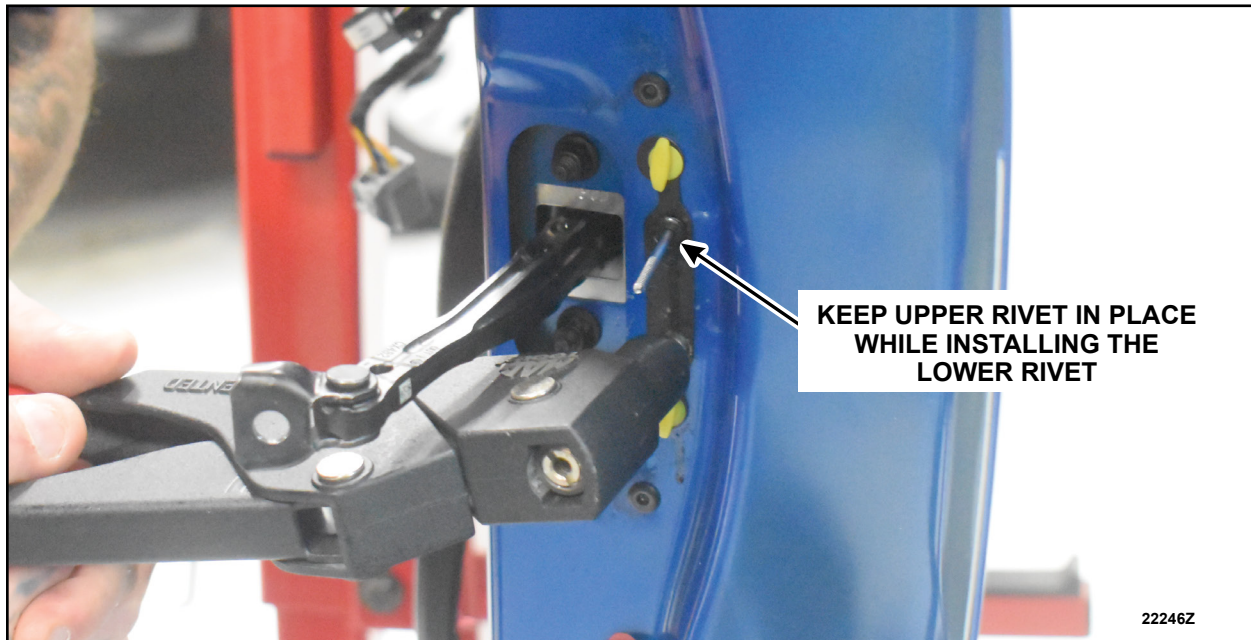
FIGURE 20

17. Using the rivet plate as a template, center punch the lower rivet plate hole and drill a 5 mm (13/64 in.) hole.
18. Remove both of the rivets to prepare for the next step.
19. Using a brush, apply Motorcraft® PM-13-A (anti-corrosion coating) to the bare metal portion of both holes that were just drilled out.
20. Place a rivet in each hole. Tighten the lower rivet while the upper rivet stays in place. See Figure 20.

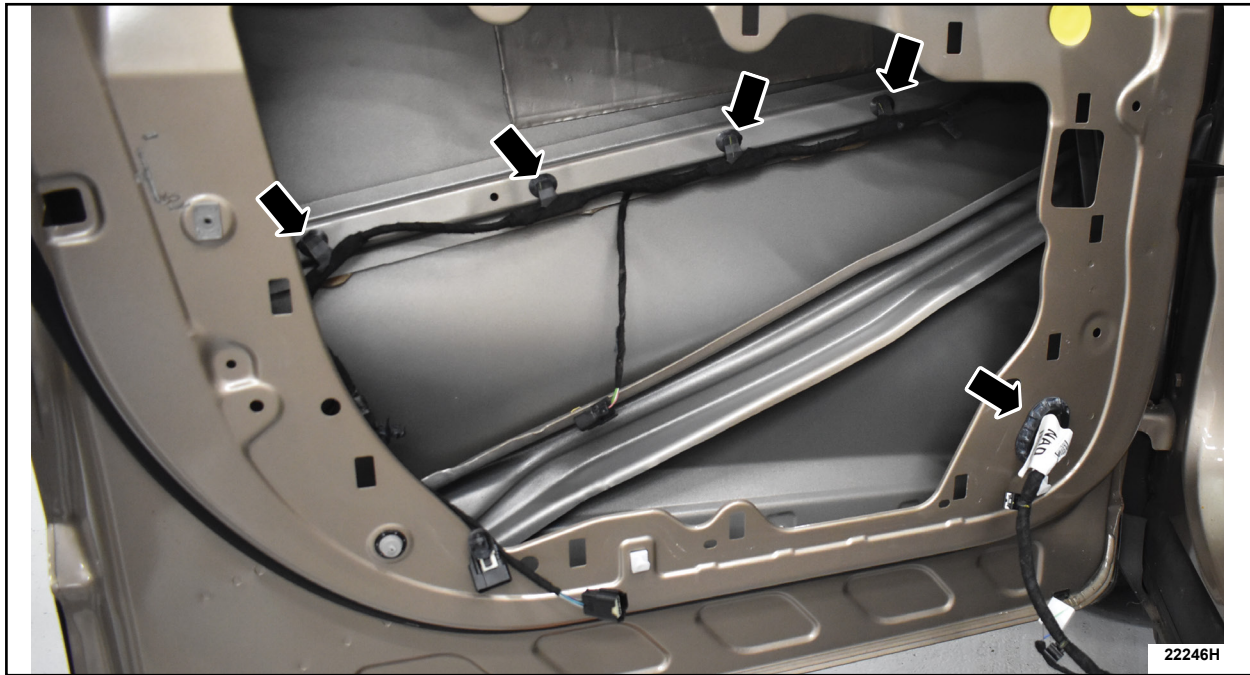
FIGURE 2

- Release the wiring harness retaining clips from the interior of the door. See Figure 2.
- Disconnect the three (3) door to body electrical connectors. See Figure 3.
- Remove the front door wiring harness.

16. Install the door wiring harness and attach all clips in their original locations. Reverse Step 8 and see the corresponding Figures.

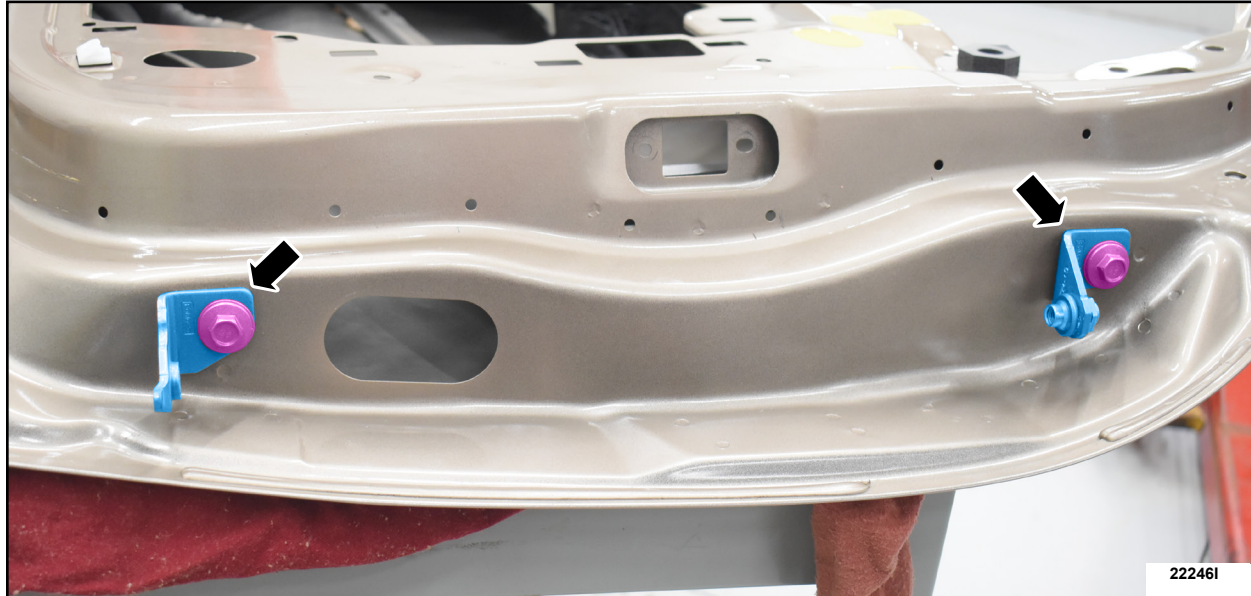
FIGURE 4

10. Remove the upper and lower front door mounted hinges. See Figure 4.

14. Once the *new* door assembly has completely dried, install both front door hinges. See Figure 4.

- Torque to: 35 ft lbs (47 Nm).
