# Technical Service Bulletin

<b>Subject:</b>  <b>CHECK ENGINE LIGHT ON WITH DTC P0126:00</b>	<b>Bulletin No.: 01-003/25</b>
	<b>Last Issued : 12/03/2025</b>

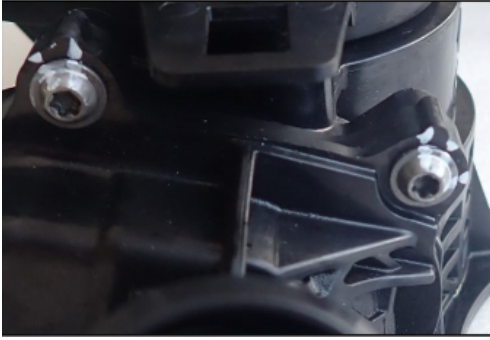
**Marking Example 1:** Draw **marking** lines over the screws and the thermostat cover as shown above.

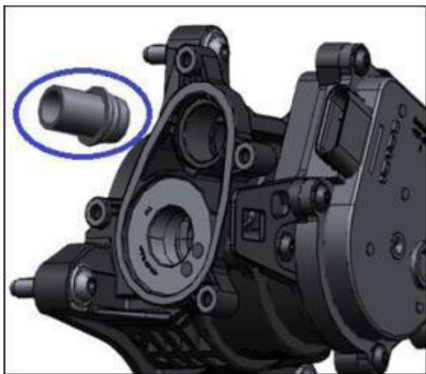
4. Replace the thermostat **with the plug**, which is included in the **Dummy Plug for CCV** set.

**NOTE:** Do not use lubricants, spray lube, silicone sealer or petroleum grease on any of the gaskets.
