HYUNDAI Technical Service Bulletin	GROUP	NUMBER
	CAMPAIGN	25-01-087H-1
	DATE	MODEL(S)
	DECEMBER 2025	SEE BELOW
SUBJECT: ECU SOFTWARE UPDATE FOR THETA II EMISSIONS IMPROVEMENT (SERVICE CAMPAIGN 9C2)

Description: Certain Santa Fe (TMA), Sonata (LFA) and Tucson (TL) vehicles equipped with Theta II engines may exhibit elevated engine-out emissions. This bulletin provides instructions for updating the Engine Control Module (ECM) to address this condition.

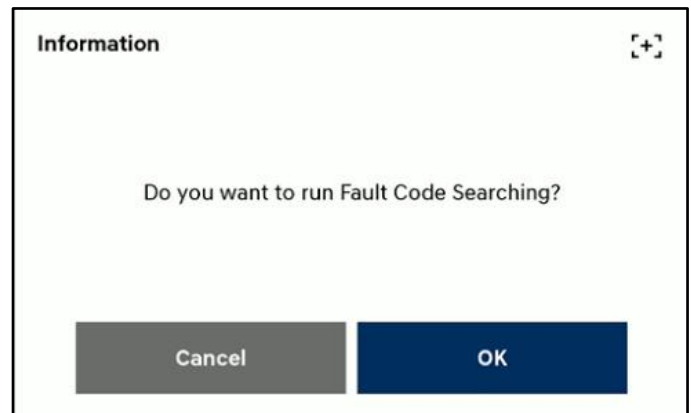
5. Perform an **All Systems Fault Code** search and erase DTC history that had incidentally occurred from the ECU update.

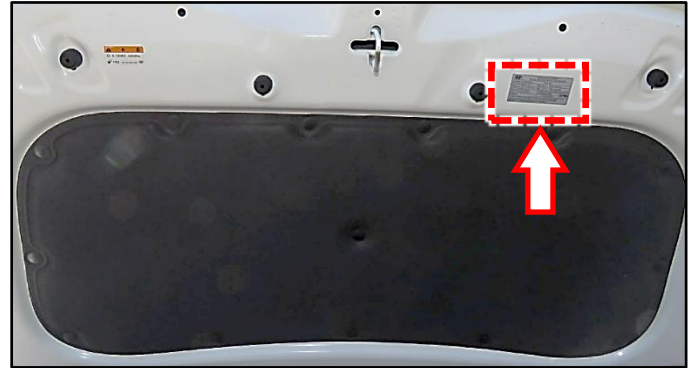
1. Fill in the Dealer Code and Date on the Emissions Label, and apply adjacent to the existing label, on the underside of the hood, as shown.

Be sure to clean the mounting surface to ensure proper label adhesion.

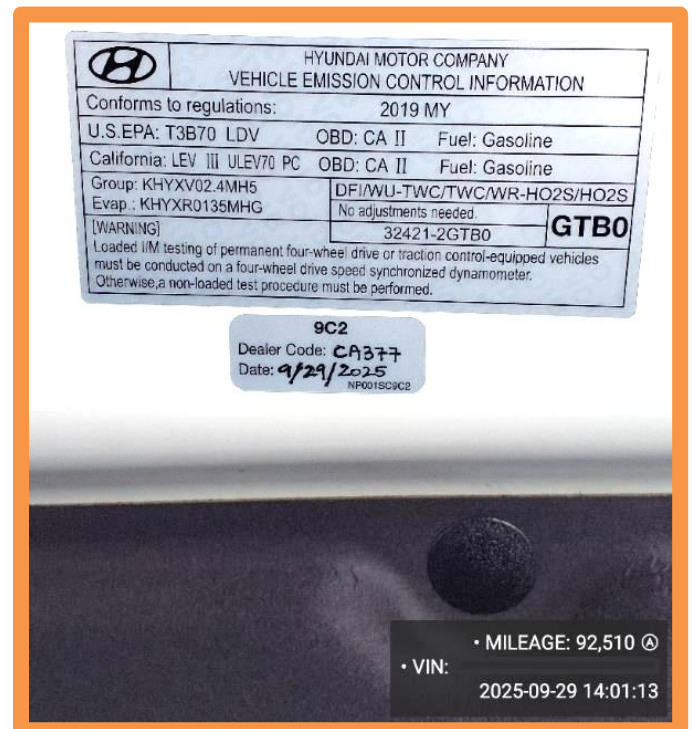
Using the STUI camera function, take a photo of the Emissions Label attached to the vehicle.

NOTE: If the STUI camera function is **NOT** used, write the last 6 digits of the VIN and the date of repair on a piece of paper to include in the photo.
