APB5 - Replacing the Cell Block Module on High-Voltage Battery (Recall Campaign)

Vehicle Type: **Taycan (Y1A / Y1B / Y1C)**

Concerns: **Cell block module**

Action: **Replace cell block module.**

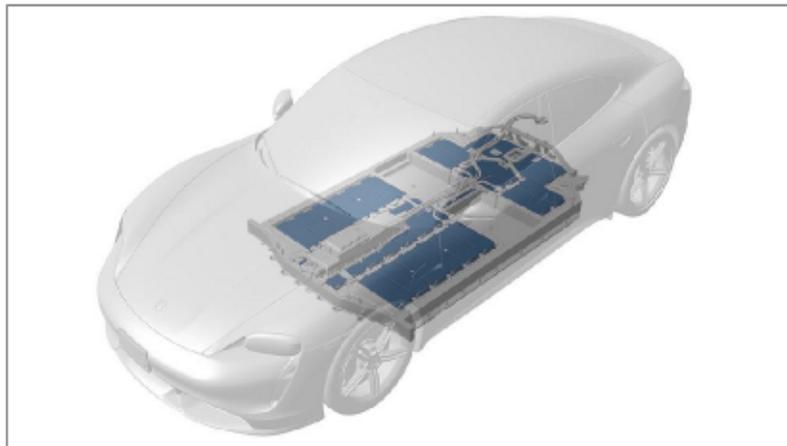
Installation position: Cell block module
