Front Display and Control Panel Replacement Required: Procedure to be Observed for Component Replacement (98/25)

Model Line: **911 (992)
Taycan (Y1A/Y1B/Y1C)
Panamera (YAA/YAB)
Cayenne (9YA/9YB)**

Model Year: **As of 2024 up to 2025**

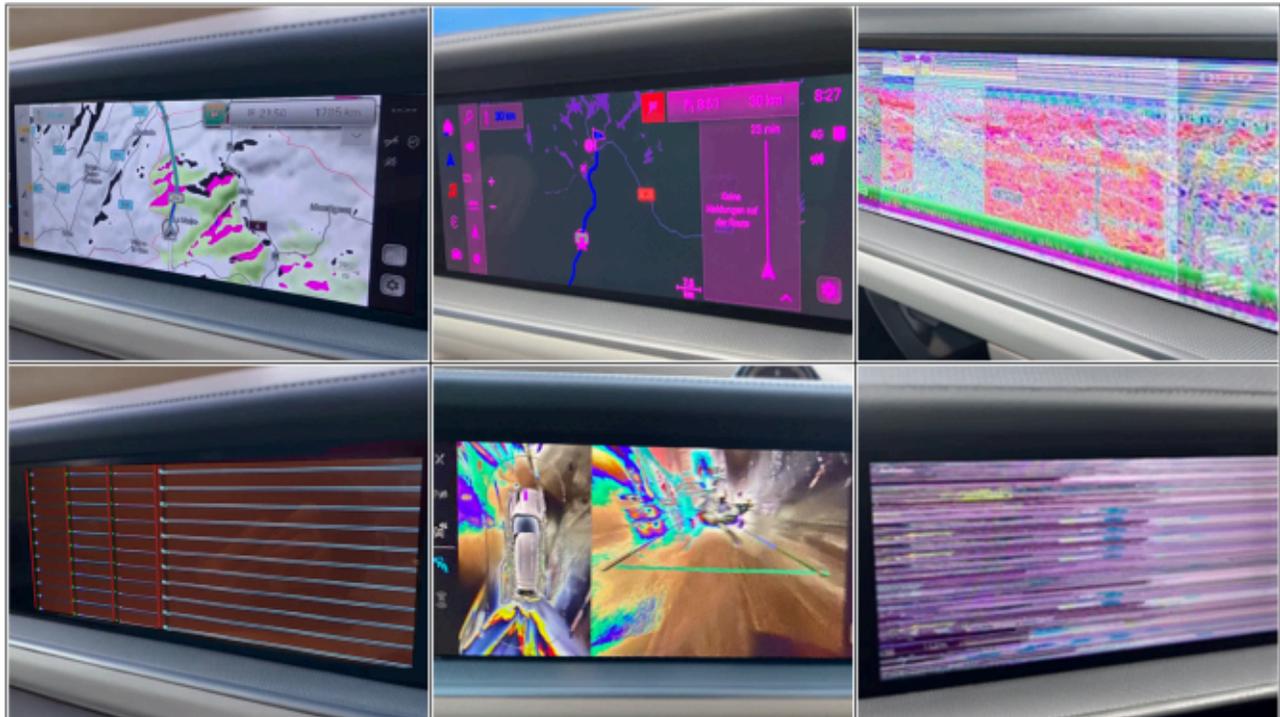
Cause: **It is possible that spare part displays are currently still in the inventories that do not have the last planned software release.**
Non-current software releases can cause the display and control panel to flicker at the front, occasionally fail or display content in a distorted/divided manner. ⇒ *Exemplary representations of possible complaints due to software releases that are not up-to-date.*

Exemplary representations of possible complaints due to software releases that are not up-to-date.

Action: If the central display or passenger display needs to be replaced, the software release of the **new** display **must** be checked after installation.

If the software release of the respective affected display **is smaller than listed in the "Software overview" table**, perform the software update described in Technical Information 221/24.
