# Optimized Idle with Key Off Functionality

**Feature** Schneider's 5<sup>th</sup> Gen missed an electrical deviation & needs to be corrected

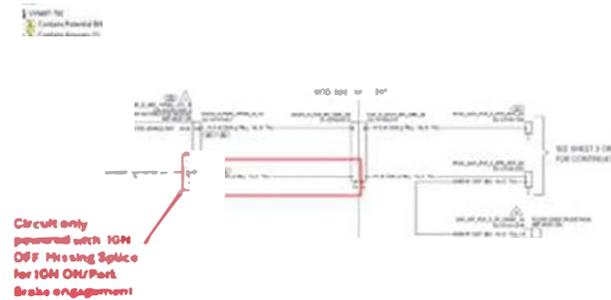
## Root Cause

Has BOM 70C-C068111 applied vs CWO  
Incorrect! This is non-Of van 1. Contains harness A06-91387-000, which should have been A66-  
Correct BOM: 70C-C06433

**Description** need to pin the current harness to match the drawing on harness # A66-32346-000 to correct Espar key on/off operation.

we will have to install a harness
