**RAPID UPDATE**

# Rapid Update 814 Grecale – Brake Disc Noise

DATE: January 27, 2026

**VEHICLES INVOLVED:** (M182) Grecale MY25 MHEV

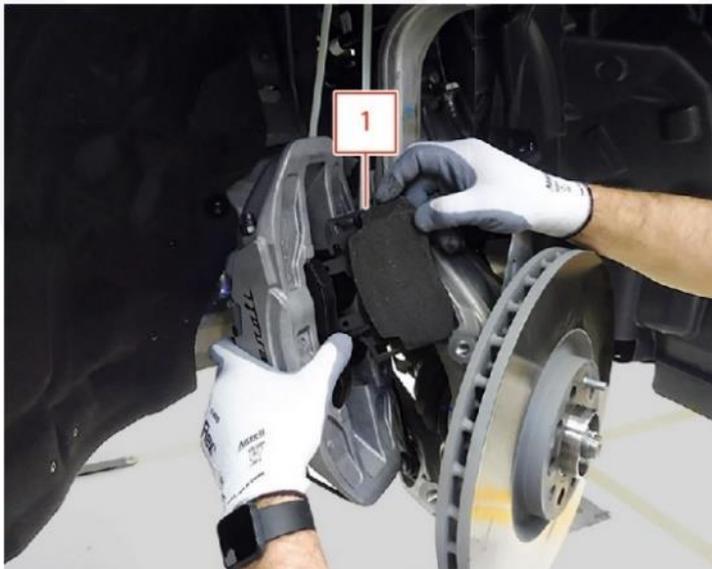
3. **Replace Front Brake Pads (Customer Vehicles Only)**

For Customer vehicles that have accumulated mileage with the non-compliant discs, replace the front brake pad kit at the same time. Follow the procedure in the workshop manual:

- **4.10.005 FRONT BRAKE PADS Replacement**
