Preview Solution CBR-2539-1

Volvo Chassis - Grille Spacers Loosening Over Time

Volvo Chassis - VN

Model Year - 2018 to Current

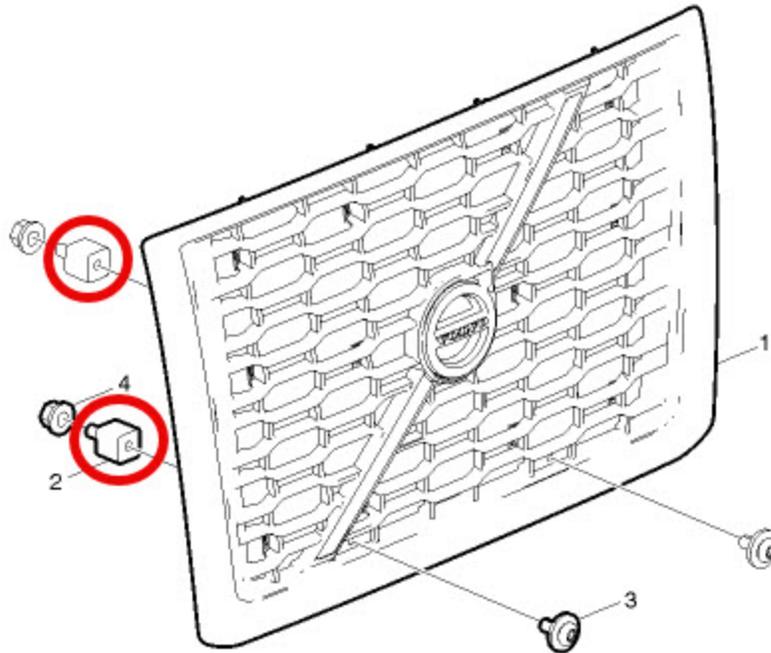
The purpose of this CBR is to address reports of grille spacers falling out and causing radar issues and damaging hoods.

When you have a report of missing grill spacers on 2018 to current VN grills, please order P/N 4403K71 from McMaster-Carr to solve this issue.

Part Number	Description	QTY	Supplier
4403K71	Spacer	2	McMaster-Carr
