Preview Solution CBR-2540-5

Upper Bunk Restraint System – Plastic Gable Retention Field Fix

Published 15 January 2026

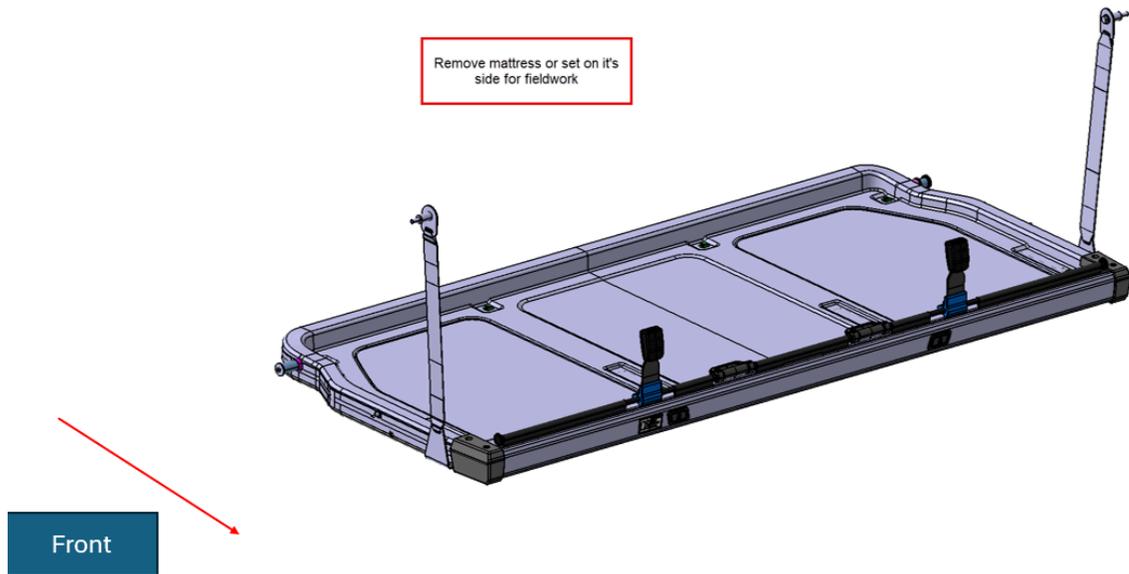
- Remove or set aside upper bunk mattress.

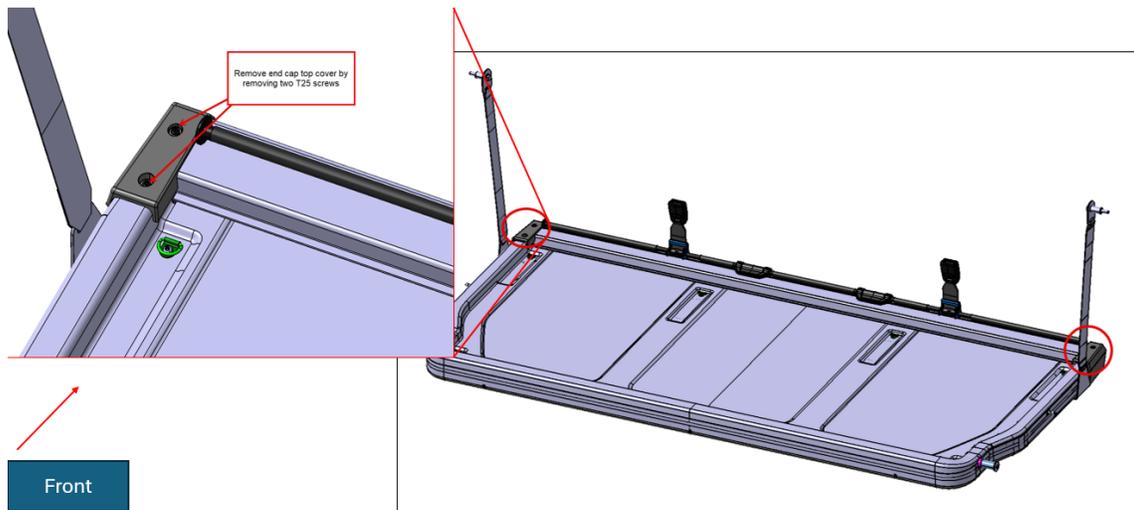
- Remove LH and RH top portions of end caps and retain for reinstallation.

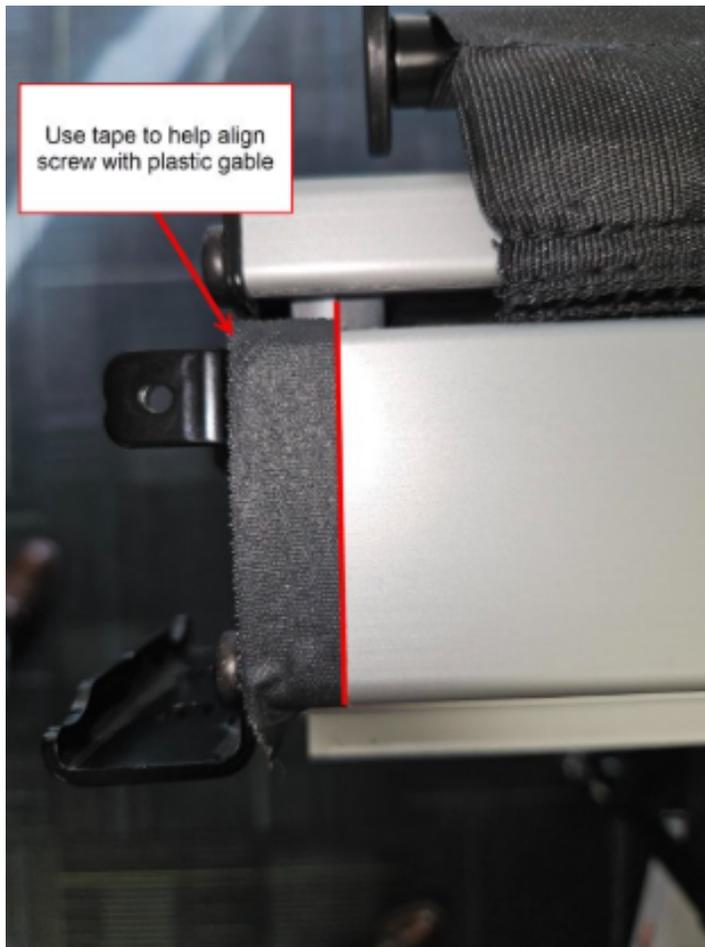
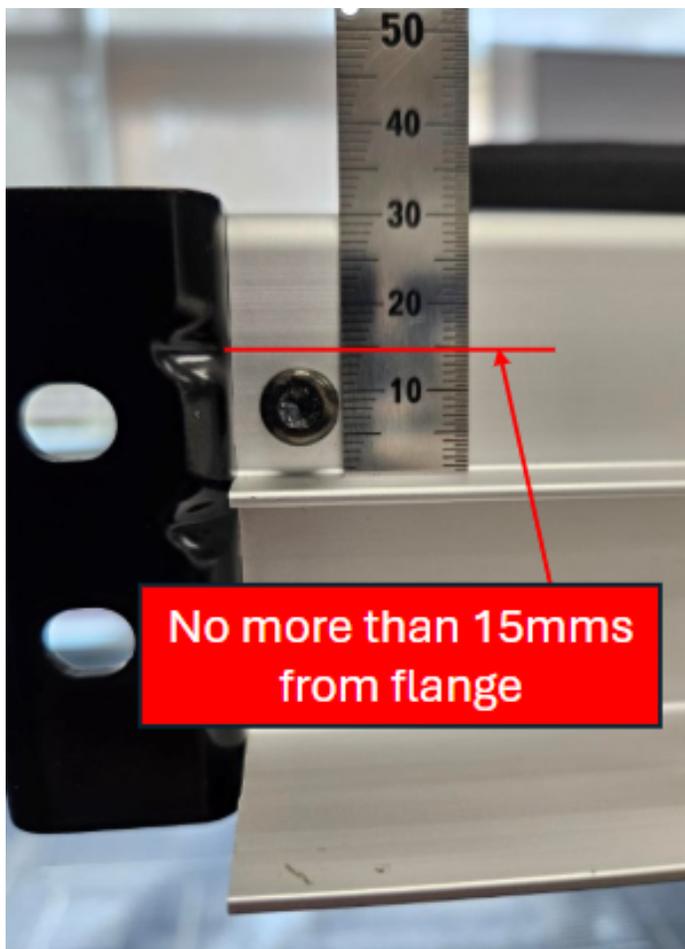
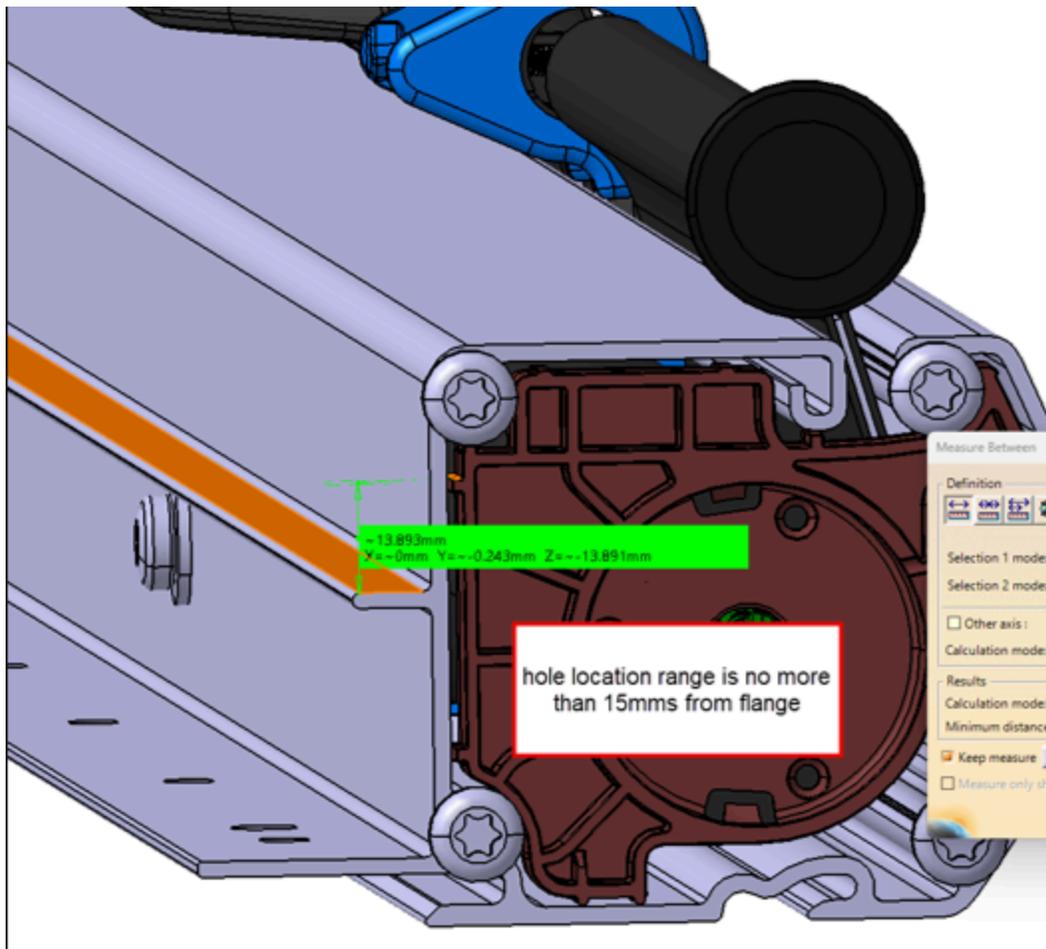
- Mark centerline of each plastic gable using masking tape.
- Measure approximately 15 mm from the back flange of the restraint. Do not exceed this measurement.
- Drill pilot hole if needed (do not exceed 1/8 in bit).
- Work from one end to the opposite end to prevent gable shift.

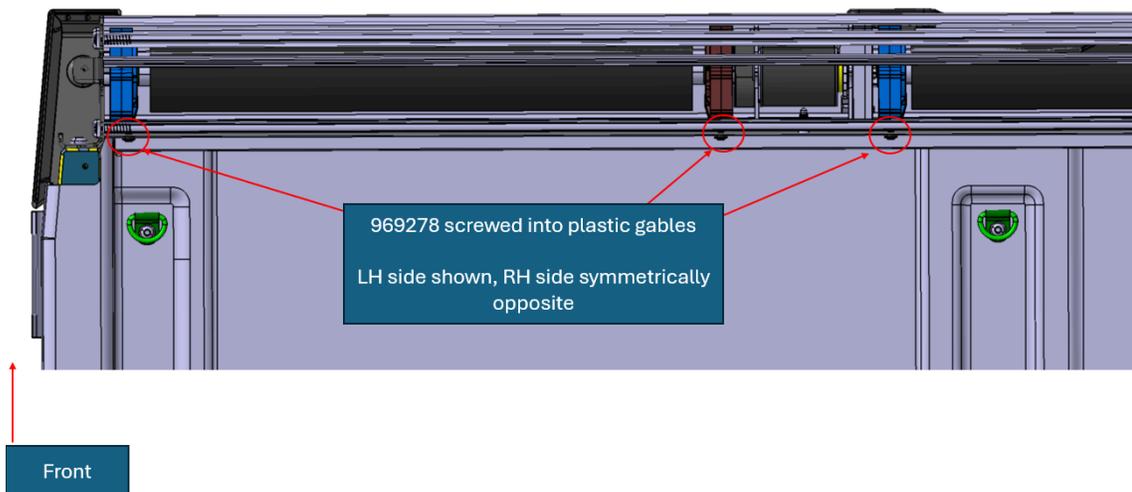
Cross-sectional view indicating the required screw fastening locations.

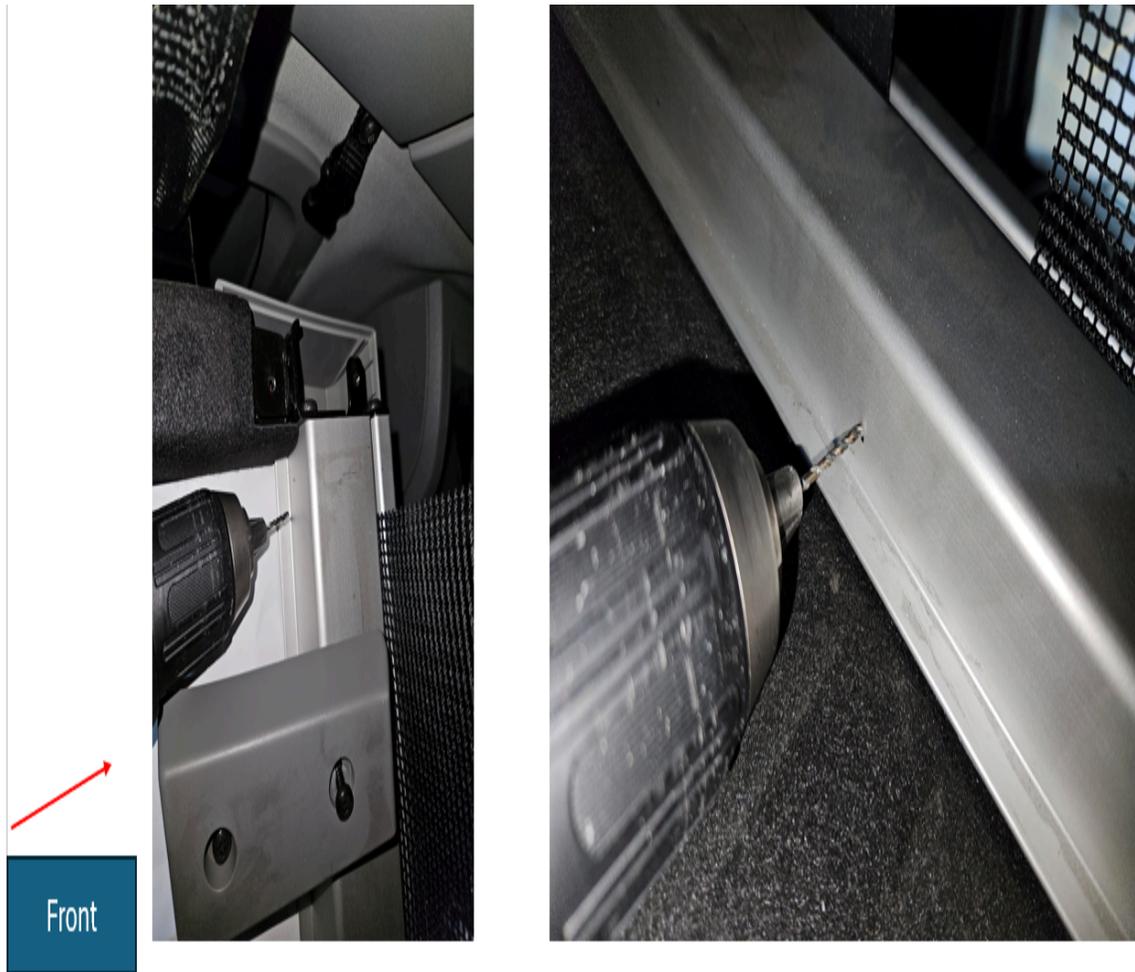
- Drill through aluminum restraint and plastic gable.
- Maximum drill depth: 0.5 in.
- Install screw 969278 into each plastic gable.
- LH side shown; RH side is symmetrical.

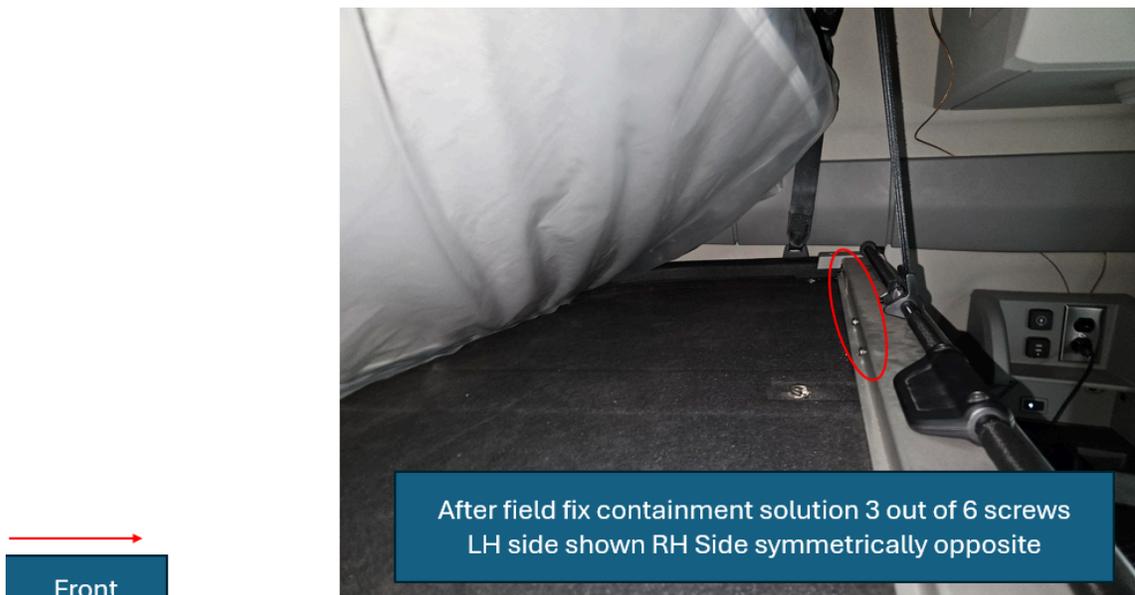
After field fix containment solution 3 out of 6 screws
LH side shown RH Side symmetrically opposite
