Powertrain – Coolant Leak Troubleshooting and Workshop Manual Changes

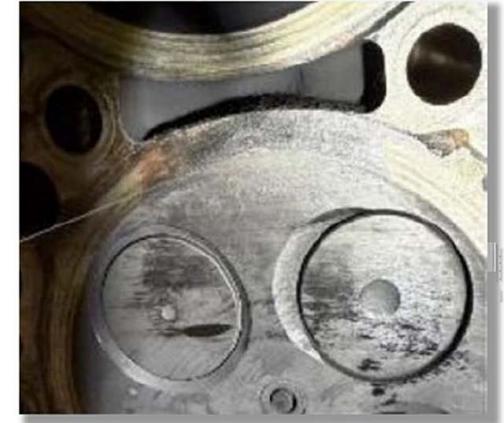
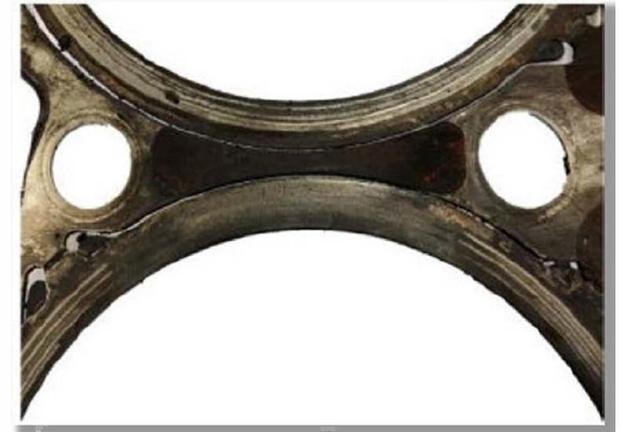
- New repair strategy will lead to replace a liner if it is confirmed a compression seal of the head gasket has failed
- Also leads to cylinder head inspection and replacement if issues are found

- The inspection of the cylinder head gasket section of the workshop manual has already been updated
- Coolant loss troubleshooting leads to the inspection section of the workshop manual
- TSB to be released in the next few days to point out the change as well(TSB-01-003-DDC)
