# Technical Service Bulletin

<b>Subject:</b>  <b>ENGINE TEMPERATURE AND HEATER PERFORMANCE CONCERNS WITH OR WITHOUT DTC P0126:00</b>	<b>Bulletin No.: 01-001/26</b>
	<b>Last Issued : 01/30/2026</b>

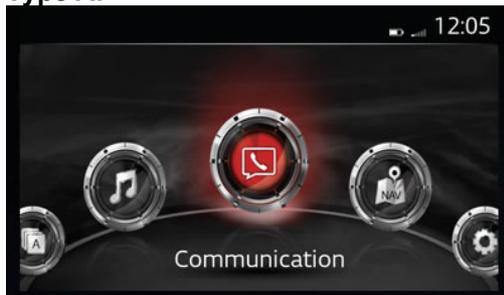
**Type A:**

**NOTE:** 2020 CX-5 with **Type B** Mazda Connect (7th Gen Infotainment) use MDARS and models with **Type A** Mazda Connect (6th Gen Infotainment) use IDS.

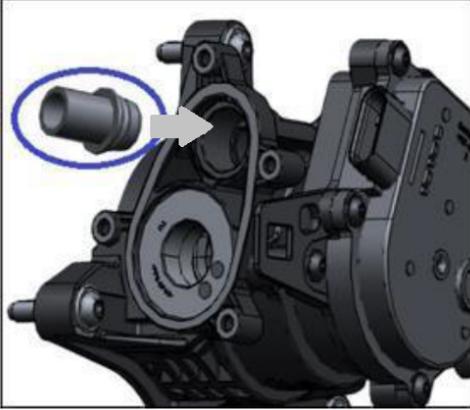
- Pay close attention to the orientation of the dummy plug when installing it into the coolant control valve (CCV).
- DO NOT force the dummy plug in the wrong direction.
- If the dummy plug is installed in the wrong direction, it may cause DTC P0126:00 to return and slow heating of the HVAC system.
- Be aware that Fig. 1 and Fig. 2 (below) are both correct, but show the dummy plug orientation from opposite ends.

Fig. 1: Shows correct orientation with the flat side (or short end) of the dummy plug (with o-ring) going into the upper hole (see arrow) of the CCV.

**NOTE:** Be sure to install the dummy plug into the correct CCV hole.

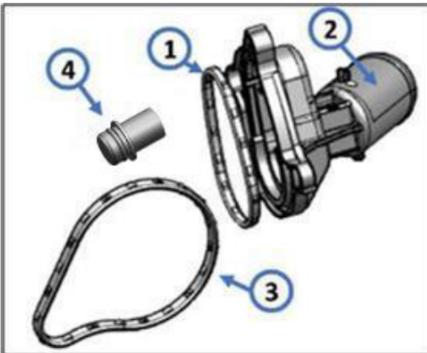
**Dummy Plug for CCV set includes:**

1. Thermostat cover gasket\*
2. Thermostat cover
3. Water outlet gasket
4. Dummy Plug

\*Thermostat cover gasket is already assembled to the thermostat cover.

Fig. 2: Correct dummy plug (4) orientation to the thermostat cover (2).
