ASA3 – Re-Program Reversing Camera Control Unit and, if necessary, Replace Reversing Camera and Surround View Cameras (Recall Campaign)

Model Year: **As of 2024 up to 2026**

Model Line: **Macan Electric (XAB)**

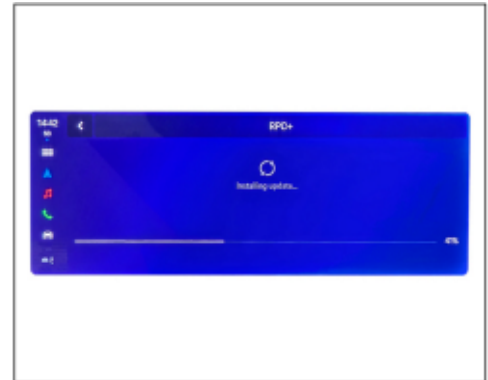
Update progress on central display

If Wi-Fi coverage is insufficient, the connection between the PIWIS Tester and VCI can be interrupted (battery charge indicator inactive on the Tester display at the top right). The vehicle will, nevertheless, continue programming **independently**. In the meantime, no entry may be made on the PIWIS Tester, and the programming must not be restarted. In such a case, the progress of the update can still be followed inside the vehicle via the central display by activating the **"Messages"** tile.
