**Complementary CP1074: Polestar 3 VCU2 Upgrade  
Model Year 2025 Polestar 3**

<b>GROUP:</b> 71	<b>NO:</b> CP1074	<b>ISSUING DEPARTMENT:</b> Product, Safety and Compliance	<b>CAR MARKET:</b> United States and Canada	
<b>REVISIONS:</b>			<b>ISSUE DATE:</b> 2026-02-13	<b>STATUS DATE:</b> 2026-02-13
<b>Page 1 of 17</b>

<b>Title</b>	Vehicle Computational Unit (VCU)	<b>Page</b>	1 ( 14 )
<b>Action</b>	Replacement	<b>Operation number:</b>

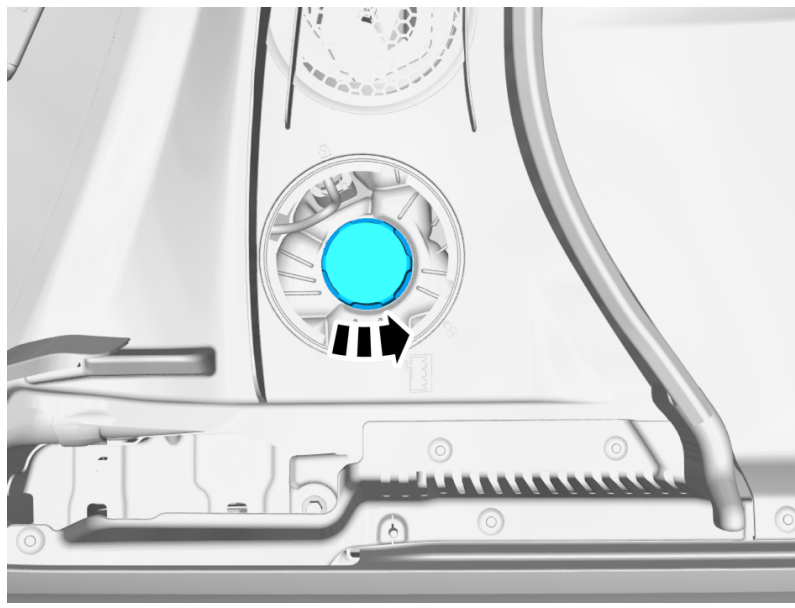
**Warning!** When releasing the cooling system pressure, cover the coolant expansion tank cap with a thick cloth.

Remove the marked part.

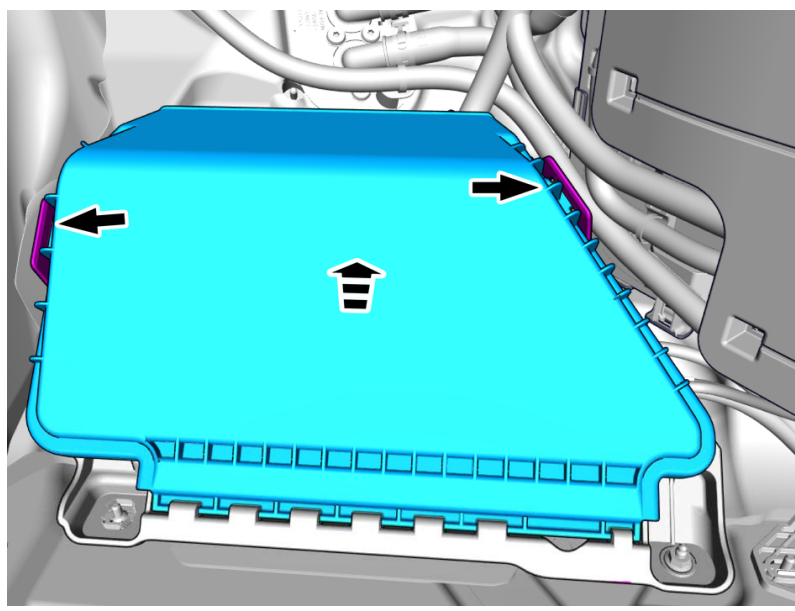
Release the locks.  
Remove the marked part.

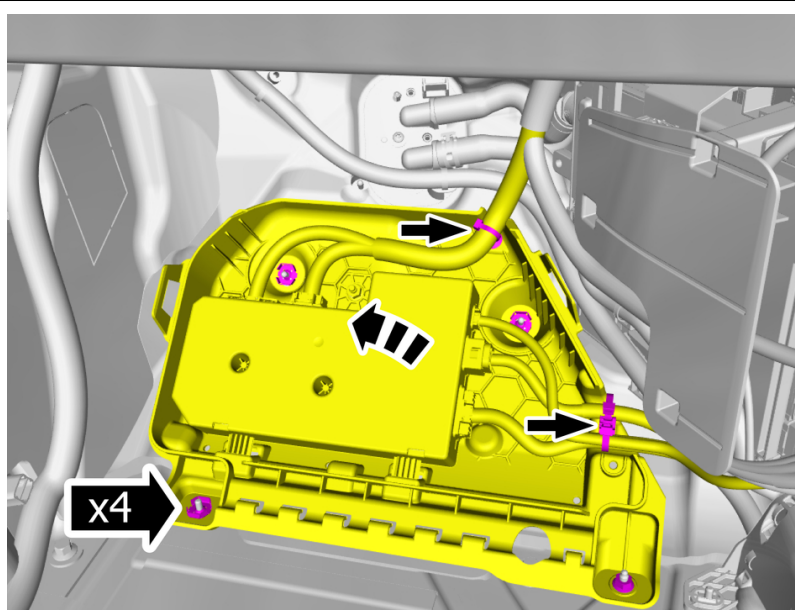
Remove the cable harness clips.  
Remove the nuts.  
Fold marked parts aside.

**Torque:**  
M6 , 10 Nm

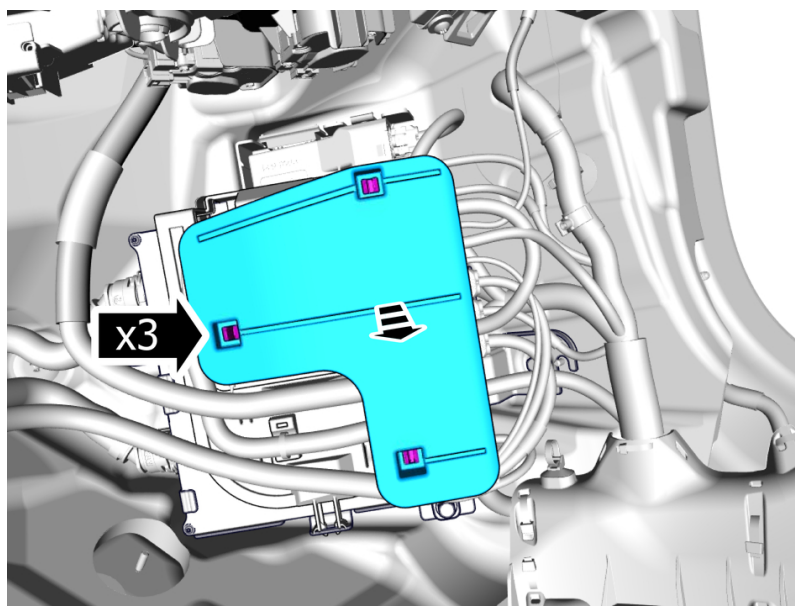
Depress the locking devices.  
Remove the marked part.

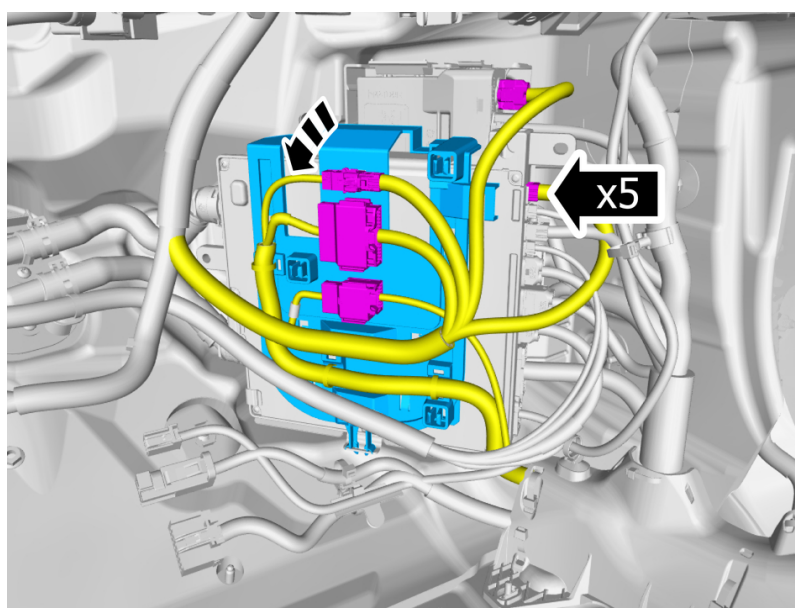
Disconnect the connectors.  
Fold the cable harness aside.

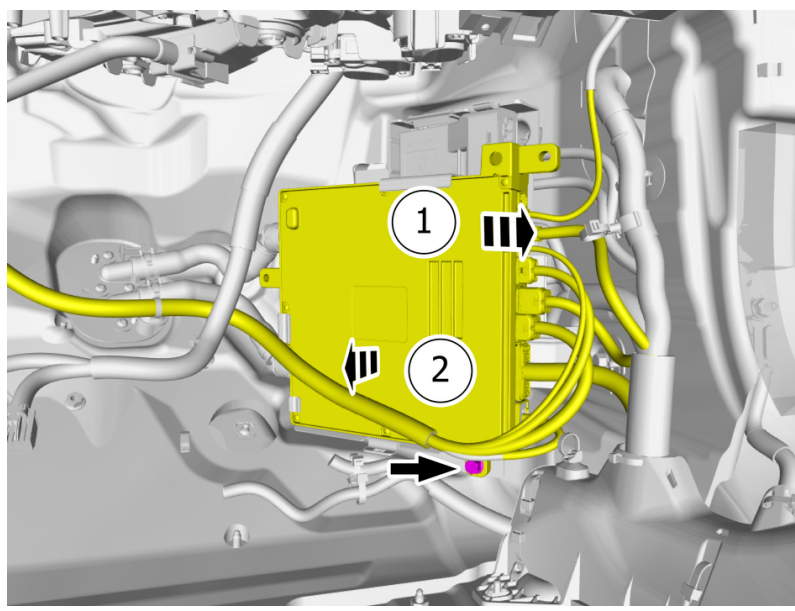
Remove the screw.  
Loosen the marked details.

**Torque:**  
M6 , 10 Nm

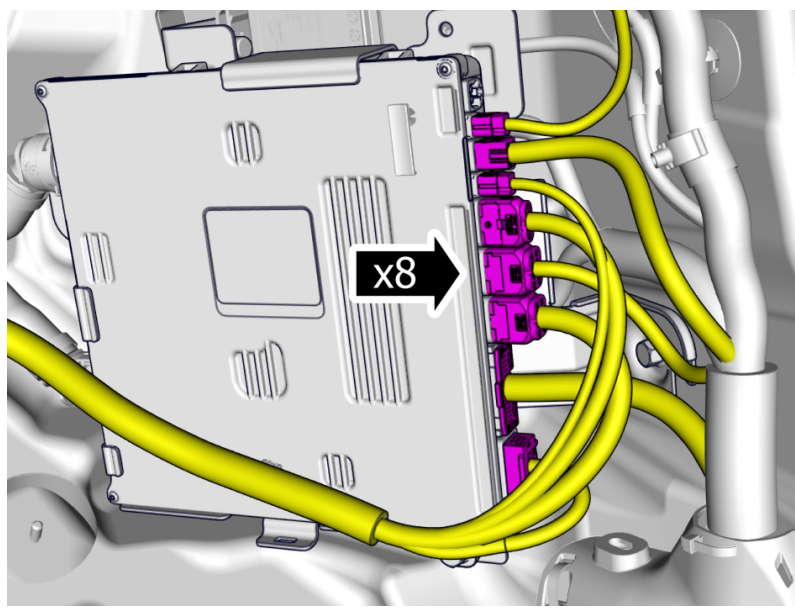
Disconnect the connectors.  
Fold marked parts aside.

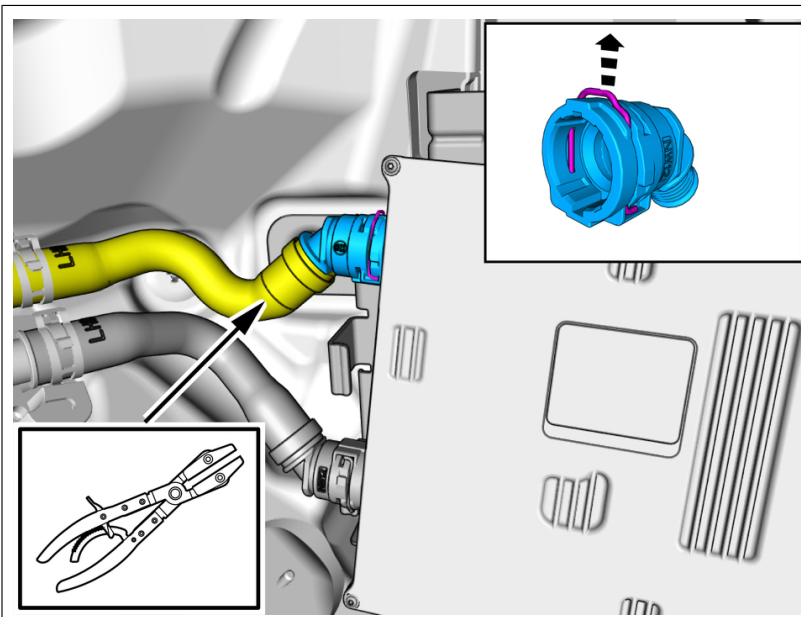
**Caution! Use suitable paper to absorb any escaping fluid.**

**Note! Tilt the unit to minimize leakage.**

Undo the hose from the connection.  
Allow the tool to remain.

Special Tool: T9512578, Plug kit in bag

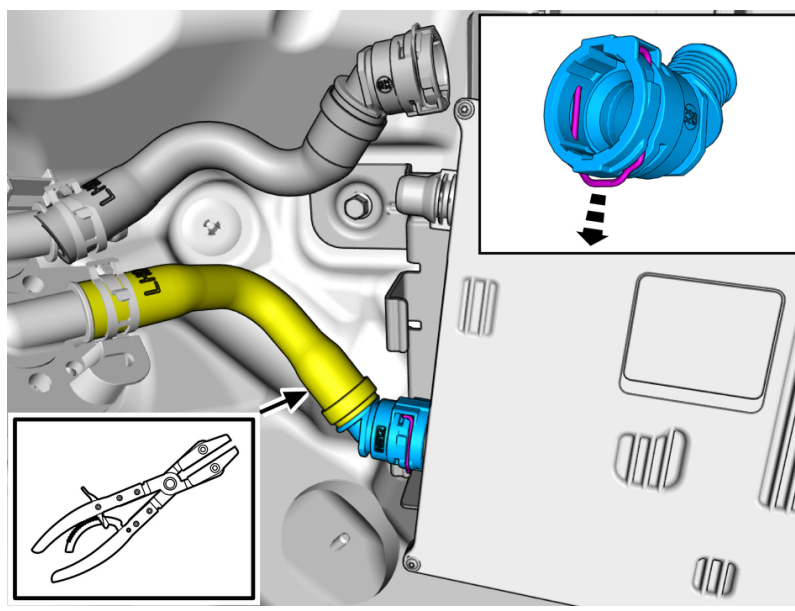
**Caution!** Use suitable paper to absorb any escaping fluid.

**Note!** Tilt the unit to minimize leakage.

Undo the hose from the connection.  
Allow the tool to remain.

Special Tool: T9512578, Plug kit in bag

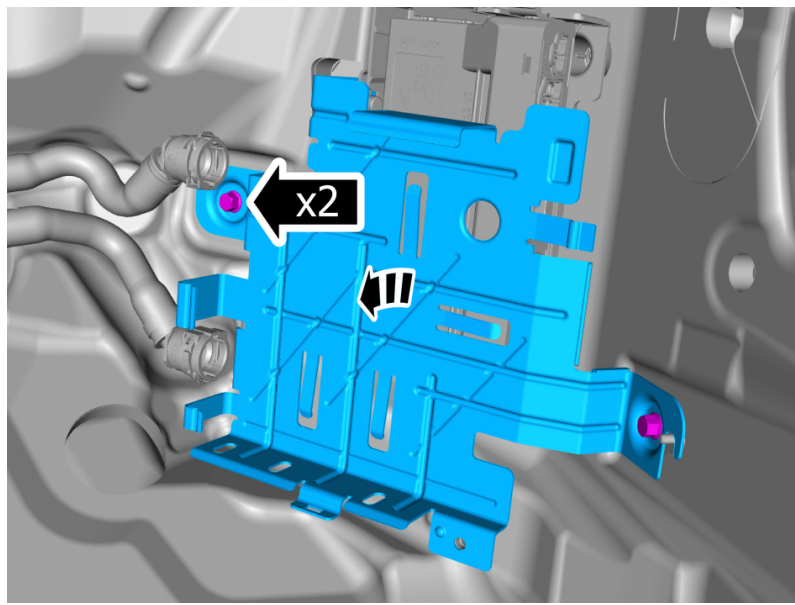
Remove the screws.  
Remove the marked part.

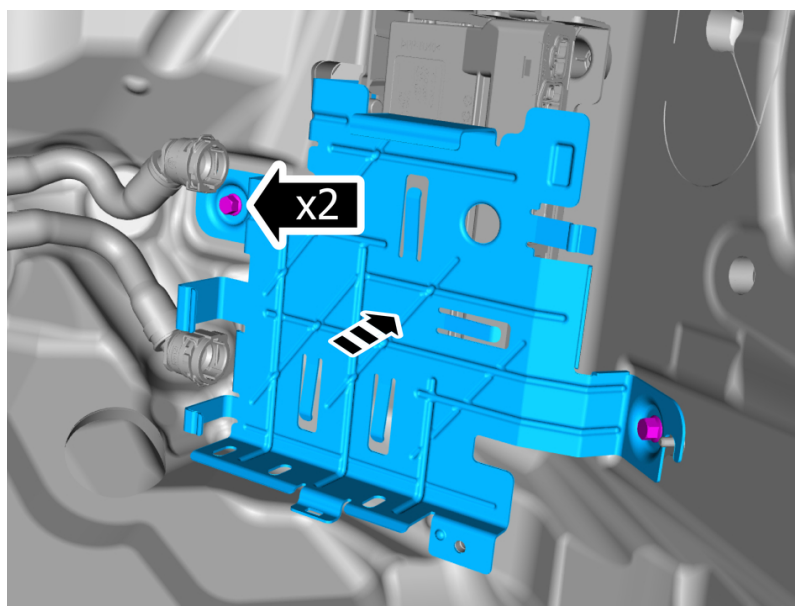
Install the marked component.  
Install the screws.

**Torque:**

M6 , 10 Nm
