# V O L V O

## Technical Journal

Technical Journal Title Coolant Pump Coolant Mix Residue		Ref. No. TJ 36923.9.0	
Issuer (Dept.) Technical Service		Issue Date 2/5/26	Status Date 2/13/26
Car Market United States and Canada	Partner 3 US 7510 Volvo Car USA	Function Group 2621	
Function Description Coolant pump, complete		Page Page 1 of 3

## Technical Journal 36923.9.0

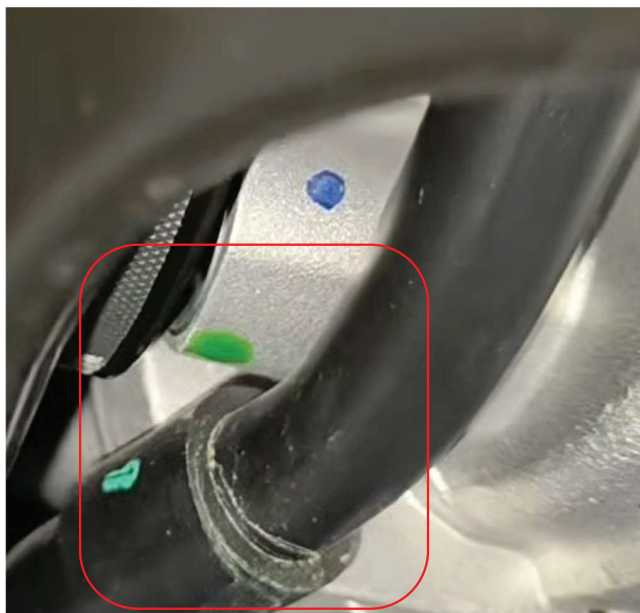
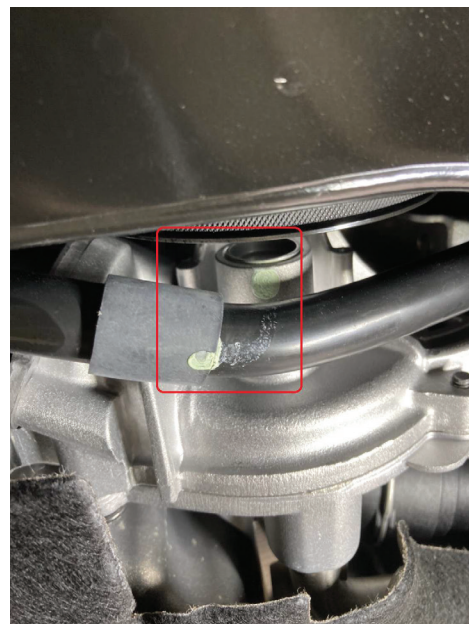
TJ 36923

If the coolant pump has a small sign of green/white coolant mix (see example as in attached picture TJ\_36923\_1.pdf) without a DTC set, follow advice under "Service".

If there are traces of coolant seen after engine shut off with no other symptoms (see example as in attached picture TJ\_36923\_1.pdf), this is normal and should not be seen as an indication to replace the coolant pump.

*\*No replacement of the coolant pump is allowed without a genuine customer symptom e.g. low coolant warning message.*
