**ID #** CBR-2361

Volvo Chassis - Debris In 13L Cooling Systems Filled With Extended Life (VCS2)

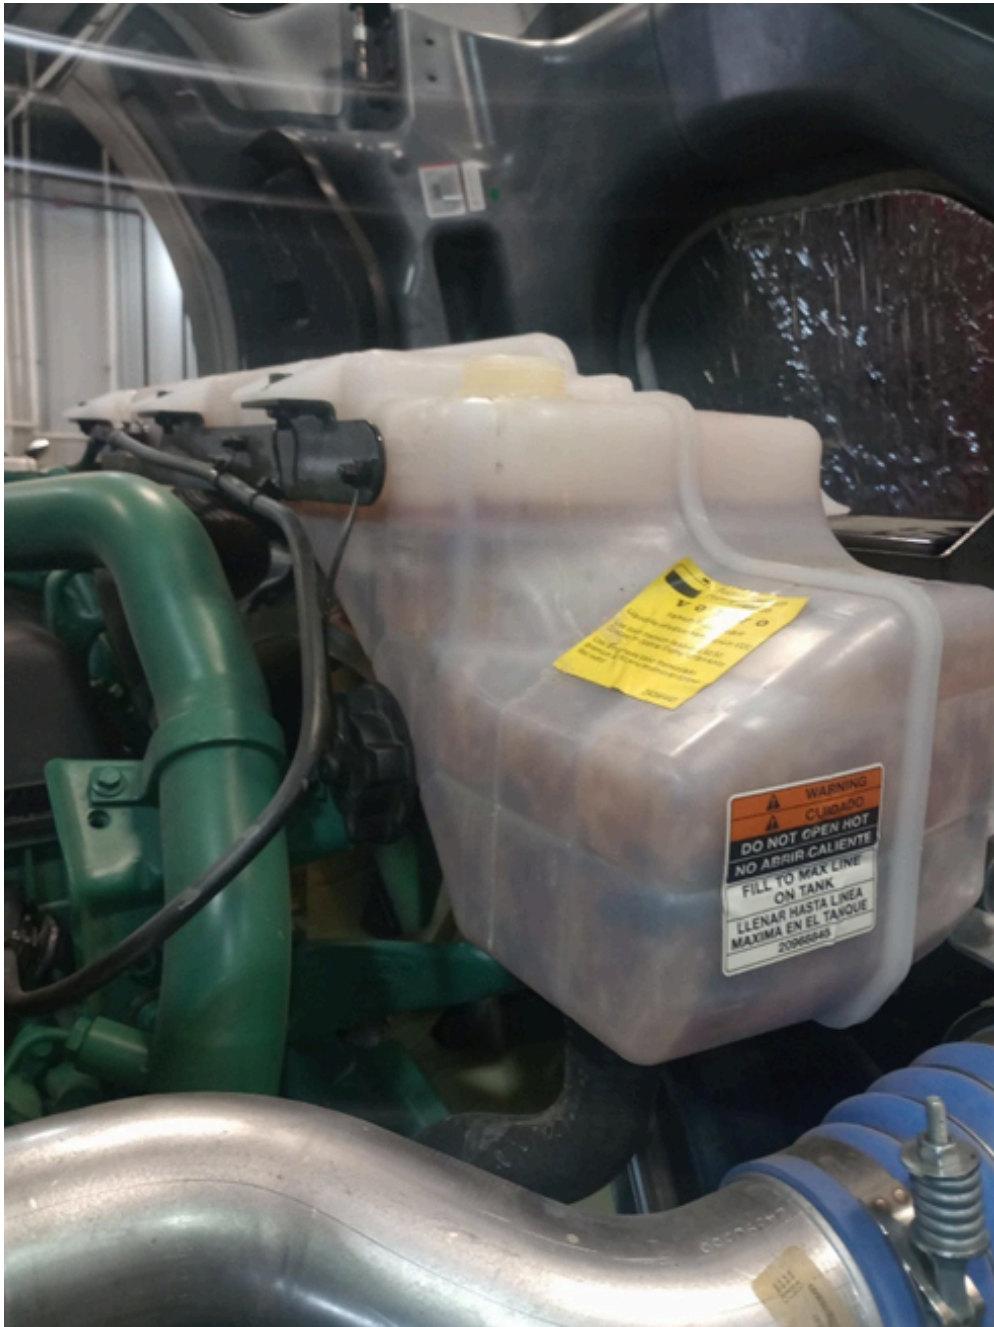
Observing debris within the cooling system is possible, with this debris potentially being dark and resembling sand. Such debris has the potential to cause blockages in both the heater core and oil cooler.

- 1) Flush the coolant (per IMPACT 2609-11-03-01)
- 2) Install a new coolant filter, over flow tank, and fill with new coolant.
