Hadley Smart Valve – Raising Suspension – Progress Update

Concern: Hadley Smart Valve causing rear suspension ride height to inflate to max

Affected Models: 4th Generation Cascadia

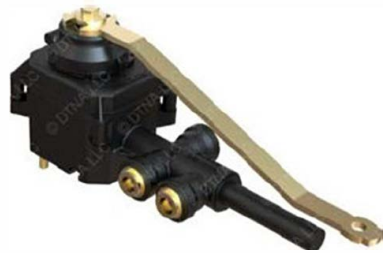
Fig. 1, Hadley SmartValve

- 1. 1/4-20 Locknut
- 2. 1/4 Flat Washer
- 3. EHCV Mounting Spacer

- 4. 90° Stem Fitting - 1/4 PTC x 3/8"
- 5. Series EHCV Valve

Root Cause: Software bug causing unintended raised suspension while in bobtail mode

Correction: Current Field Fix: Replace valve with latest p/n OR Laptop + CAN cable firmware to locations w/ highest concentration of trucks (via connection @ highlighted)
