SSPD8 - ENGINE TEMPERATURE AND HEATER PERFORMANCE CONCERNS WITH OR WITHOUT DTC P0126:00

WARRANTY EXTENSION

**REPAIR PROCEDURE & PARTS AND WARRANTY INFORMATION
WARRANTY EXTENSION SSPD8**

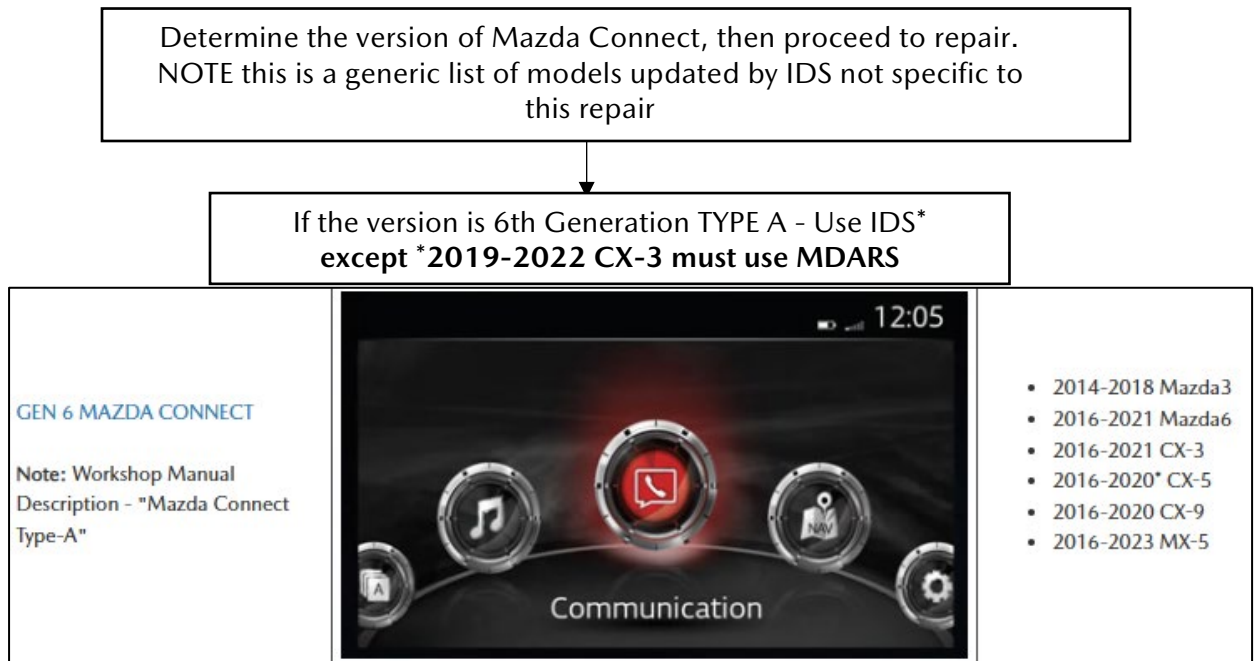
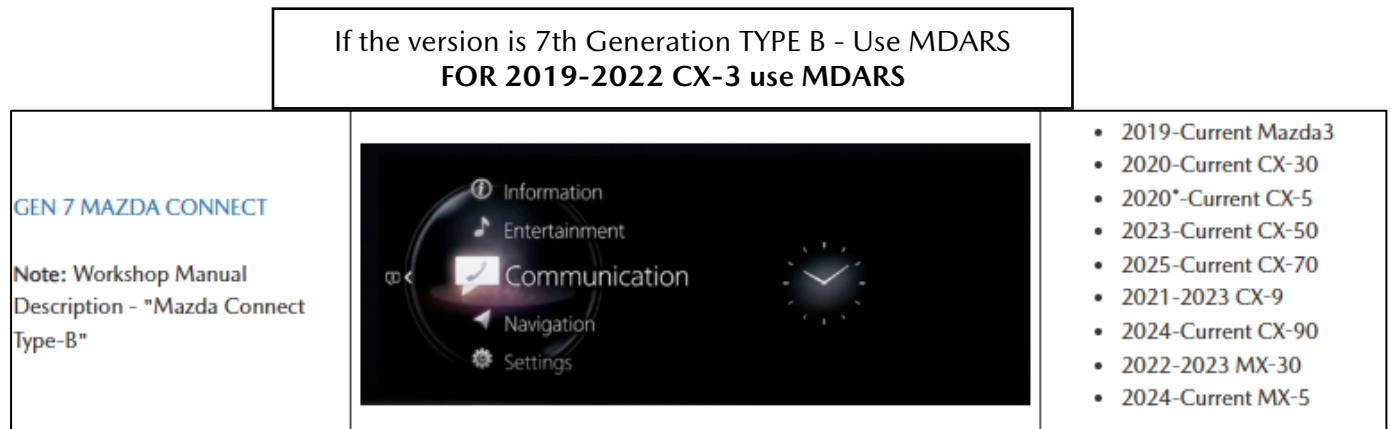
Section A: Flow Chart: **NOTE: This Flow Chart needs to be followed strictly.**

The dummy plug and PCM update repair procedure are required as of December 8, 2025. The TSB has been updated to repair with the dummy plug and PCM update here: [6](#).
