Reference	SSM76404
Models	Defender / L663 Discovery / L462 New Range Rover / L460 New Range Rover Sport / L461
Title	Rear Driveline Click - Noise
Category	Driveline
Last modified	18-Feb-2026 16:23:00
Symptom	597997 Driveline Noise Concerns
Attachments	20250327_152057.mp4 (20250327_152057.mp4) SSM76404_Attachment 2.0.jpg (SSM76404_Attachment 2.0.jpg) SSM76404_attachment 1.0.png (SSM76404_attachment 1.0.png)
Content	<p><u>Model / Model Year / Derivative</u> DISCOVERY / 22MY onwards / All derivatives DEFENDER / 22MY onwards / All derivatives RANGE ROVER / 23MY onwards / All derivatives RANGE ROVER SPORT / 23MY onwards / Excluding SV Variant</p> <p><u>Situation:</u> JLR Engineering investigations have found that some vehicles may exhibit a 'clicking' noise from the rear of the vehicle. The noise may be heard from one or both sides of the vehicle when moving forwards or backwards.</p> <p><u>Action:</u> Refer to the service information below.</p> <p><u>Service Information:</u> NOTE: *An allowance equivalent to £8 Sterling: ZZZ001 for 100g Castrol Molub-Alloy Paste White T for 2 vehicle applications.</p>

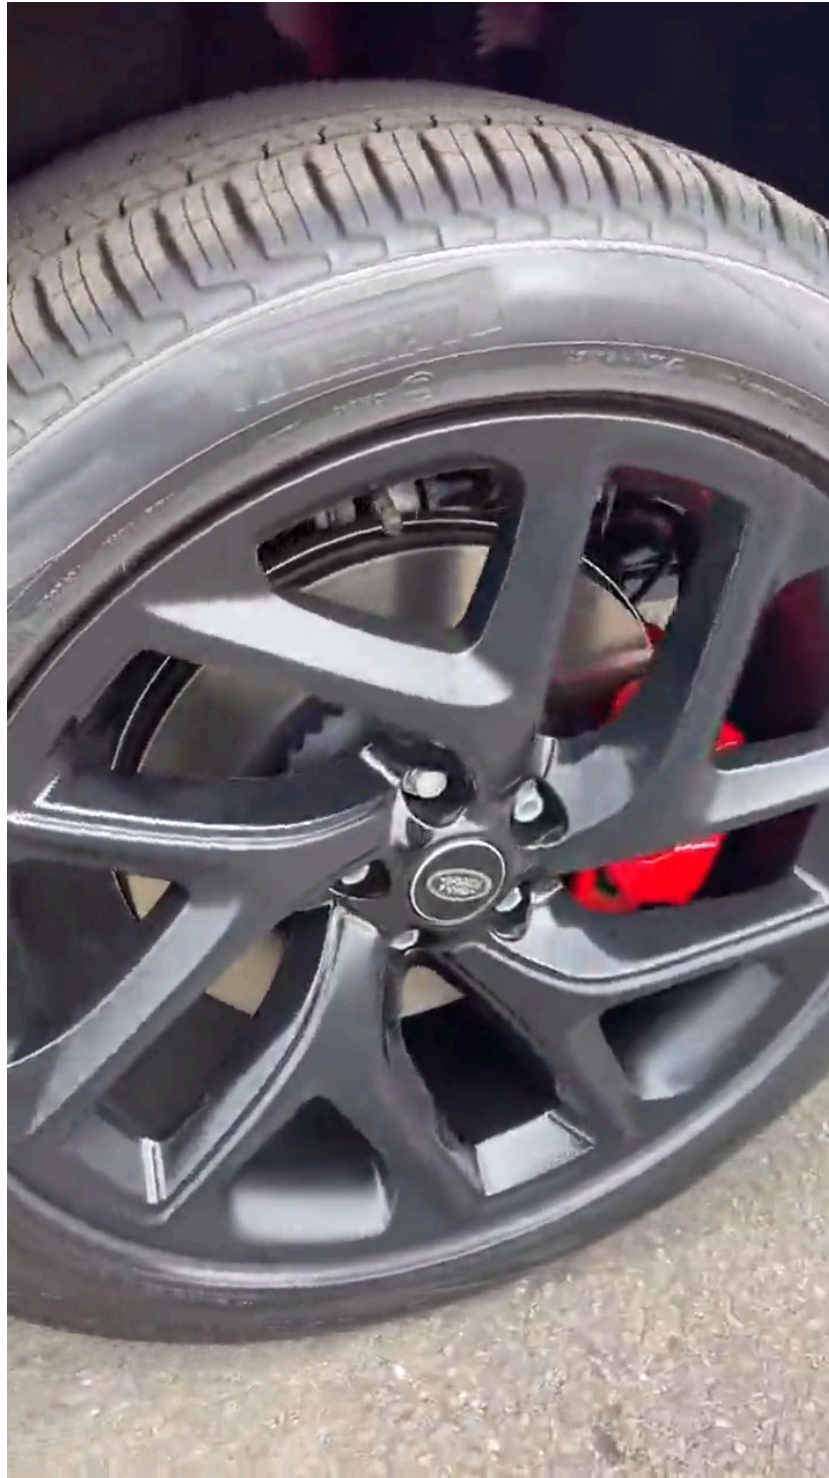
1. Remove the rear wheel knuckle(s) (See TOPIx Workshop Manual section 204-02: Rear Suspension Removal and Installation – Wheel Knuckle)
2. Use a suitable cleaning fluid to clean rear halfshaft spline(s) (See attached image 1)
3. Apply Castrol Molub-Alloy Paste White T grease to the halfshaft face(s) on the rear halfshaft(s). (See attachment, image 2 showing Castrol Molub-Alloy Paste White T grease being applied to the rear halfshaft face, image 2 shows condition following application)
4. Install rear wheel knuckle(s) (see TOPIx Workshop Manual section 204-02: Rear Suspension – Removal and Installation – Wheel Knuckle).
5. Torque new rear halfshaft nuts to below specification:

Stage 1: 300 Nm

Stage 2: -90 deg

Stage 3: 135 Nm

Stage 4: 60 deg
