Technical product information

Topic	12 volt - Battery condition checks - Battery replacement requirements
Market area	Bentley: worldwide (2WBE),China 723 Volkswagen (Anhui) Automotive CO (6723),China 796 VW Import Comp. Ltd (Vico), Beijing (6796)
Brand	Bentley
Transaction No.	2051562/15
Level	EH
Status	Released for publication
Release date	Feb 16 2026

All Models - 12 volt battery condition checks

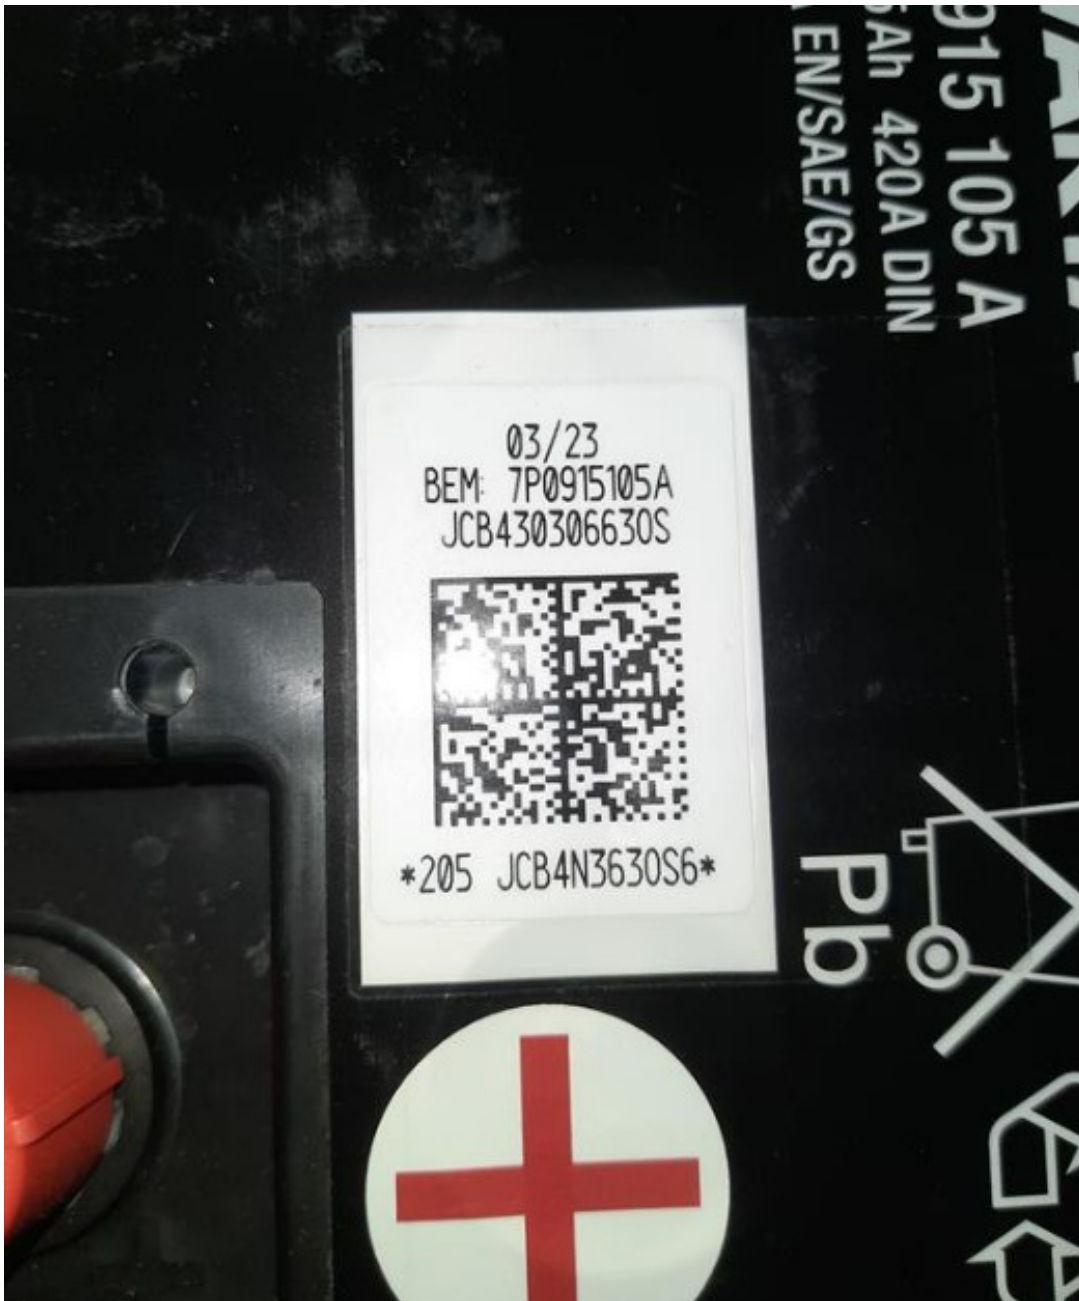
Figure 2

- Confirm the Alternator charge ratings are to specification - Refer to ElsaPro Rep.Gr 27 (*Not applicable to hybrid vehicles*)
- Attach a clear photo of the battery label (Figure 2) the photo must clearly show all information which is on the label
