Service Bulletin

Bulletin No.: PIT6413A

Subject: Radio Goes To Controls And Safety Screen And Displays Infotainment Features Unavailable Banner On Bottom Of Screen After Update

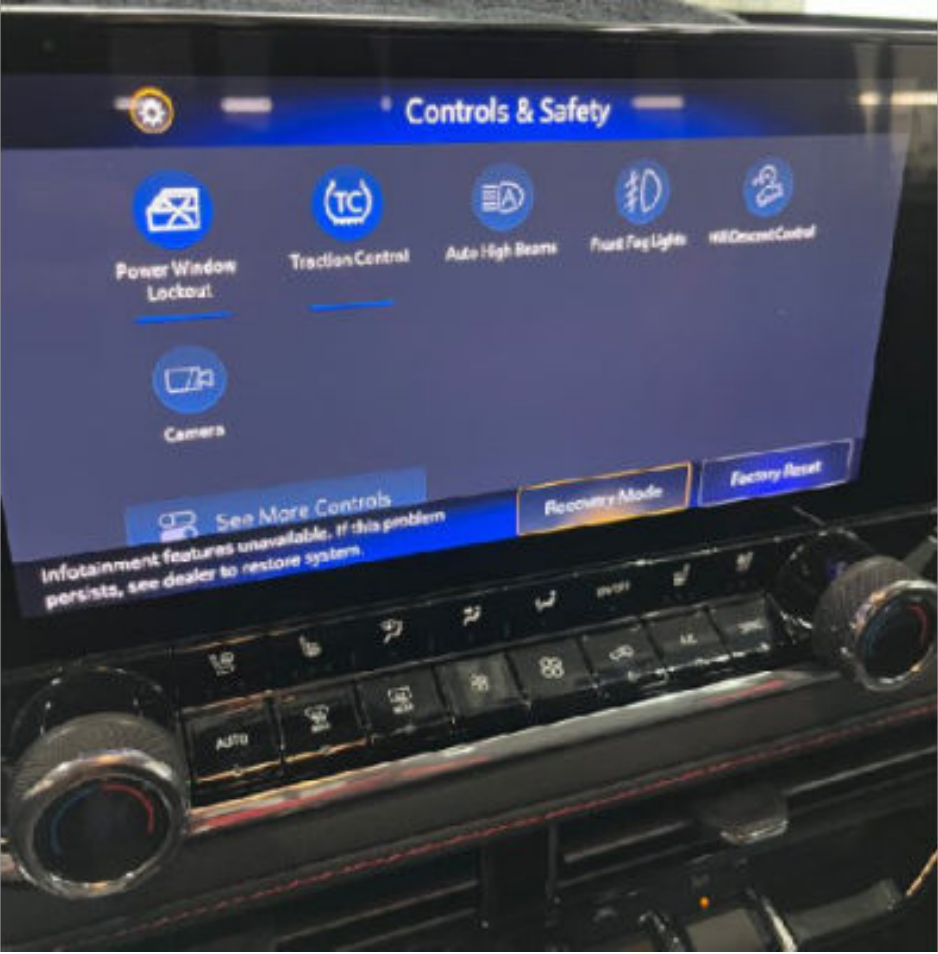
<p>Condition</p>	<p>A technician may notice after updating the A11 radio that it goes to the controls and safety page and displays a banner on the bottom of the screen that infotainment features are unavailable.</p>

<p style="text-align: right;">6985472</p>
<p>Cause</p>	<p>Software anomaly after the update</p>

On the banner on the bottom of the display, please hit factory reset and the radio will return to normal operation.
