SIM 65 03 26

“STORAGE SPACE RUNNING OUT” MESSAGE APPEARS – HU-H6  
2026-03-17

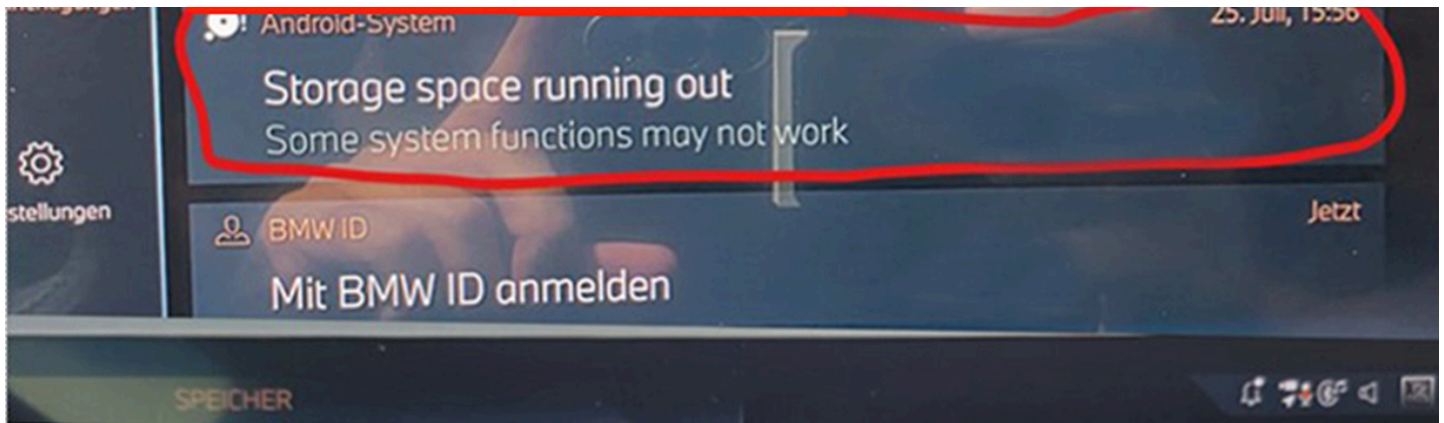
The following message is displayed on the central information display (CID): “Storage space running out”. Afterwards, apps can no longer be updated, and additional content can no longer be loaded.

Note: Photo shows the corresponding image for BMW. MINI is similar, using the MINI Interaction Unit.

Reset the head unit (HU-H6) to factory settings.

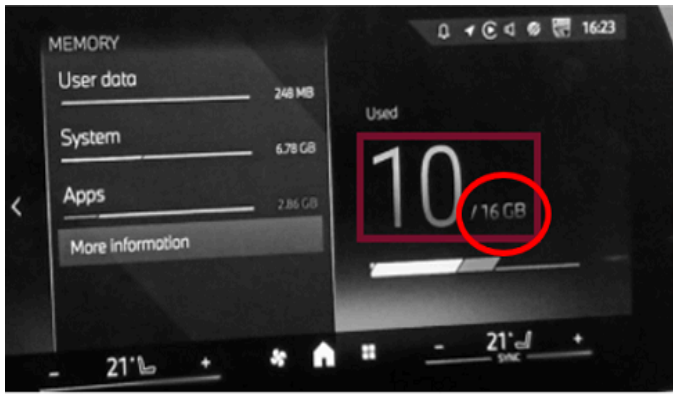
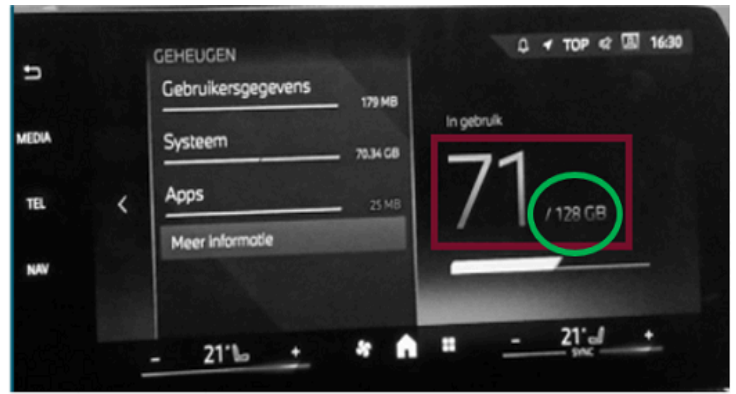
Access the Memory app in the CID. Under the “More Information” menu, check the used memory settings of the HU-H6. If the total memory settings show 16 GB instead of 128 GB, the HU-H6 memory settings are incorrect.

To restore the correct memory settings, perform a Factory Reset of the HU-H6 using the following path:

- App Menu
- System Settings
- Reset Vehicle Data
- Confirm

Recheck the Memory Capacity has changed to 128 GB.
