Technical Service Bulletin

GROUP	NUMBER
ENGINE MECHANICAL	26-EM-009H
DATE	MODEL(S)
MARCH 2026	SEE BELOW

SUBJECT: ECM SOFTWARE UPDATE FOR ITM LOGIC IMPROVEMENT – DTC P2B59F0

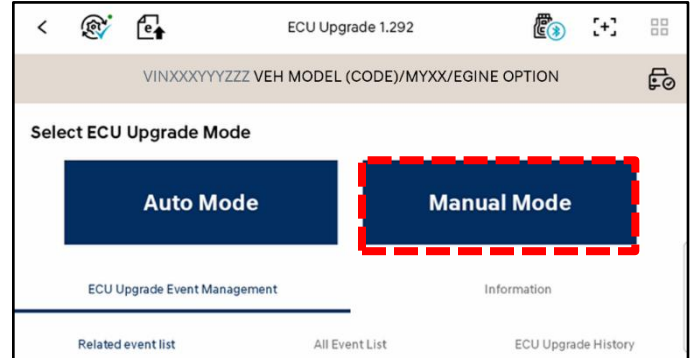
1. Perform the ECU update in **Manual Mode**.

Refer to **TSB # 25-GI-011H**, “**ECU Update Procedure for Tablet-Based GDS-Smart**”, for additional information.

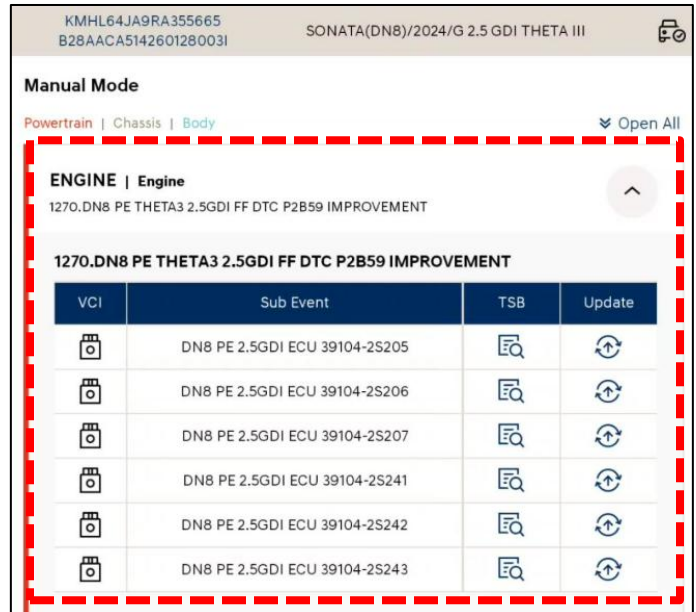
2. Verify the ROM ID by selecting the **ENGINE** system to scan the vehicle's current ROM ID.

Check the current ROM ID version and compare it to the [ROM ID Information](#) table before attempting to perform the software update.

If the update fails, remove the power connector from the in-cabin fuse box for at least **5 seconds**. Reassemble and retry the update.

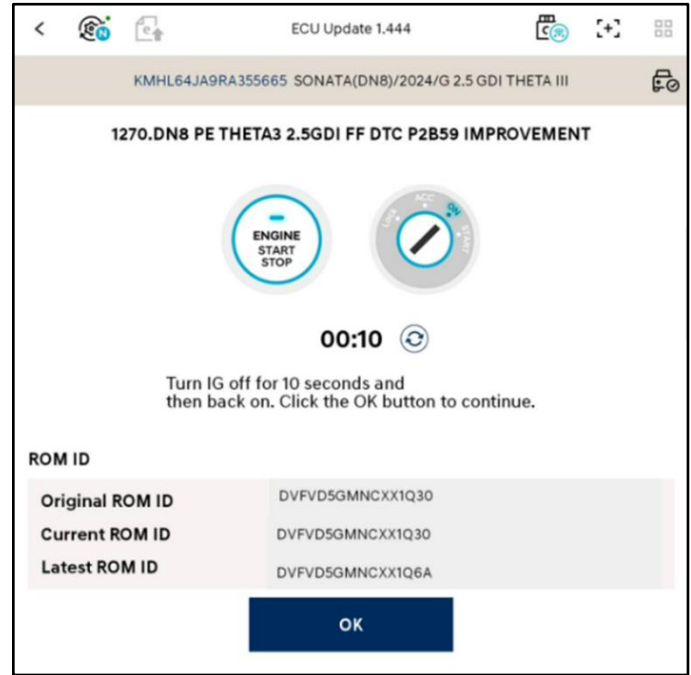
3. After the ECU update process shows 100% complete, follow the prompts on the screen to cycle the ignition **OFF** for at least **10 seconds** to reset the control unit (certain models may take up to **30 seconds**).

Use the **Refresh** button to reset the timer.

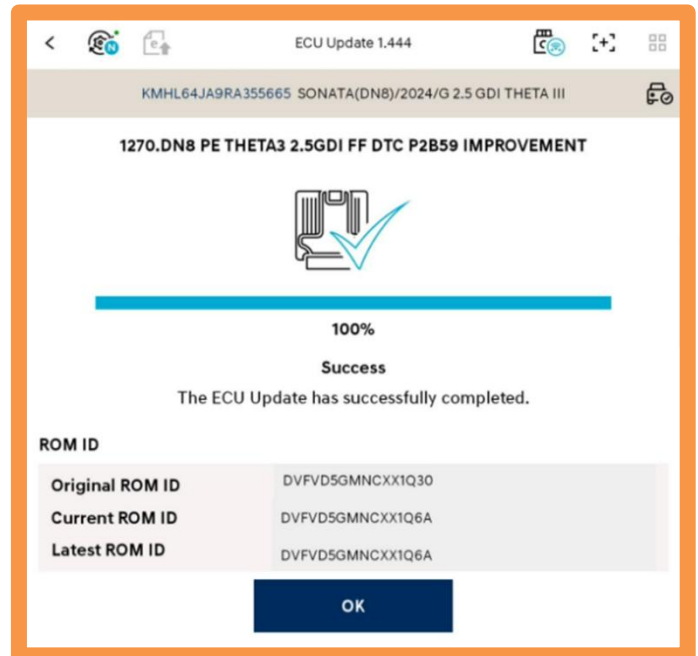
Using the tablet or GDS screen capture function, take a screenshot of the ECU Update "Success" result screen.

Upload the photo to STUI.

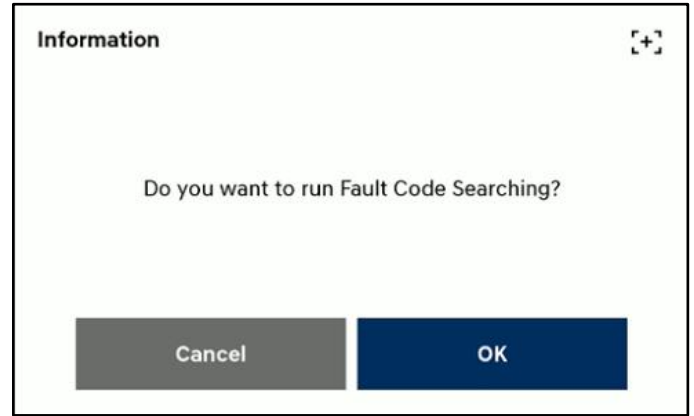
5. Perform an **All Systems Fault Code** search and erase DTC history that had incidentally occurred from the ECU update.
