# Service Bulletin

Bulletin No.: PIT6244A  
Date: March, 2026

**Subject:** Diagnostic Tip - 4WD Indicator Appears To Be Missing From IPC

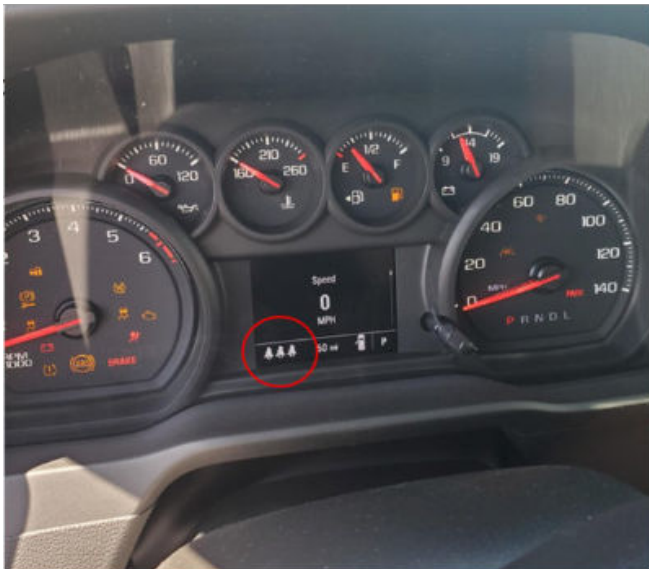
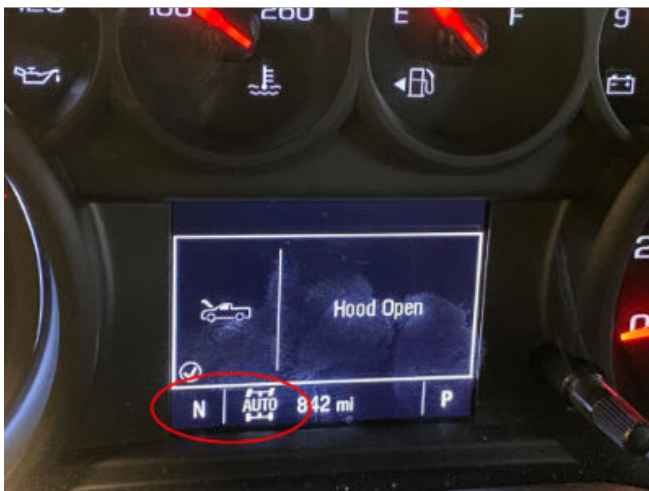
| Cause | The cause of this condition could be a misunderstanding that the left lower corner of the DIC has a dual purpose, which displays the rear passenger seat belt indicators and the four-wheel drive indicator (with compass if equipped), shown below. |

None. It is normal operation that when the vehicle is first started, the left lower corner of the DIC will display the rear seat belt reminder and then after the vehicle is driven a short distance it will change and display the four wheel-drive indicator. While the four-wheel drive indicator is displayed it will flash during transfer case shifting (2WD, 4WD, Auto, etc.) to indicate the shift is occurring.
