WST 47X 561 Crossmember Steel Replacement

FIELD SOLUTION: *TSB 31-019 WST*

PUBLISH DATE: 11/25/2025

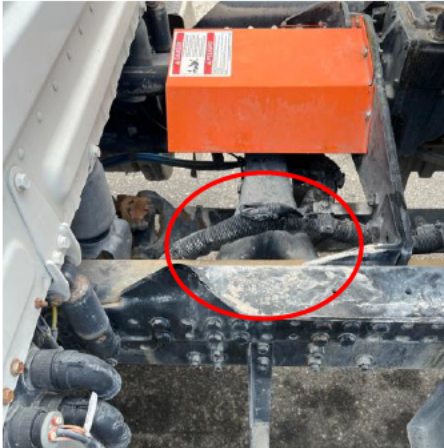
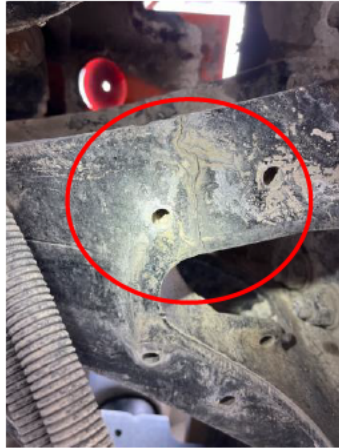
VISUALIZATION:

- Cracked one-piece Aluminum back of transmission crossmembers.
- 47X concrete mixer applications were not ordered to use steel heavy duty crossmembers.
- One-piece Aluminum cross member not suitable for load conditions at back of transmission location on concrete mixer applications.

- Production trucks from July 2024 specified with steel cross member from factory.
- TSB covers replacement of Aluminum crossmember with 5 piece bolted cross member.
