Parking Brake Improvement

The bolts for the parking brake can come loose and create premature wear on the rim.

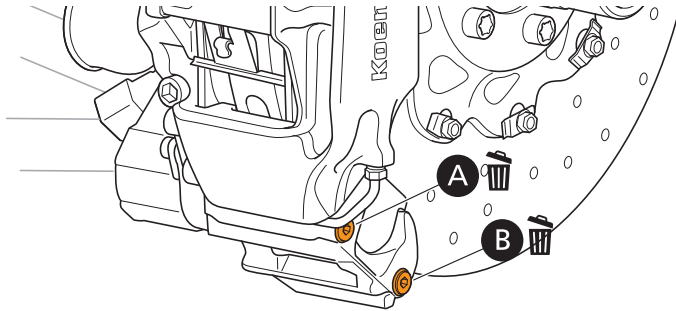
This instruction is applicable on RH and LH side. The illustration shows the LH side.

1. Do a check of the LH and RH parking brake calipers to make sure that there are no scratches or other damages.
 - 1.1 If you find a scratch or other damages, submit a KATS ticket to contact Koenigsegg.
 - 1.2 If there are no damages on the parking brakes, continue with the next step.
2. Do a check of the inner side of the LH and RH rear rim spokes. Make sure that there are no scratches or other damages that are caused by the parking brake.
 - 2.1 If you find a scratch or other damages, submit a KATS ticket to contact Koenigsegg.
 - 2.2 If there are no damages on the rear rim spokes, continue with the next step.
3. Remove and discard the H6 bolt **A** from the parking brake caliper.

4. Install the new H6 bolt to the parking brake caliper.
Part: 130-174-0553
Threadlocker: Loctite 270
Torque: 10 Nm
5. Remove and discard the H6 bolt **B** from the parking brake caliper.
6. Install the new H6 bolt to the parking brake caliper.
Part: 130-174-0553
Threadlocker: Loctite 270
Torque: 10 Nm
7. Do steps **3** thru **6** on the other side of the vehicle.
