Technical Service Bulletin

Mazda North American Operations
Irvine, CA 92618-2922

| Subject: ENGINE TEMPERATURE AND HEATER PERFORMANCE CONCERNS WITH OR WITHOUT DTC P0126:00 | Bulletin No.: 01-001/26 |

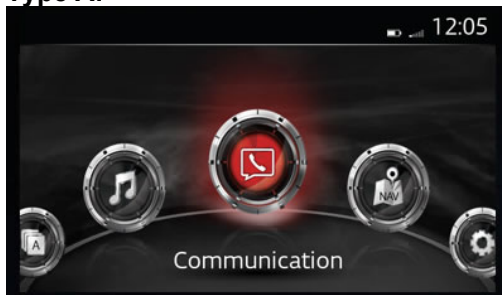
Type A:

NOTE: 2020 CX-5 with **Type B** Mazda Connect (7th Gen Infotainment) use MDARS and models with **Type A** Mazda Connect (6th Gen Infotainment) use IDS.

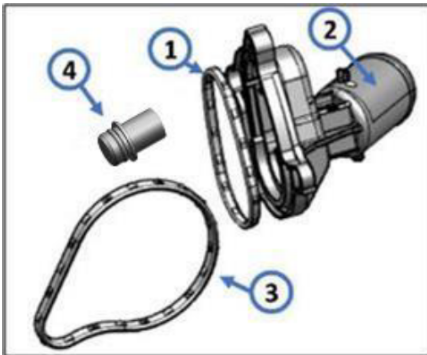
Dummy Plug for CCV set includes:

1. Thermostat cover gasket*
2. Thermostat cover
3. Water outlet gasket
4. Dummy Plug

*Thermostat cover gasket is already assembled to the thermostat cover.

Fig. 2: Correct dummy plug (4) orientation to the thermostat cover (2).
