**SSPD8 - ENGINE TEMPERATURE AND HEATER PERFORMANCE CONCERNS WITH OR WITHOUT DTC P0126:00**

**WARRANTY EXTENSION**

**REPAIR PROCEDURE & PARTS AND WARRANTY INFORMATION  
WARRANTY EXTENSION SSPD8**

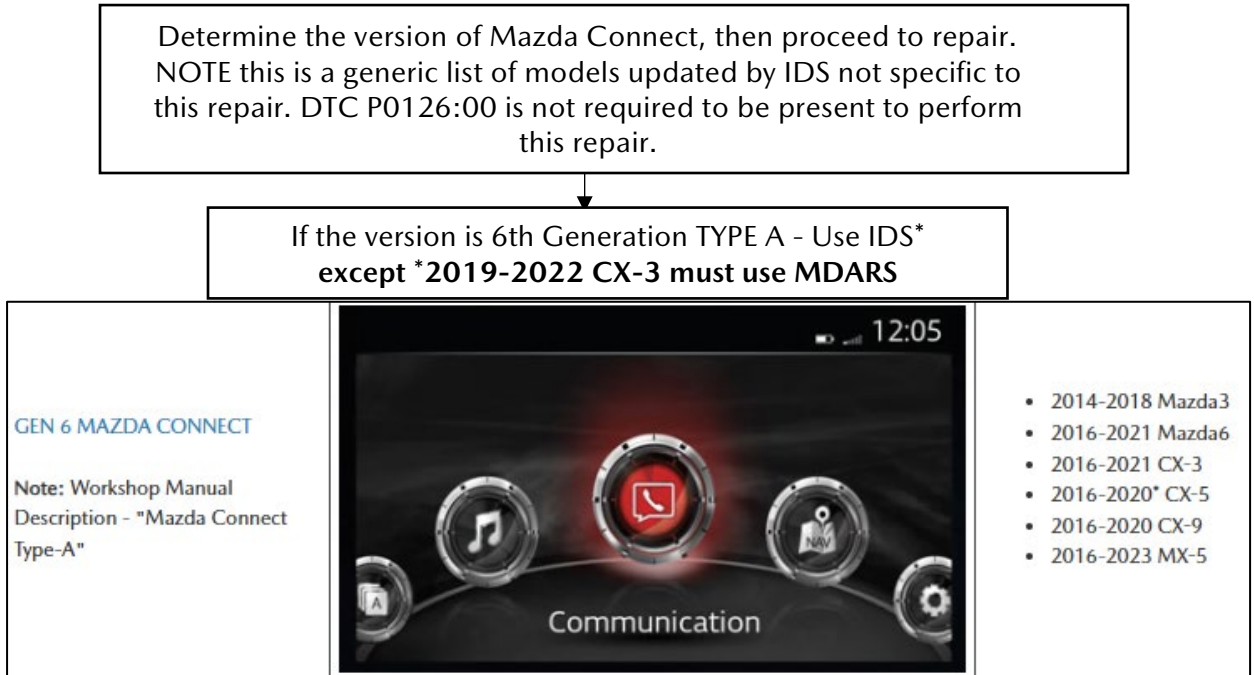
REPAIR PROCEDURE – FLOW CHART

Section A: Flow Chart: **NOTE: This Flow Chart needs to be followed strictly.**

The dummy plug and PCM update repair procedure are required as of December 8, 2025. The TSB has been updated to repair with the dummy plug and PCM update here: [6](#).
