## Volvo Car USA LLC

## Technical Journal

| Technical Journal Title<br>Check Engine Light with DTC ECM P044100 | | Ref. No.<br>TJ 37666.1.0 | |

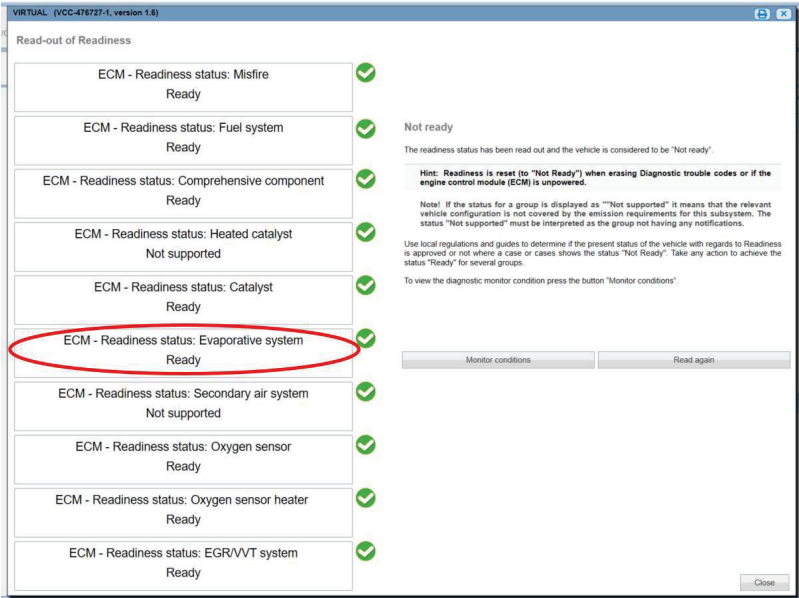
TJ 37666

Ensure that the Evaporative System monitor has reached "Ready" status before releasing the vehicle. See the attached image for more information.

After installing the software, verify the EVAP system is fault-free by checking the Readiness Monitors in VIDA. (VIDA > Planning and Diagnostics > Compo > Diagnostic Sequences > Read-out of Readiness)
